WELL ID: MW-19
LOGGING DATE: JUNE 15, 2011

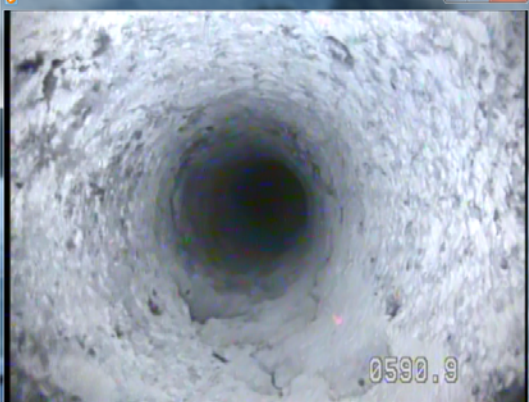
Depth: 590.9 Down view of possible fracture and vuggy porosity.	Depth: 591.9 Possible fracture.

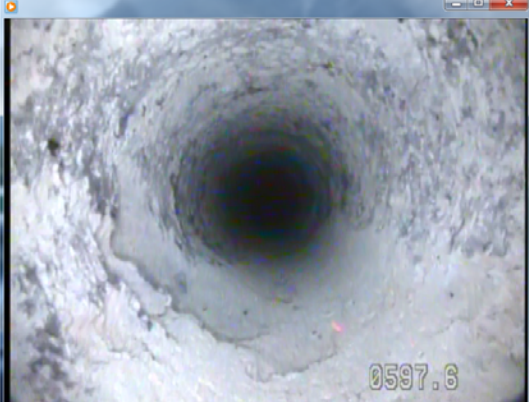
Depth: 597.6 Possible vuggy porosity.	Depth: 596.1 Coarse grained limestone.

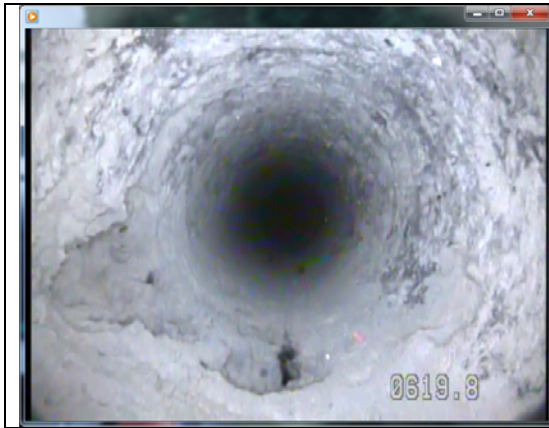
Depth: 619.8
Possible vuggy porosity.

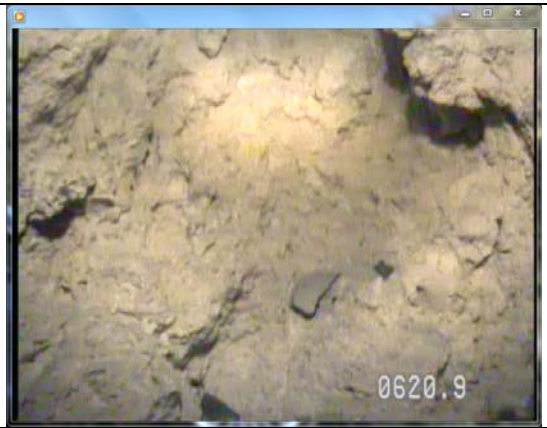
Depth: 620.9
Possible vugs or hollows.

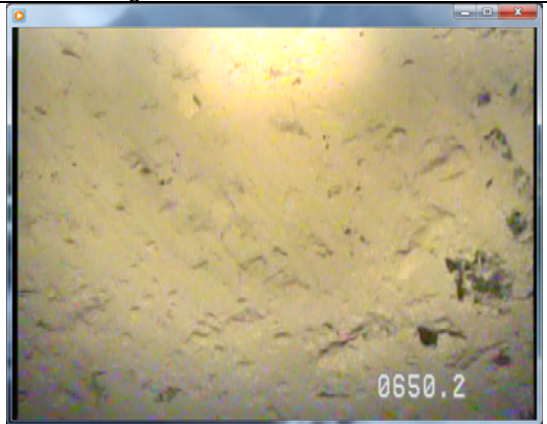
Depth: 650.2
Fine grained limestone with possible vugs.

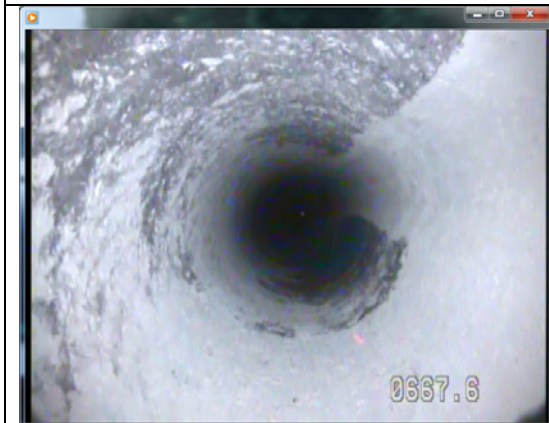
Depth: 667.6
Down view of color variations.

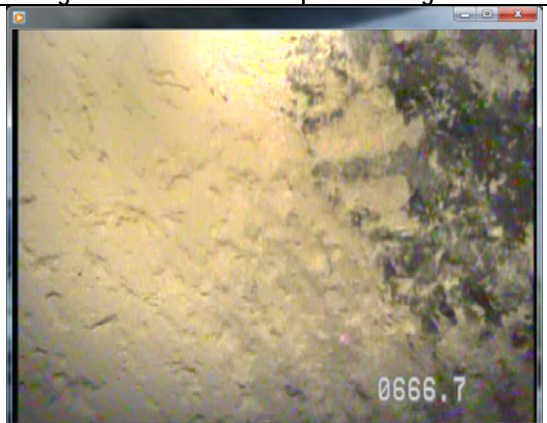
Depth: 666.7
Fine grained limestone with possible vugs.

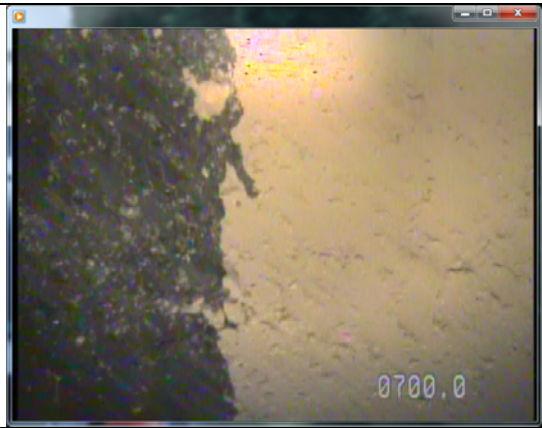
Depth: 700.0
Fine grained limestone with discoloration boundary.

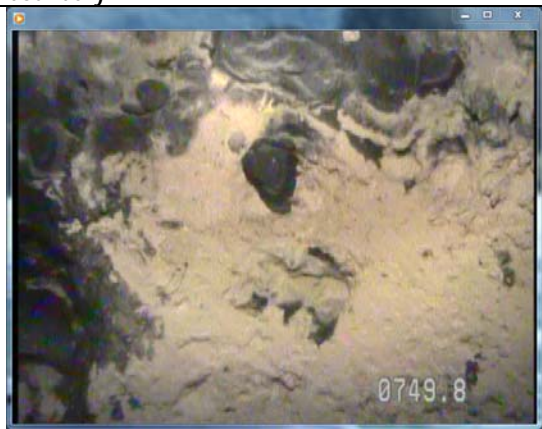
Depth: 749.8
Coarse grained limestone with moldic porosity.

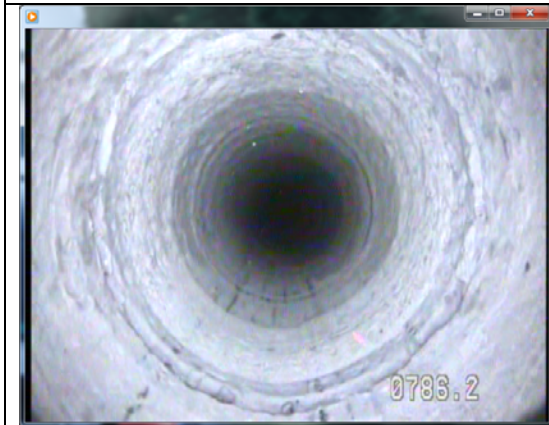
Depth: 786.2
Down view of clay bed.

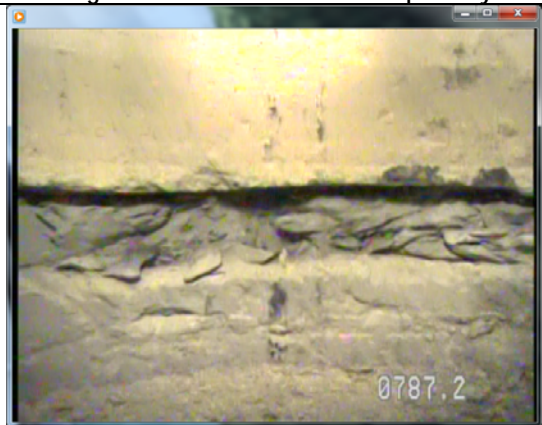
Depth: 787.2
Clay marker bed.

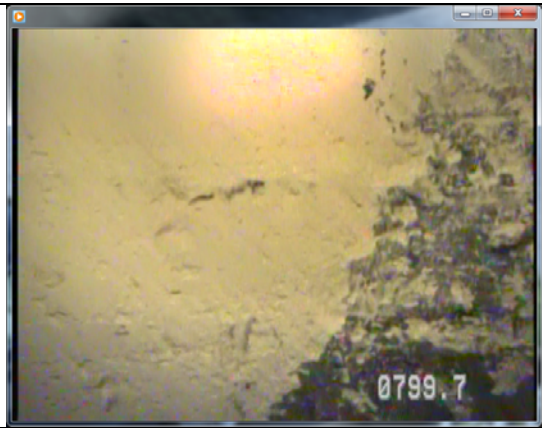
Depth: 799.7
Fine grained limestone with discoloration boundary.

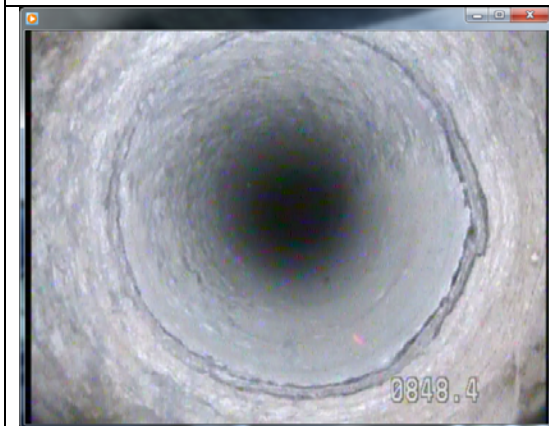
Depth: 848.4
Bedding transitions.

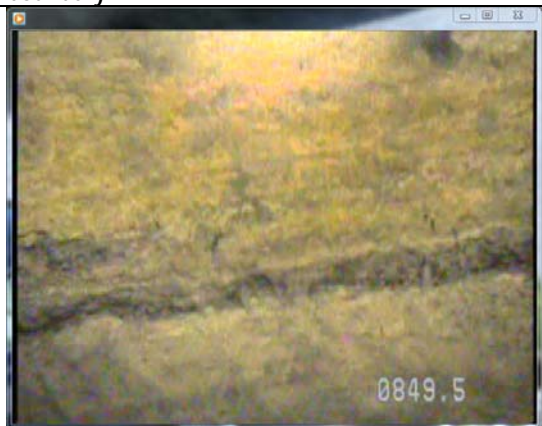
Depth: 849.5
Bedding transitions.

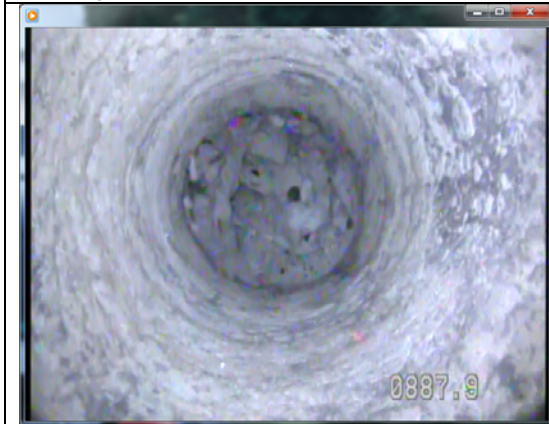
Depth: 887.9
Down view of bottom of borehole.

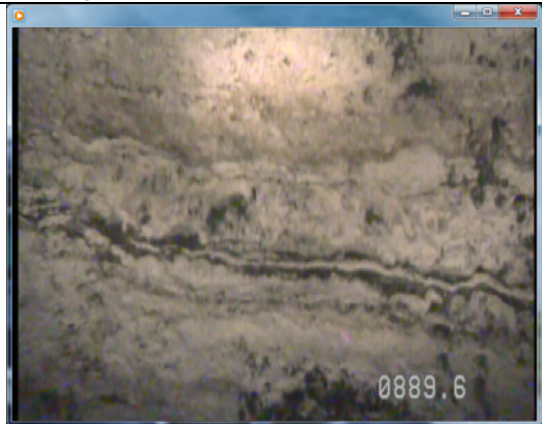
Depth: 889.6
Bedding transitions.
