S-197 Structure Replacement Project Overview

South Miami-Dade Water Issues Coordination Roundtable

March 1, 2011

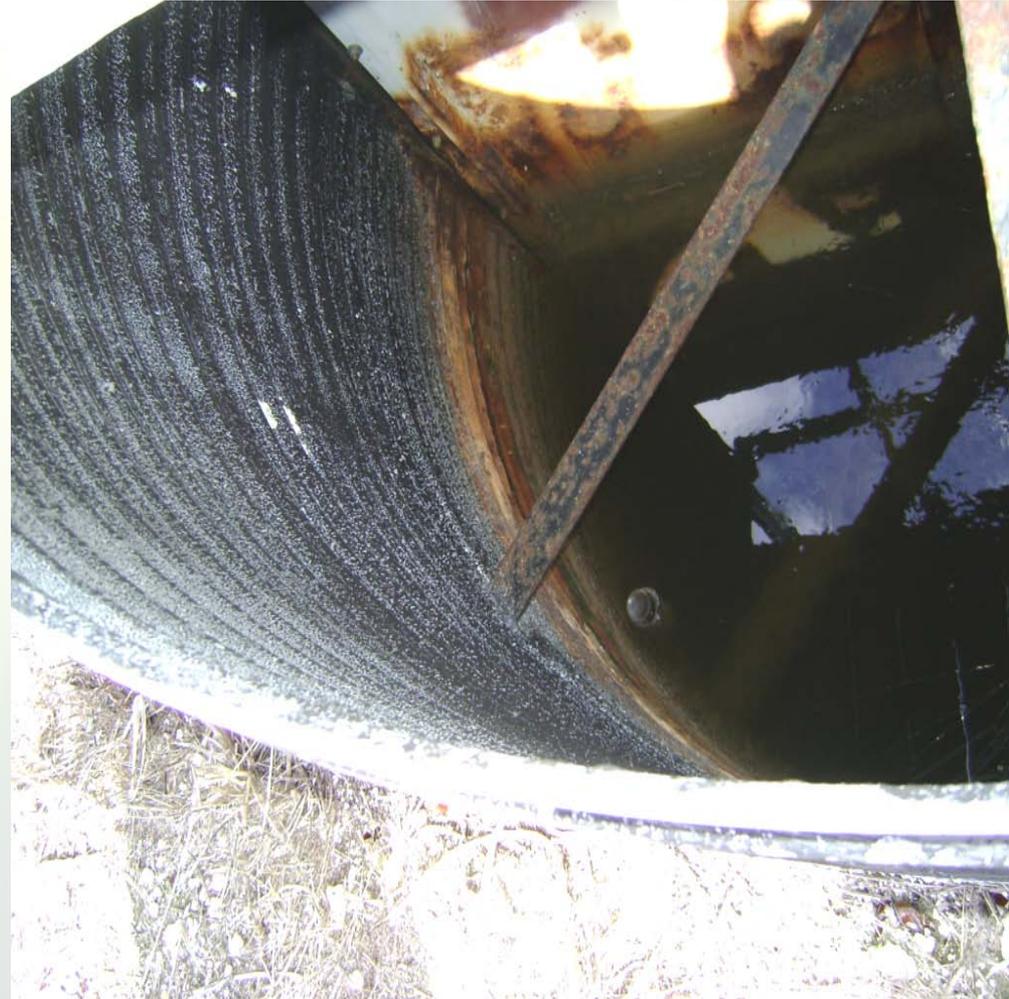
- In 2007, our Structure Inspection Program identified 100 percent structural damage in the form of holes in sections of the top of the culverts, and cracks on the gates, gate-tracks, and risers.
- This damage is caused by corrosion in this saline environment.
- *Photo shows damage to gate and riser due to corrosion.*

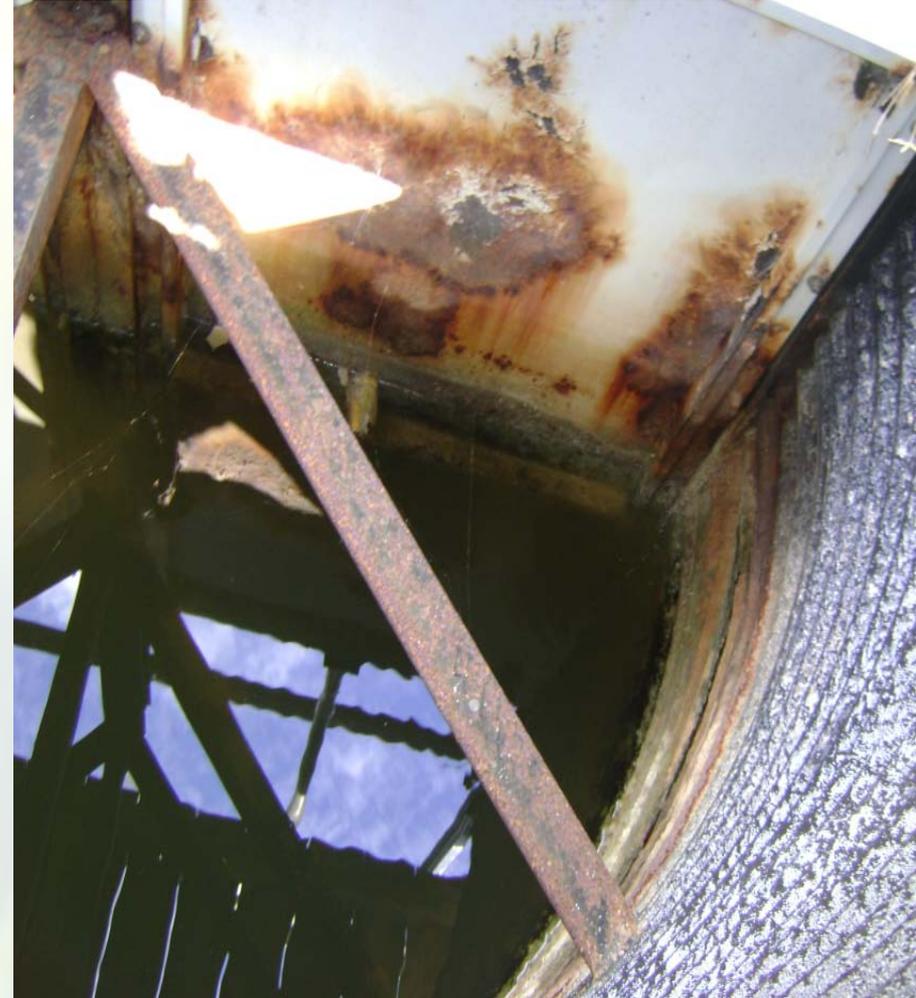
- In 2009, an underwater video revealed 100 percent structural losses throughout all the culverts.
- Structural losses appeared as advanced corrosion throughout all culverts, gates and risers, rendering the structure inoperable as intended.
- Flow through the closed gates could clearly be seen (gates are leaking significantly).
- *Photo shows structural loss to one of the gates.*

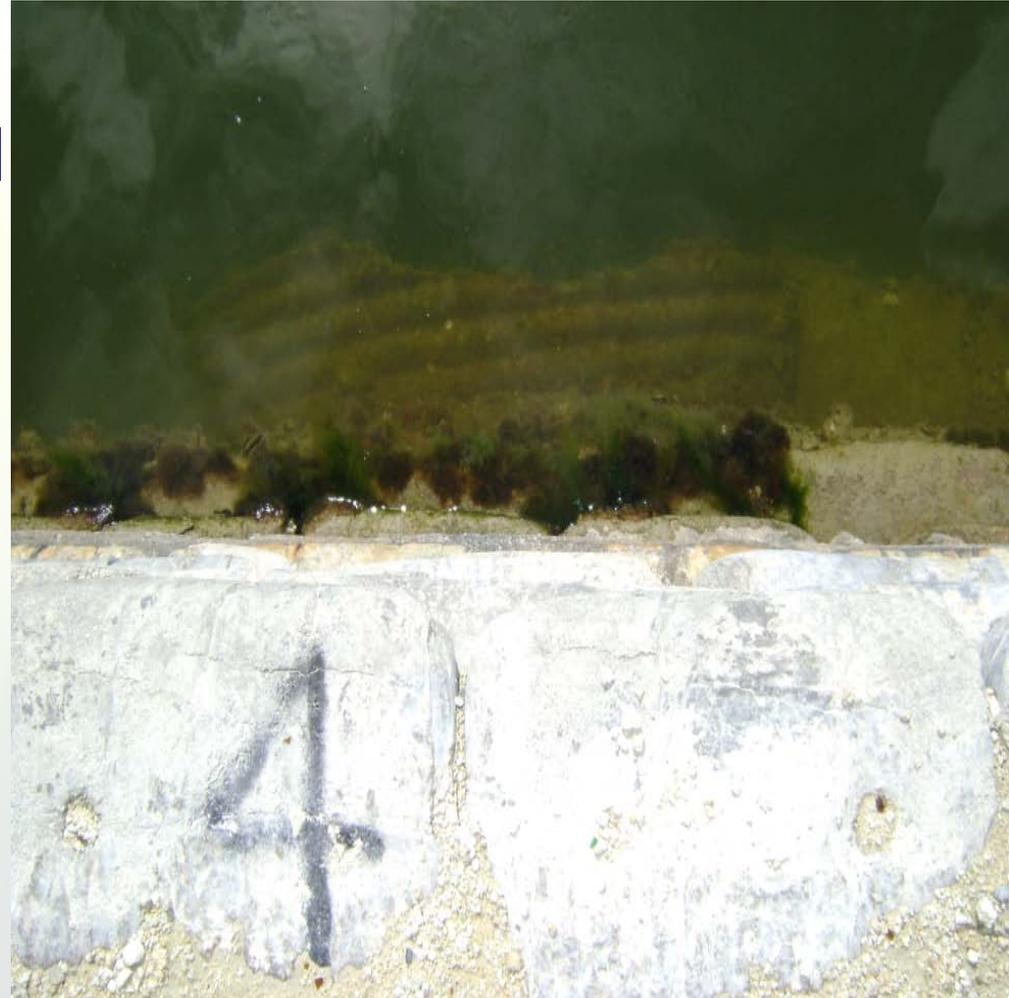
- Evidence of erosion of the earthen-plug material holding the culverts together.
- If this structure were needed during a storm event, the likelihood of failure would be very high.
- *Photo shows corrosion damage in one of the culverts.*
