CITY OF STUART DEEP MONITOR WELL REHABILITATION PLAN

Deep Monitor Well Plan August 2, 2012

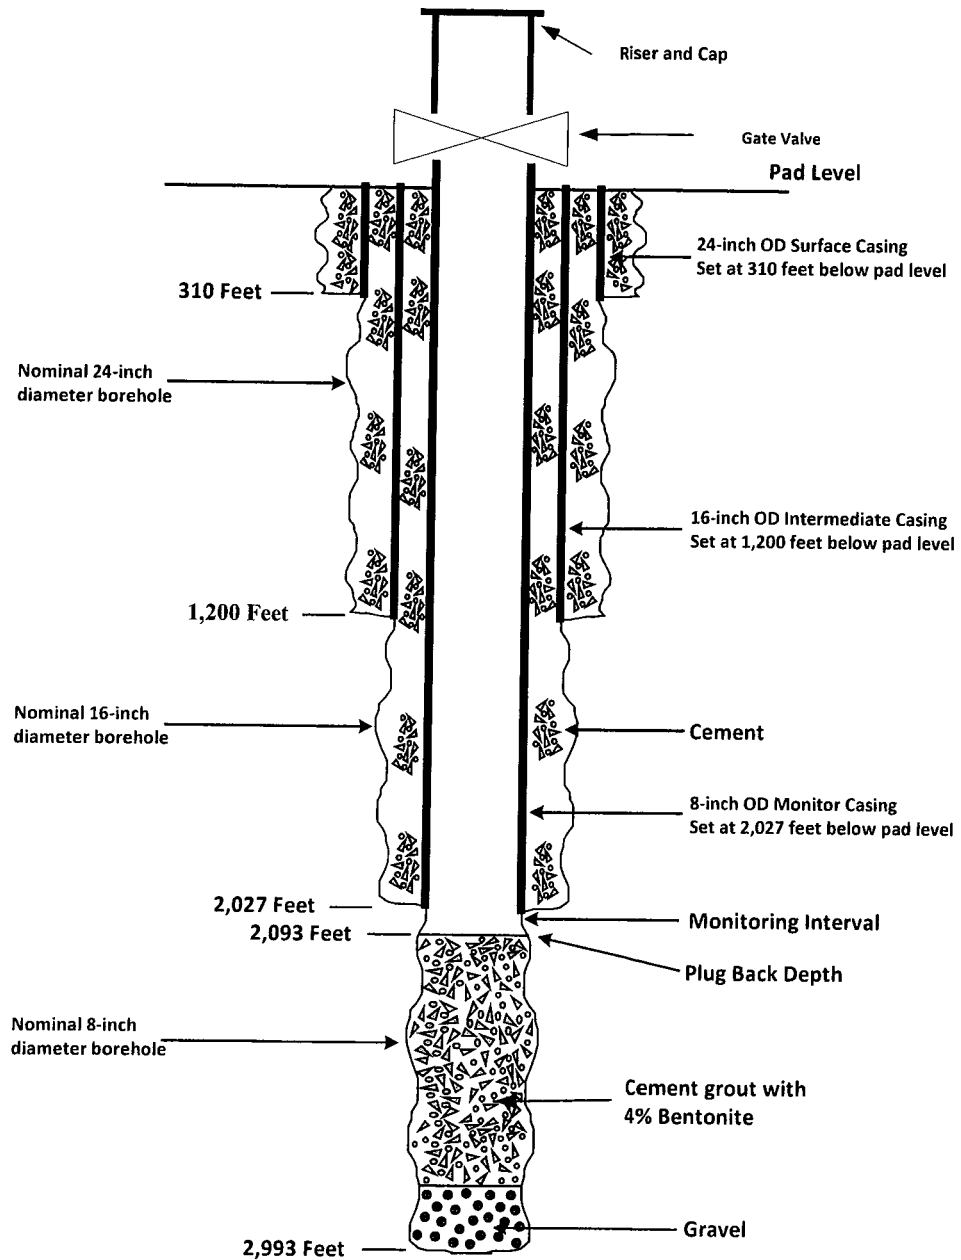
**City of Stuart Water Reclamation Facility
Deep Monitor Well - DMW-1
Figure 2**

Deep Monitor Well, DMW-1 was originally constructed as an exploratory or observation well in connection with Injection Well IW-1, which was constructed in 1974. Well DMW-1 was plugged back to its current configuration in 1982 and was part of the IW-1 monitoring system until 1995, when FDEP required the City to install a deep monitor well closer to IW-1. When Injection Well IW-2 was constructed in 1997, DMW-1 became the deep monitor well associated with IW-2 since it was located only 50 feet from IW-2. A diagram showing the construction details of DMW-1, as described in the report entitled "Rehabilitation of the Deep Injection and Monitoring Wells at the Stuart Wastewater Treatment Plant, dated April 1982. The diagram showing the known construction details of DMW-1 is presented as Figure 2.

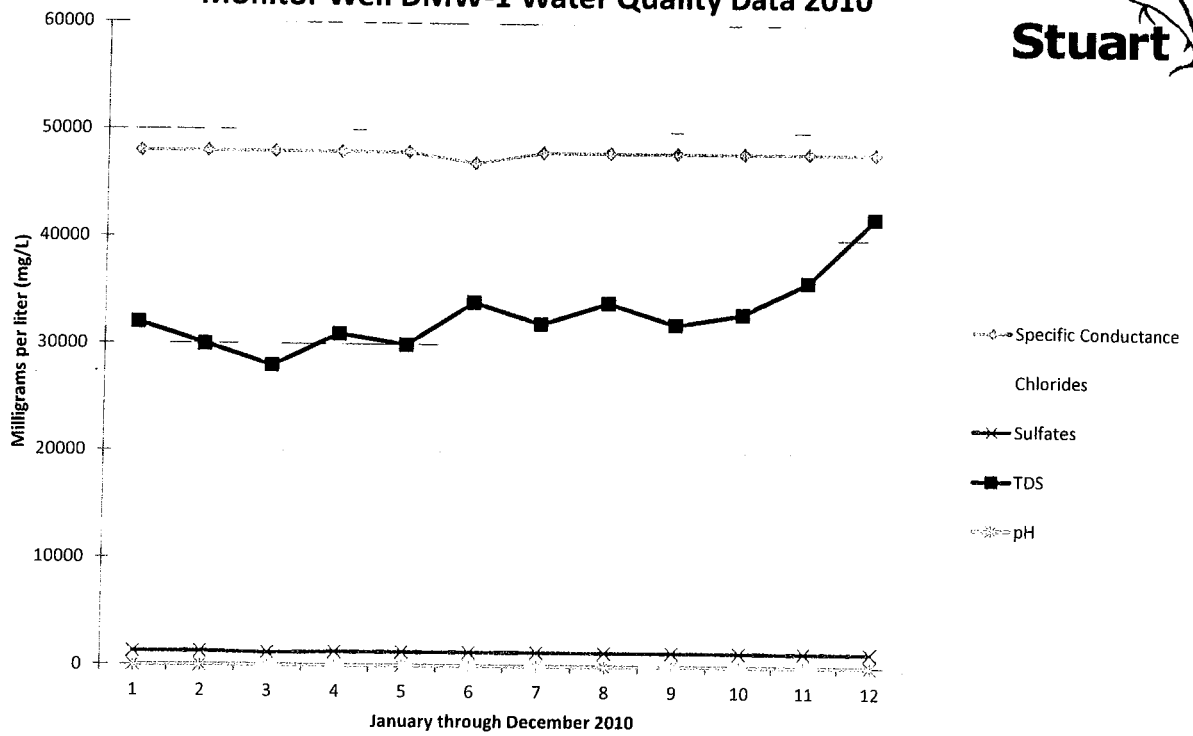
Figure 3
Monitor Well DMW-1 Water Quality Data 2010

Additionally, graphs showing water quality data trends for DMW-1 during 2010 and 2011 are shown as Figures 3 and 4.

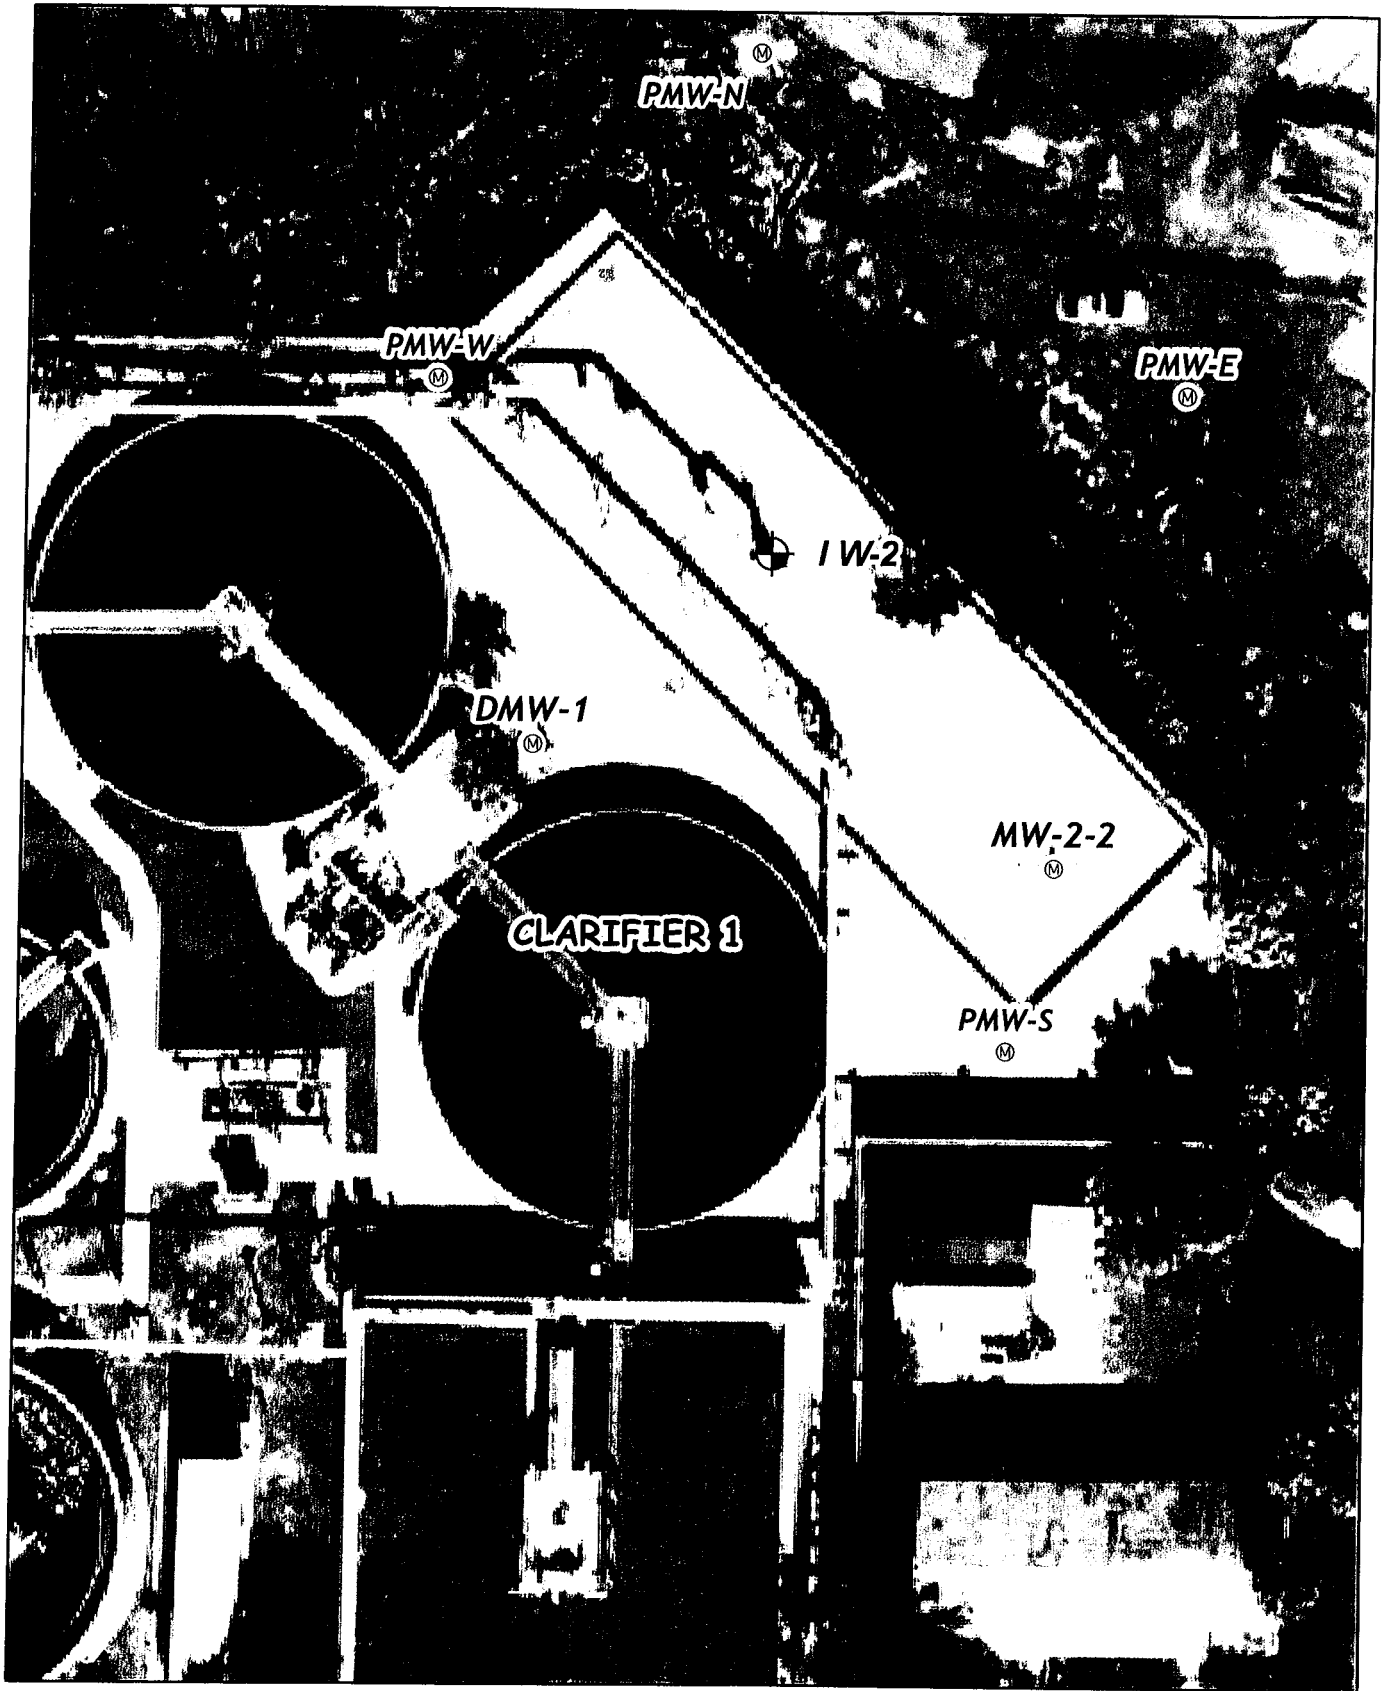
CLARIFIER 1 LOCATION FIGURE 5

The current wellhead configuration as described above will be changed to add a tee above the gate valve to enable entry into the well from above, as well as a discharge pipeline to an empty clarifier (Clarifier #1) which will be used to collect and isolate the water discharged from the well. Figure 5 shows a recent plant site map, showing the location of DMW-1 relative to Clarifier #1 and IW-2. A settling tank also will be used to isolate a majority of the material scraped from the casing so it does not go into the clarifier.

The water removed from the well will initially be isolated in an un-used clarifier tank at the plant. The high chloride water will slowly be added into the plant flow over a period of days without disrupting the wastewater process. A settling tank will be used to contain some of the
