WELL ID: MW-19
LOGGING DATE: JUNE 15, 2011

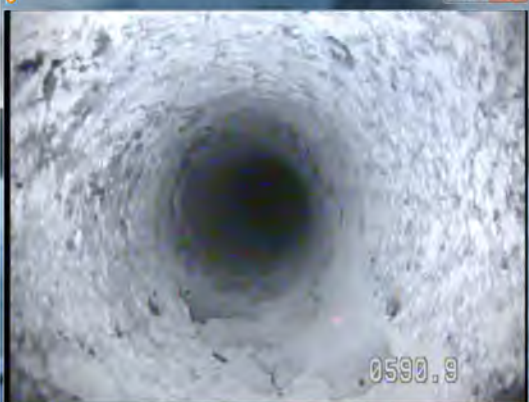
Depth: 590.9 Down view of possible fracture and vuggy porosity.	Depth: 591.9 Possible fracture.

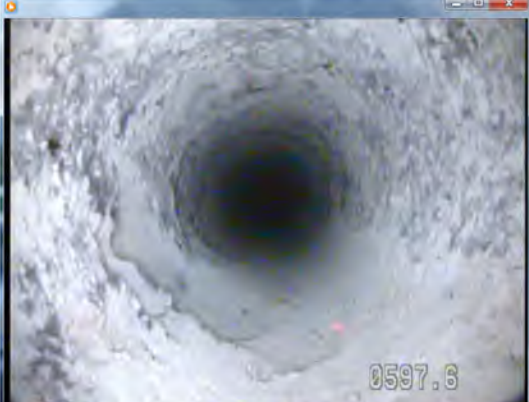
Depth: 597.6 Possible vuggy porosity.	Depth: 596.1 Coarse grained limestone.

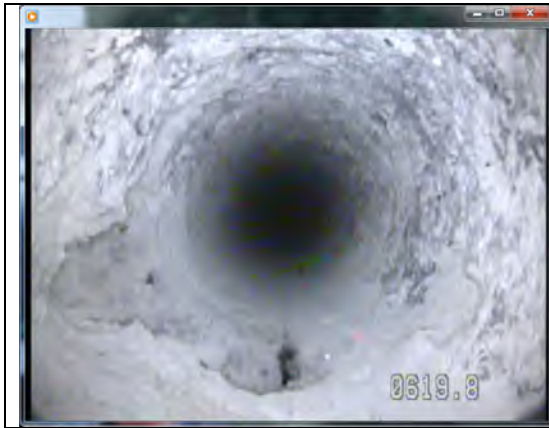
Depth: 619.8
Possible vuggy porosity.

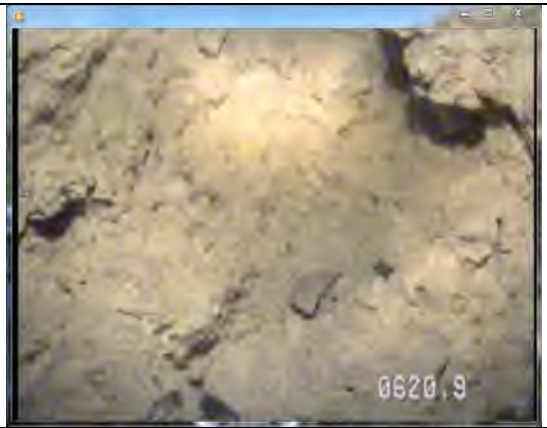
Depth: 620.9
Possible vugs or hollows.

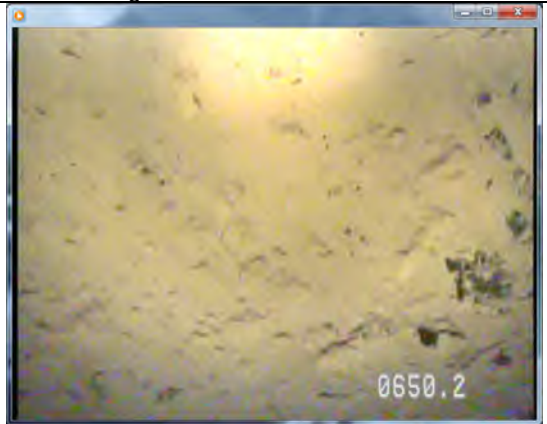
Depth: 650.2
Fine grained limestone with possible vugs.

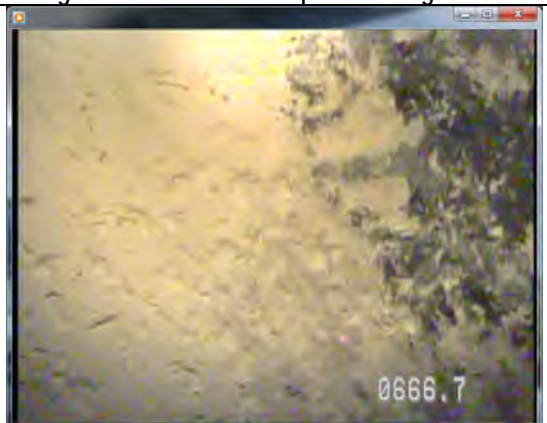
Depth: 666.7
Fine grained limestone with possible vugs.

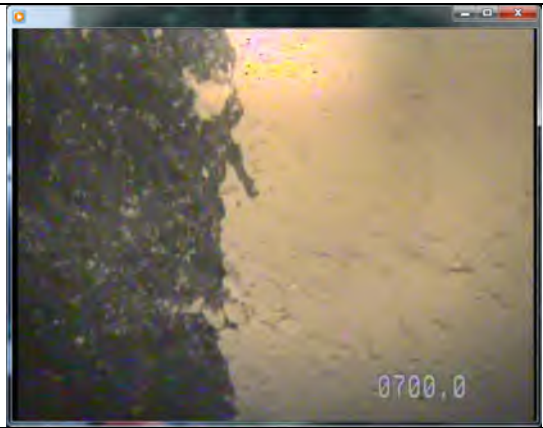
Depth: 700.0
Fine grained limestone with discoloration boundary.

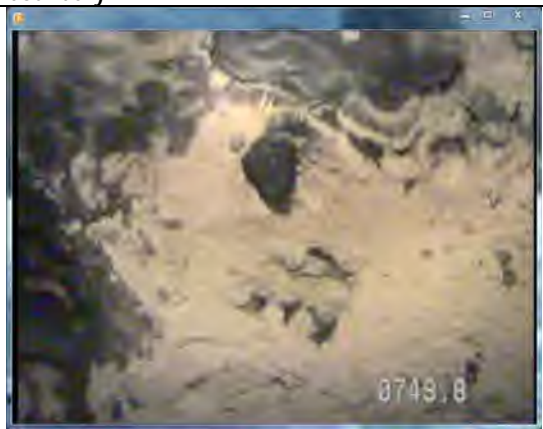
Depth: 749.8
Coarse grained limestone with moldic porosity.

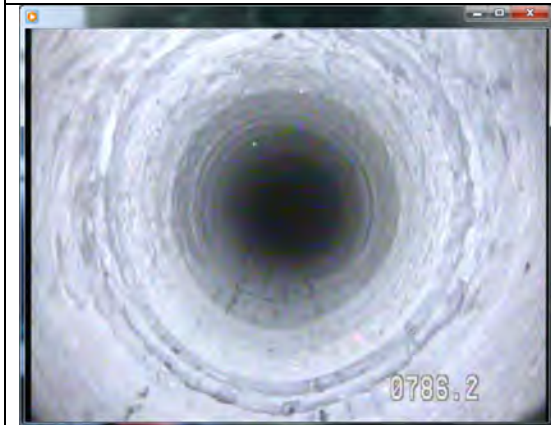
Depth: 786.2
Down view of clay bed.

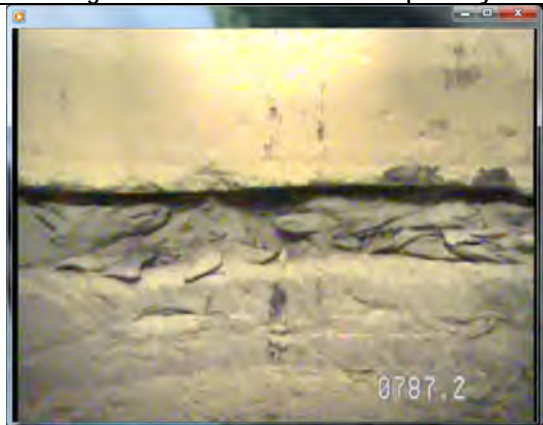
Depth: 787.2
Clay marker bed.

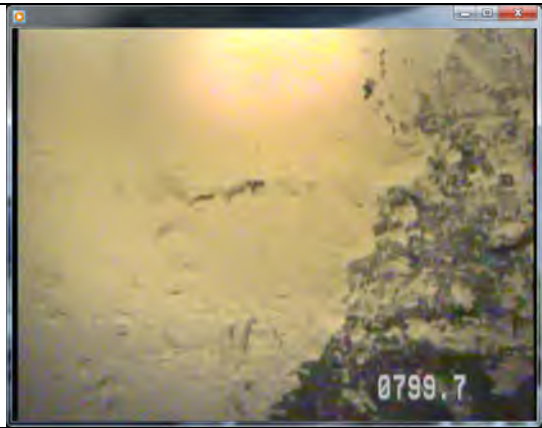
Depth: 799.7
Fine grained limestone with discoloration boundary.
