Governing Board Meeting
August 15, 2013

ECOLOGICAL CONDITIONS UPDATE

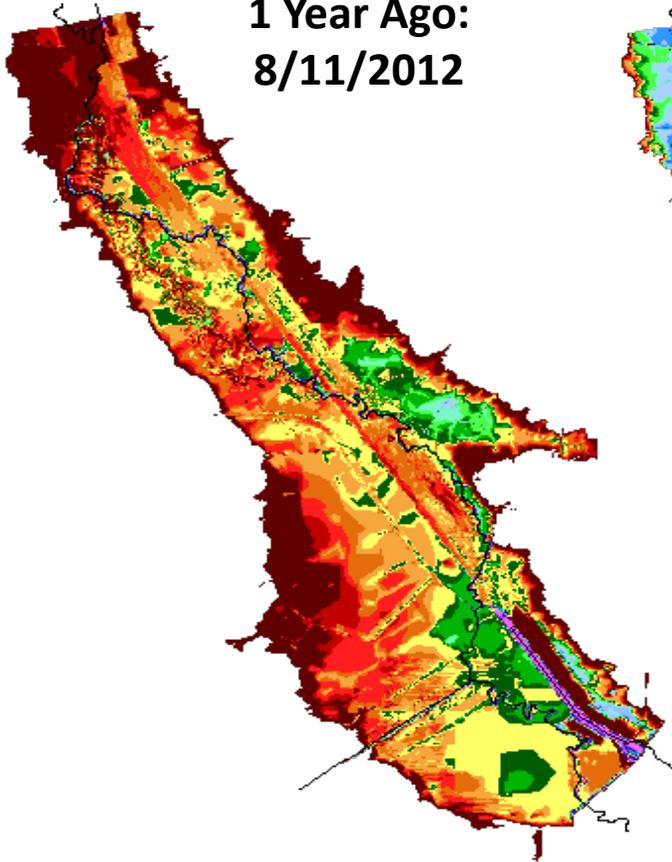
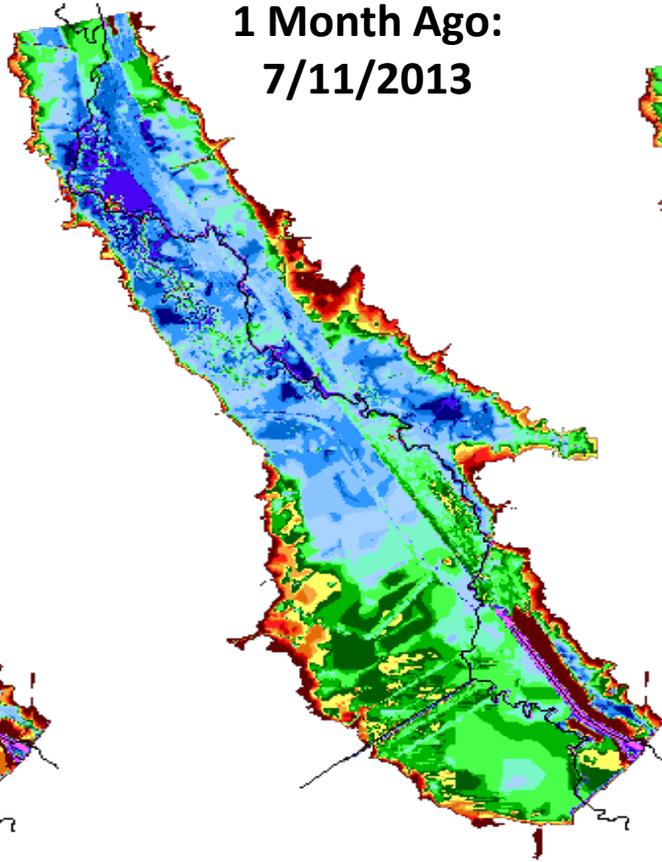
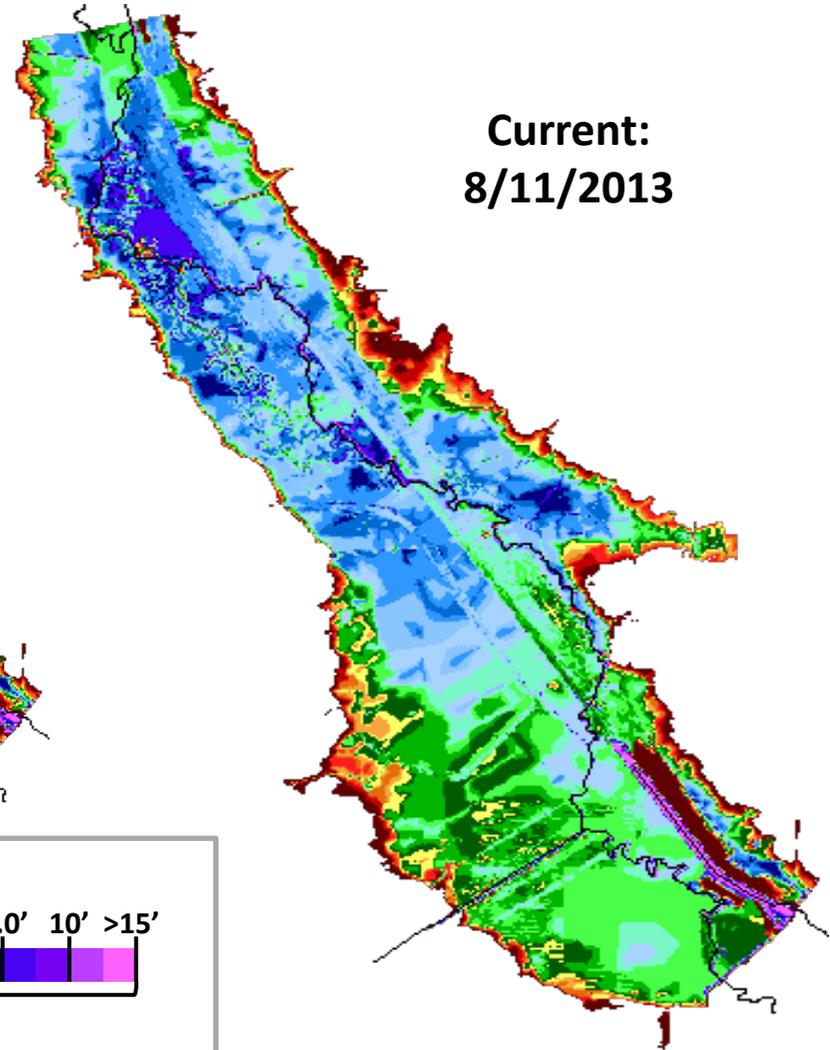
Water Depth Maps

1 Year Ago:
8/11/2012

1 Month Ago:
7/11/2013

Current:
8/11/2013

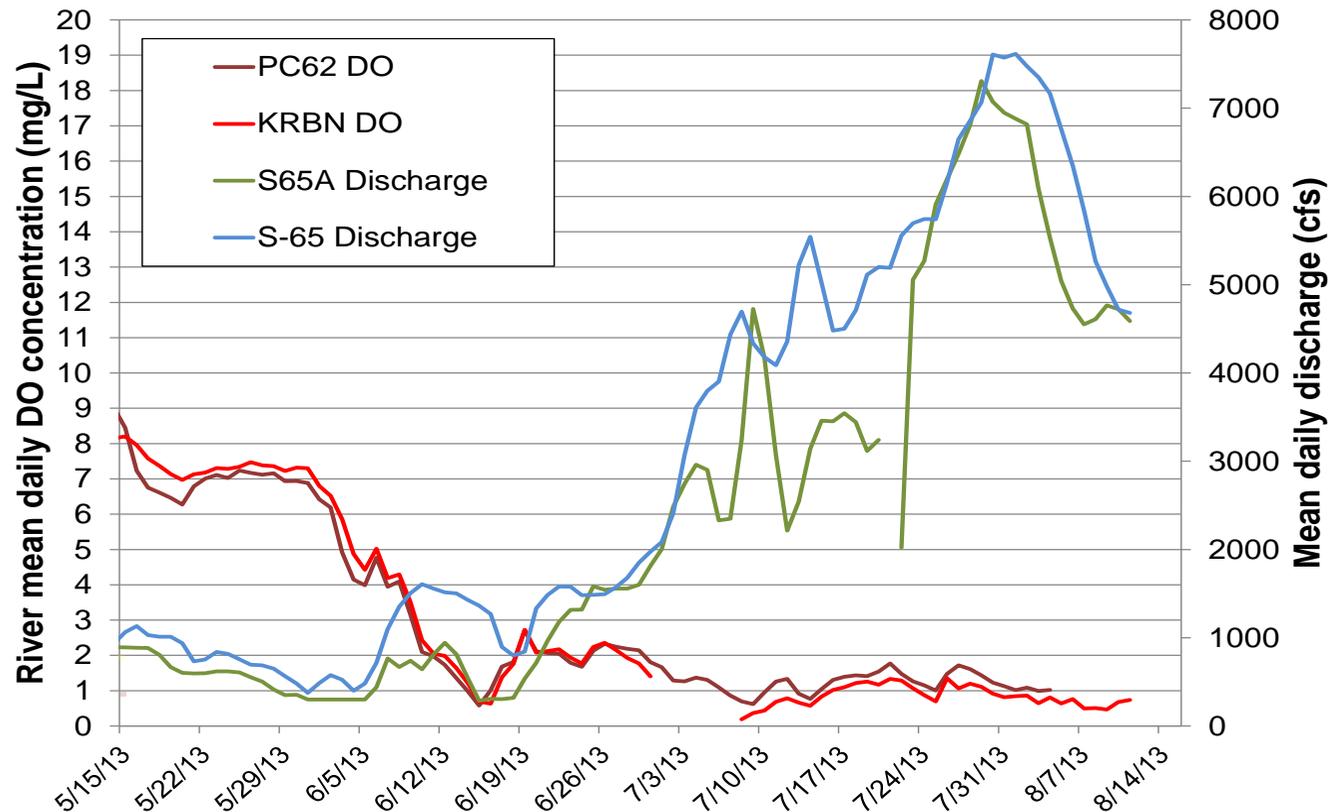
- During and after high rain/discharge events, river DO can crash

- *DO Level of Concern: below 2 mg/L (stressful)*
- *DO Critical Level: below 1 mg/L (can be lethal)*

Currently, DO in the river is averaging 1.2 mg/L (just above the critical level) and has improved recently on the floodplain to a similar level

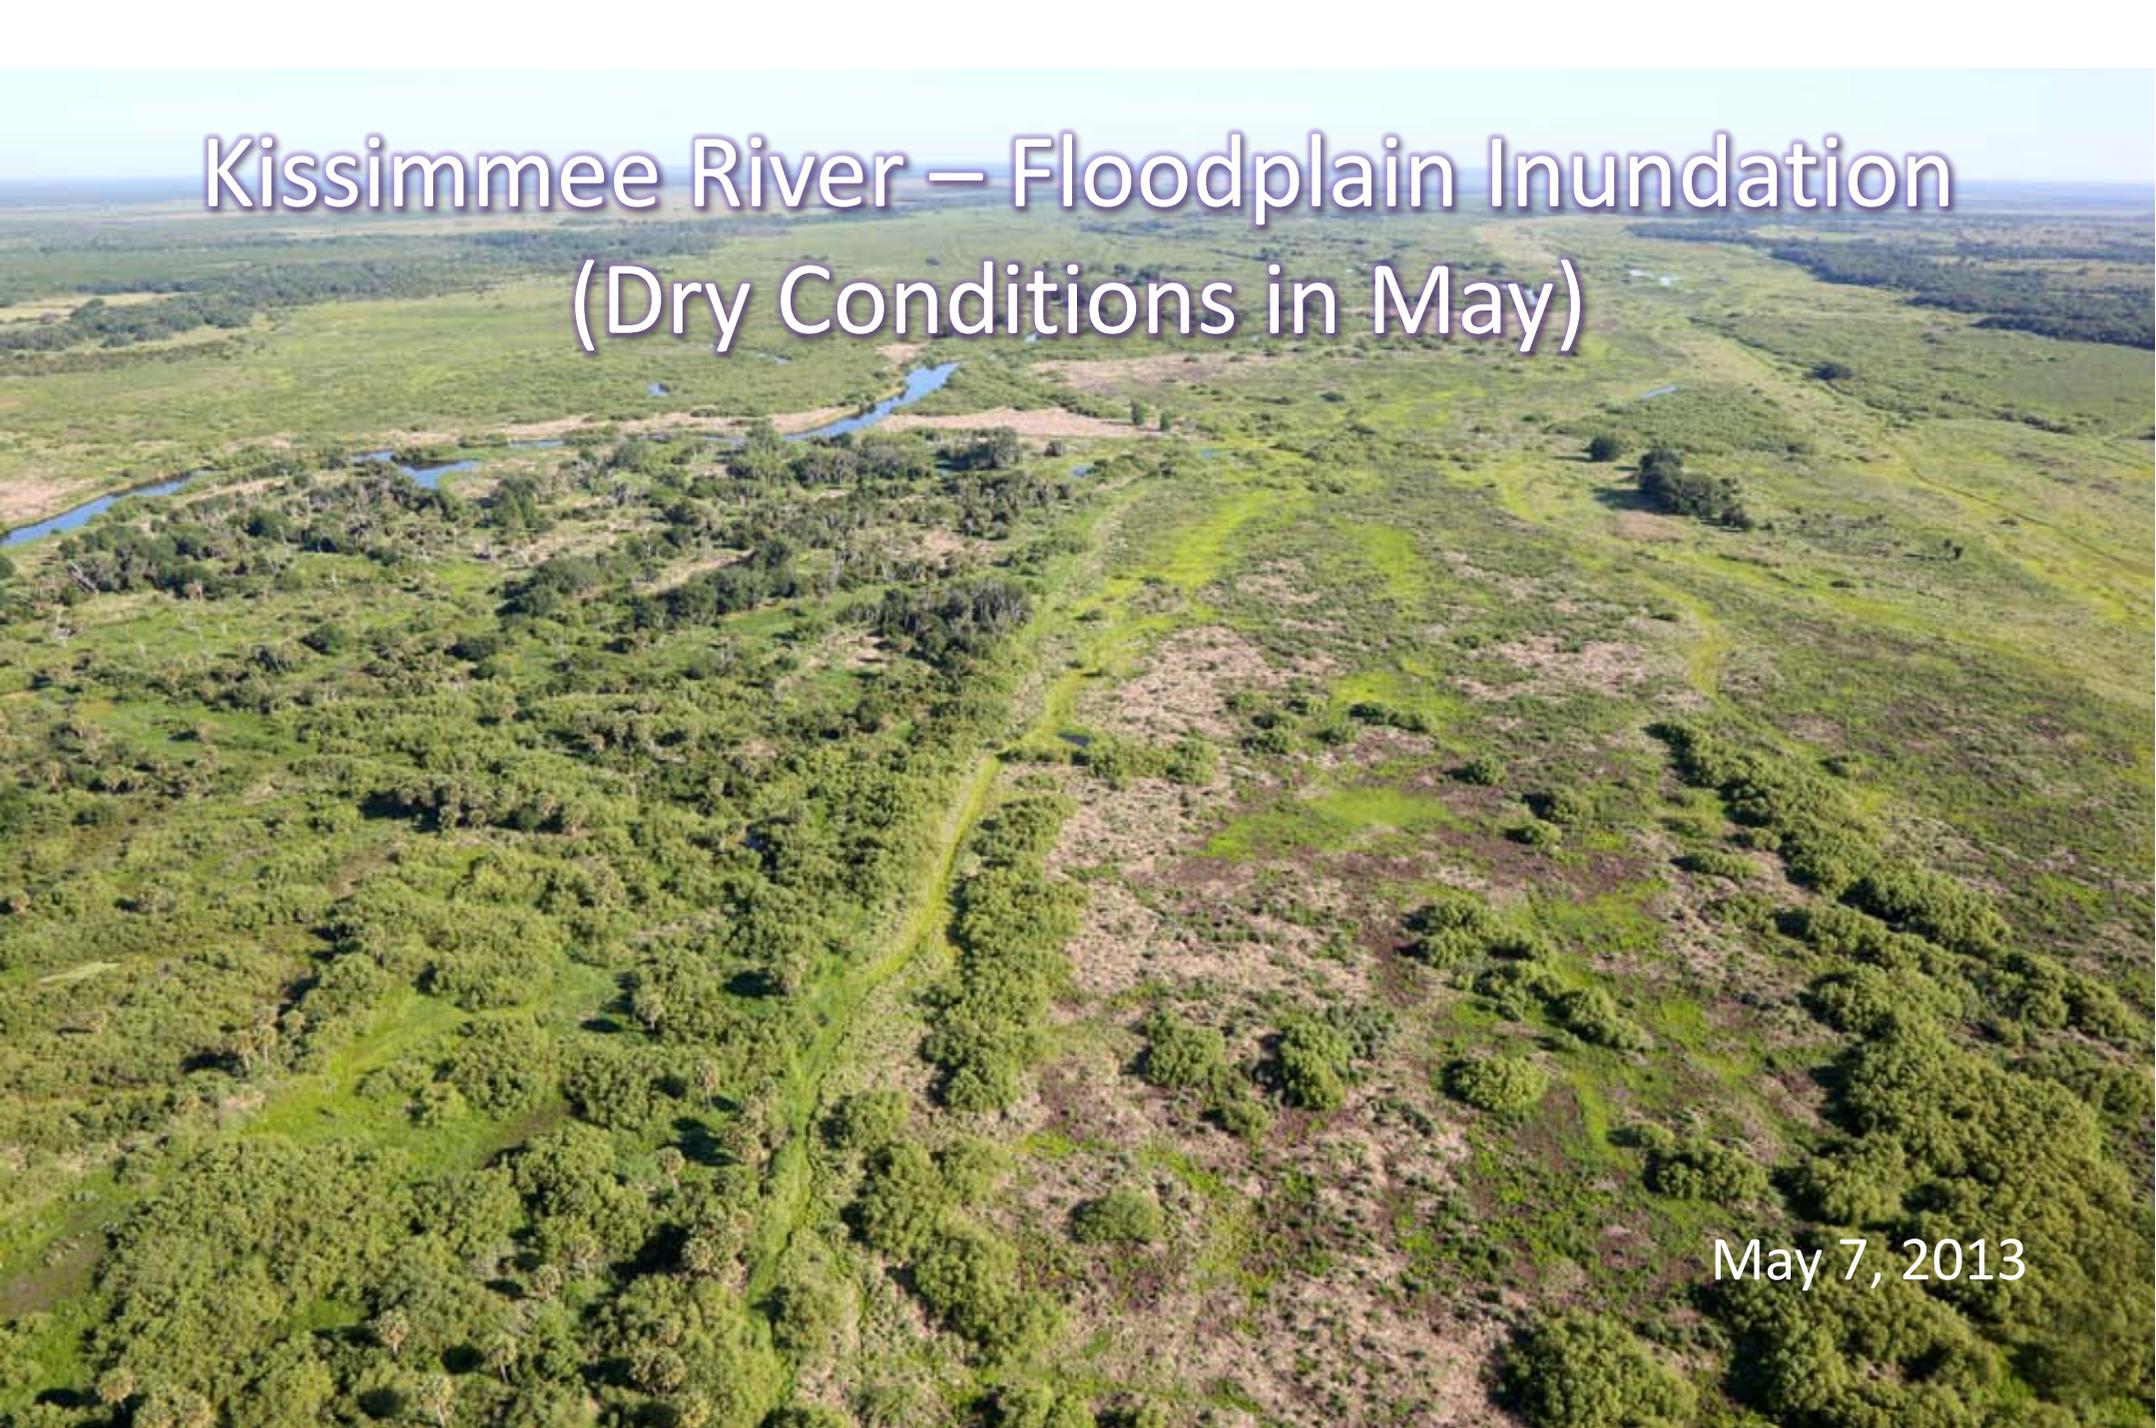
Kissimmee River – Floodplain Inundation (Dry Conditions in May)

An aerial photograph of the Kissimmee River floodplain. The river is visible as a narrow, winding blue line through a vast, green landscape. The surrounding area is a mix of dense green vegetation and patches of brown, dry earth, indicating a lack of water. The terrain appears flat and expansive, with the river meandering through it. The sky is clear and blue, suggesting a bright day.

May 7, 2013

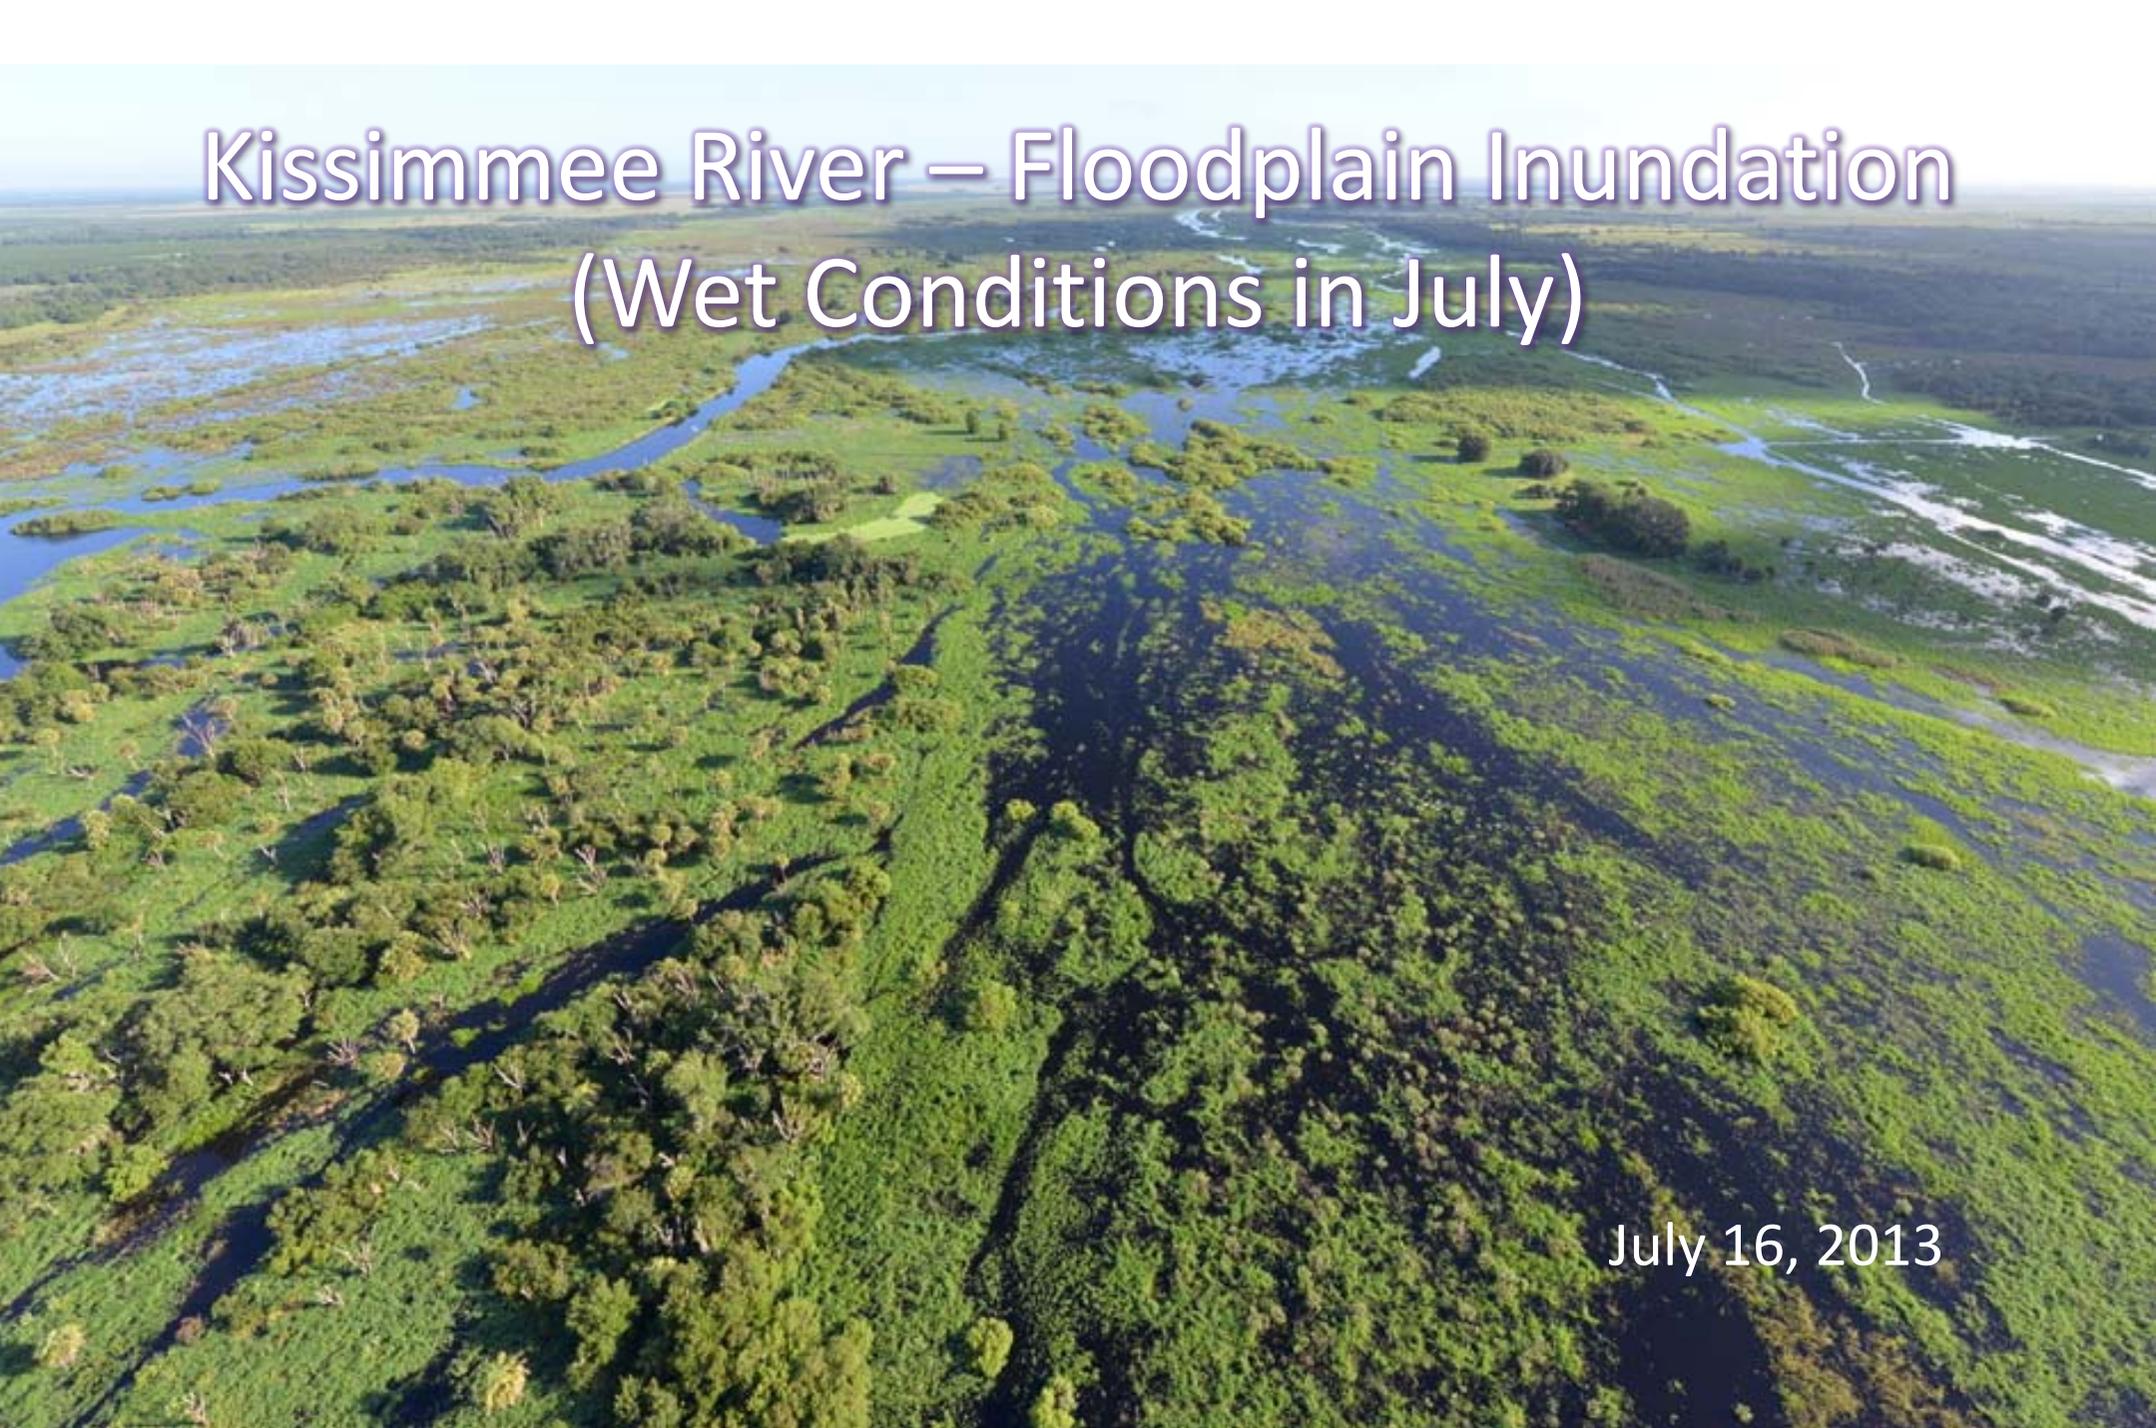
Kissimmee River – Floodplain Inundation (Wet Conditions in July)

An aerial photograph showing a vast expanse of green wetlands and marshes. A central waterway, the Kissimmee River, flows through the landscape, surrounded by numerous smaller channels and flooded areas. The vegetation is dense and lush green, indicating wet conditions. The sky is clear and blue, and the overall scene depicts a significant inundation of the floodplain.

July 16, 2013

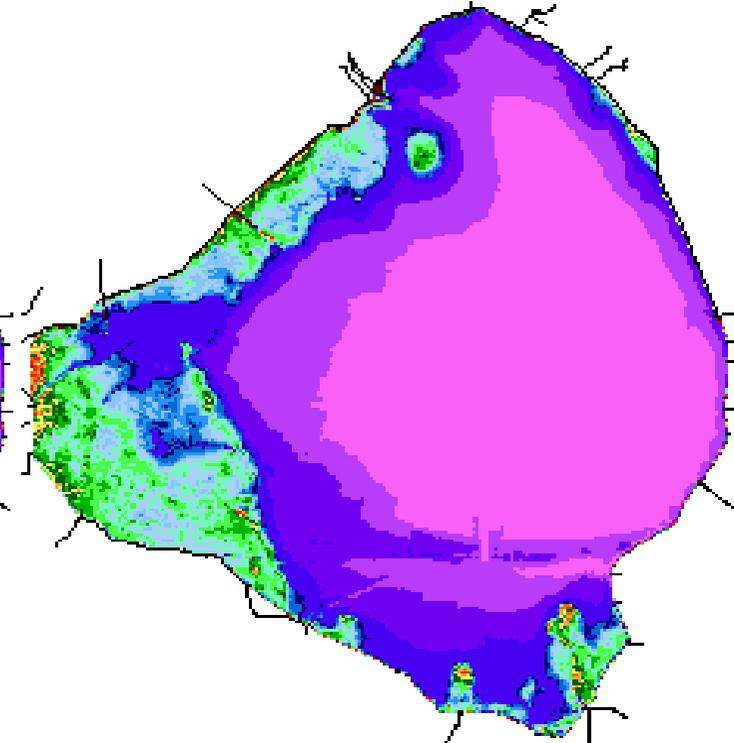
Water Depth Maps

Current: 8/12/2013

(16.01 ft
NGVD29)

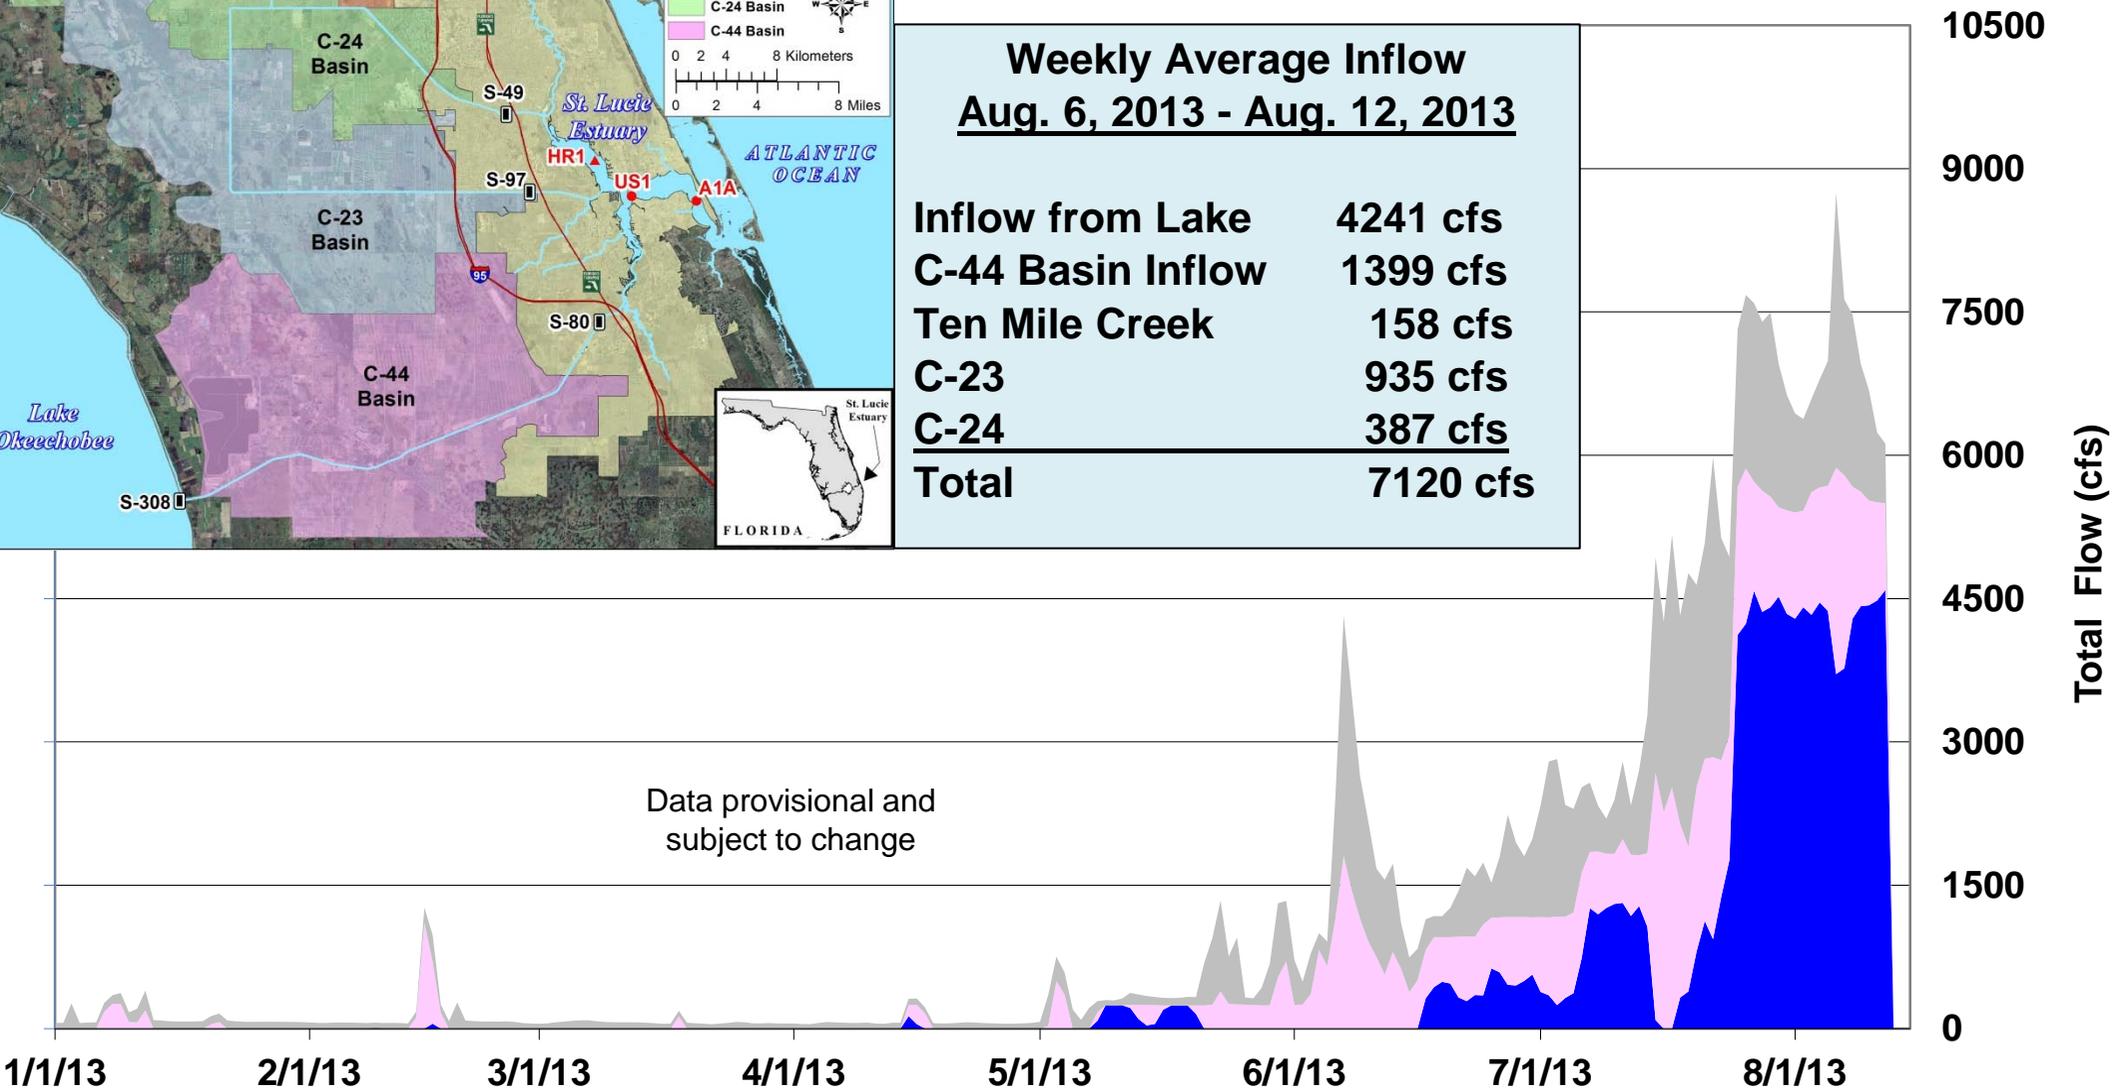
**Weekly Average Inflow
Aug. 6, 2013 - Aug. 12, 2013**

| Inflow from Lake | 4241 cfs |
| C-44 Basin Inflow | 1399 cfs |
| Ten Mile Creek | 158 cfs |
| C-23 | 935 cfs |
| C-24 | 387 cfs |
| Total | 7120 cfs |

■ Inflow from Lake ■ C-44 Basin Runoff ■ Inflow from C-24, C-23, and Ten Mile Creek Basins *

*Does not include runoff from the tidal basin or groundwater

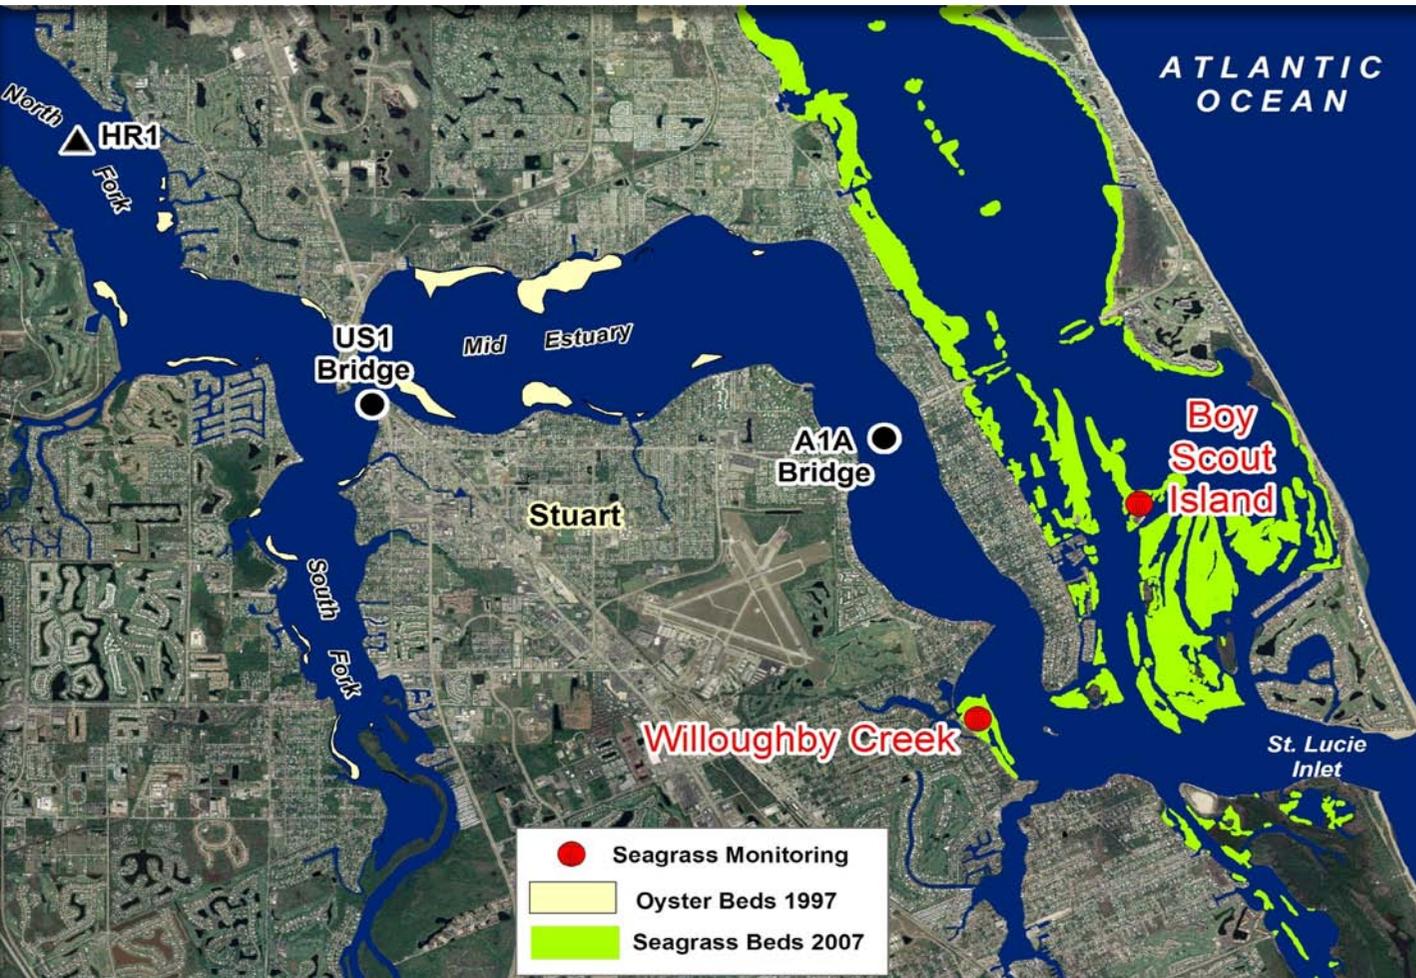
Salinity Tolerances of Oysters

- **Juveniles:** Mortality after 7 days at < 5
- **Adults:** Mortality after 28 days at < 5

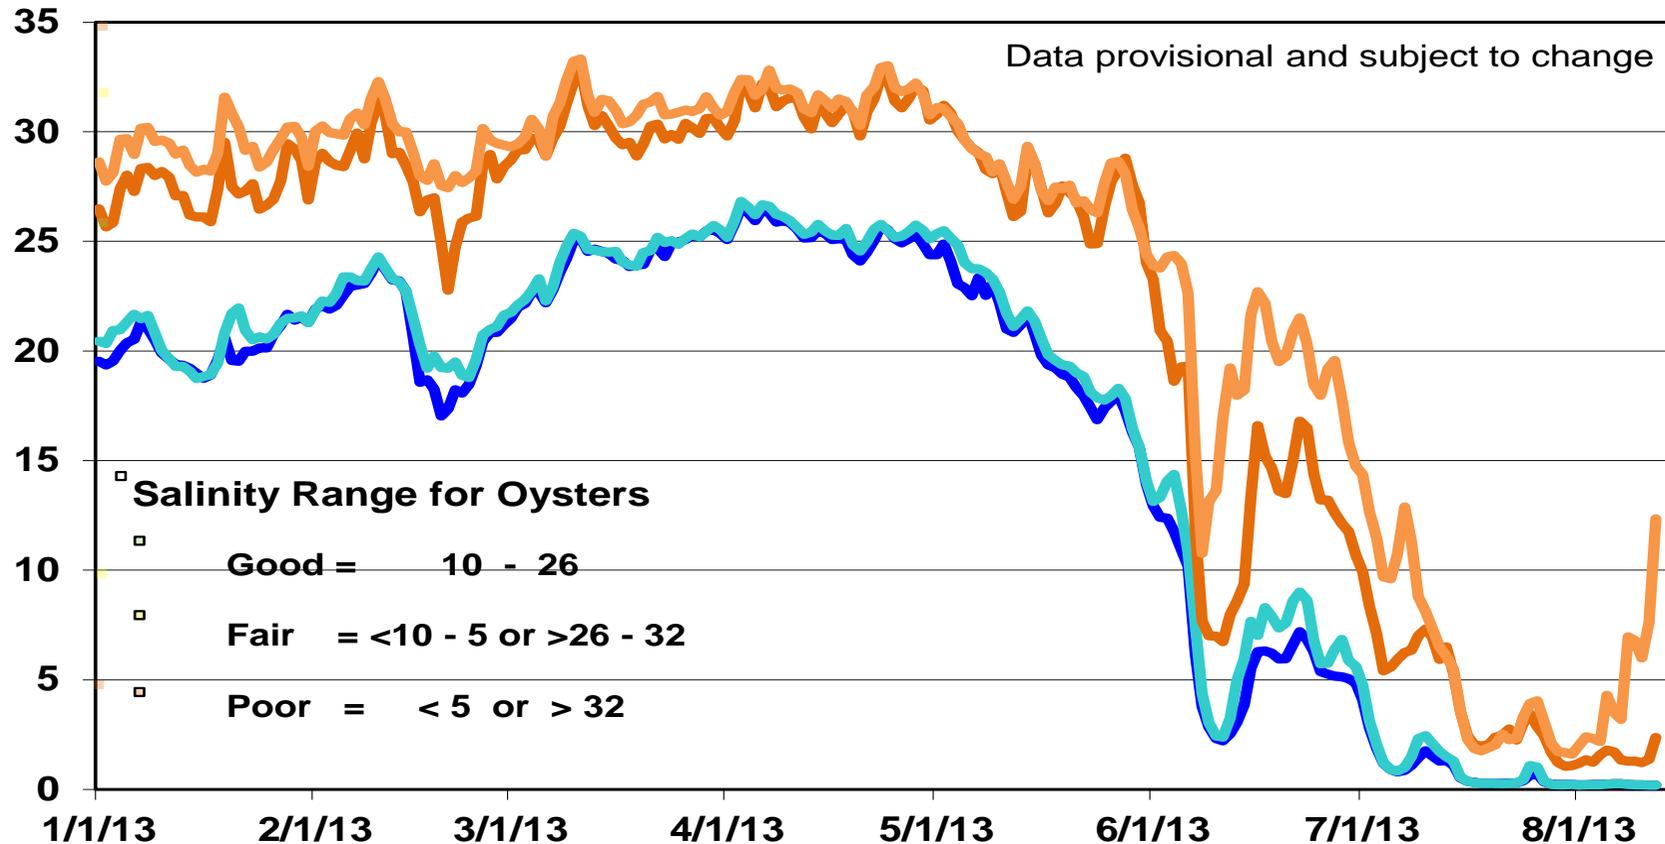
Surface and Bottom Mean Daily Salinity at US1 Bridge and A1A Bridge

- Major oyster beds are located between the US1 and A1A Bridges
- Salinity has fallen below 5 in this area

— US1: Daily Mean Surface Salinity
— A1A Daily Mean Surface Salinity

— US1: Daily Mean Bottom Salinity
— A1A Daily Mean Bottom Salinity

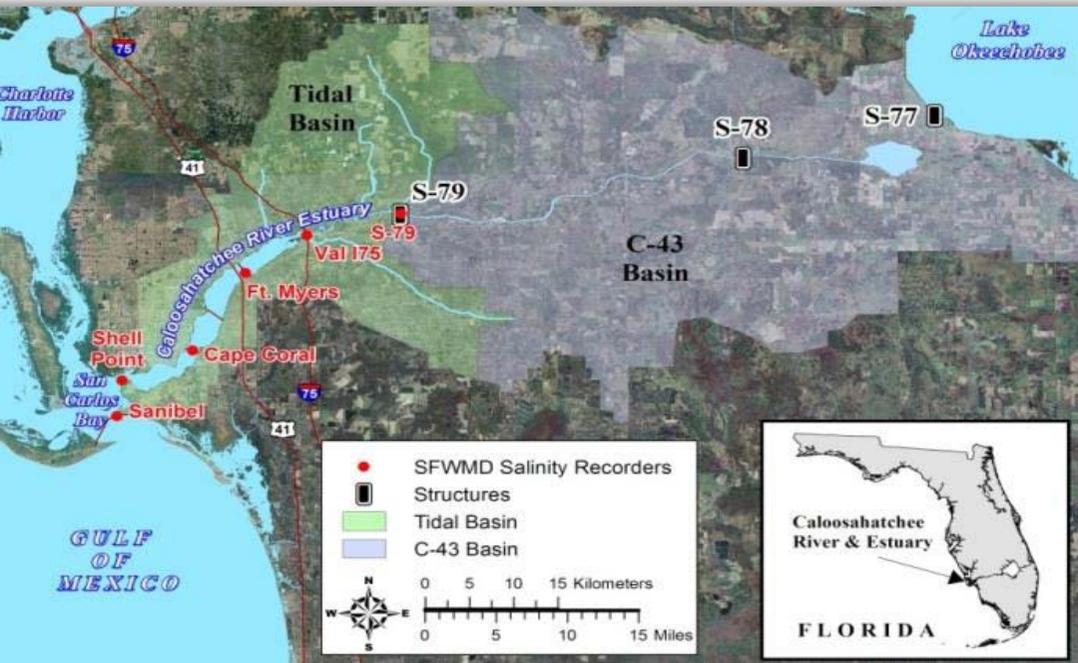
Weekly Average Inflow Aug. 6, 2013 - Aug. 12, 2013

Inflow from Lake: 6289 cfs
C-43 Basin Inflow: 3860 cfs
Tidal Basin Inflow: 2035 cfs
Total : 12184 cfs

■ Inflow from Lake ■ C-43 Basin Inflow ■ Tidal Basin Inflow (downstream of S79)

*Does not include direct overland runoff from the tidal basin or groundwater

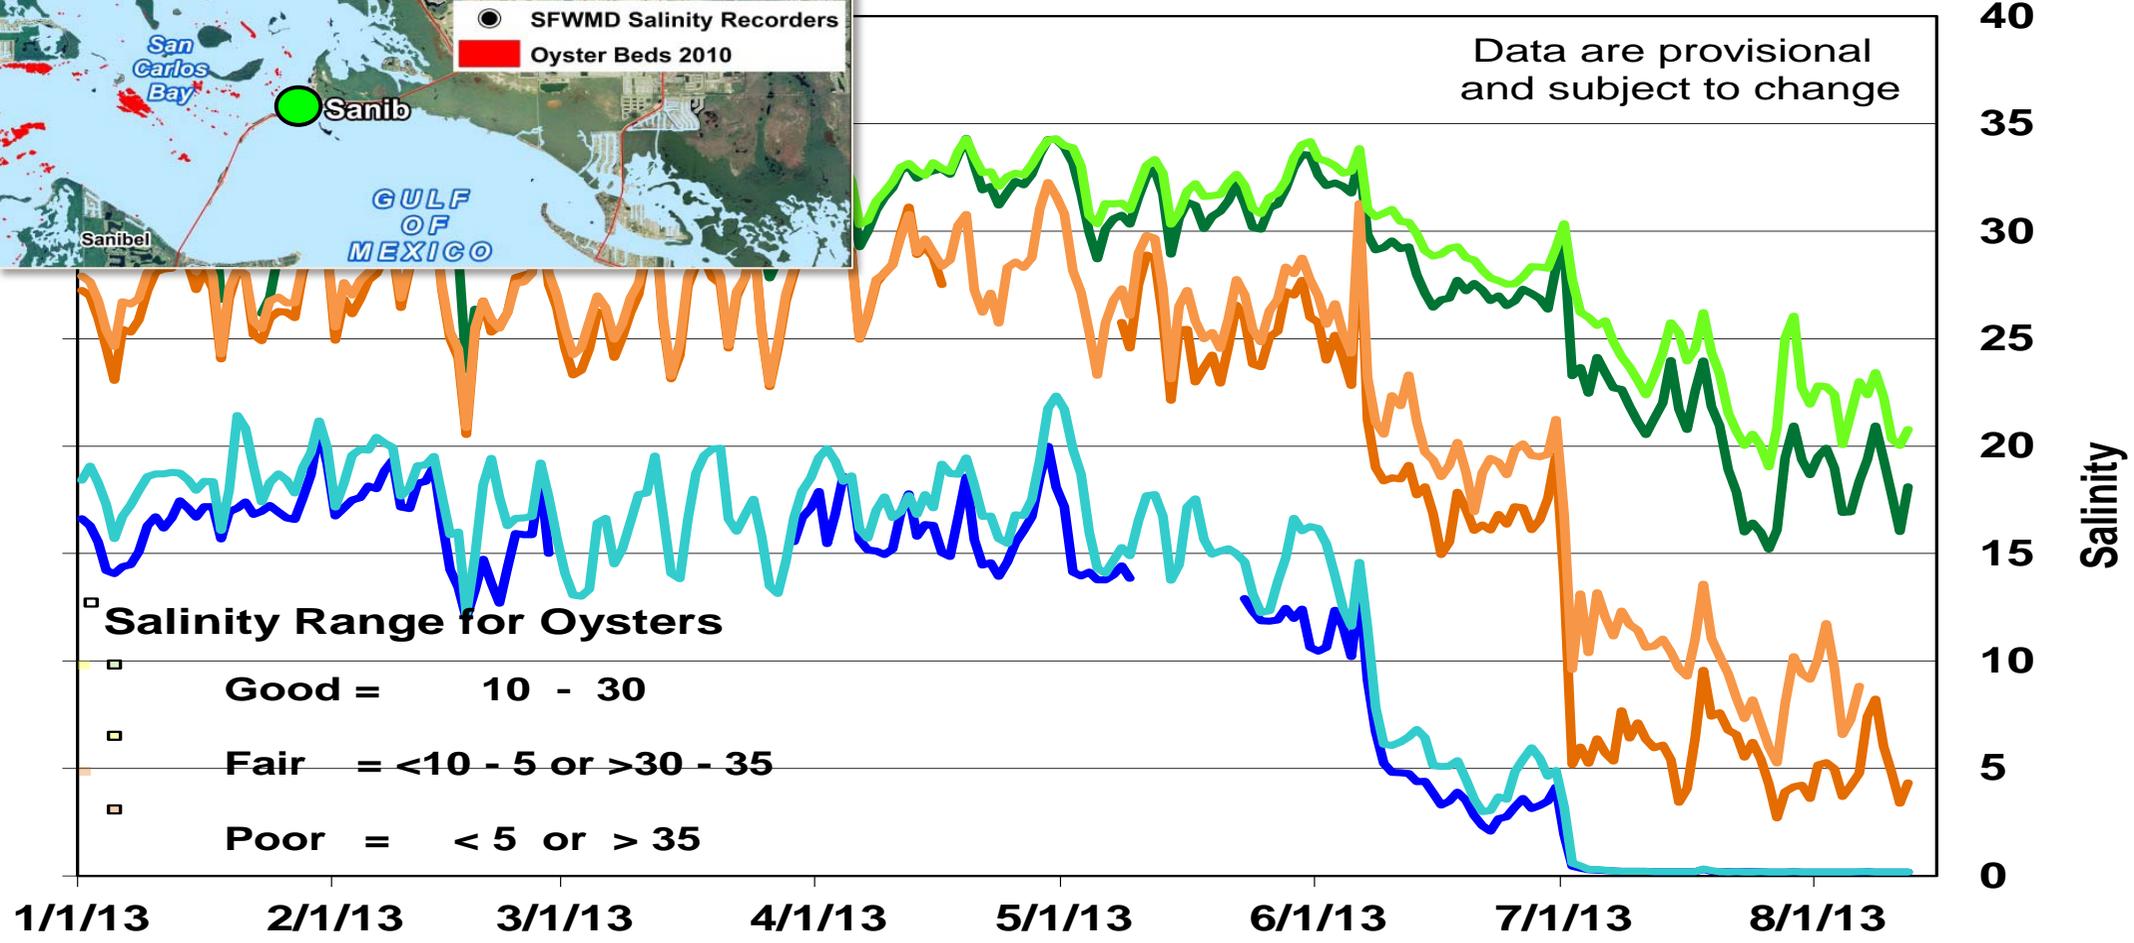
Surface and Bottom Mean Salinity at 3 monitoring stations in the Caloosahatchee Estuary

● SFWMD Salinity Recorders
 ■ Oyster Beds 2010

- Good = 10 - 30
- Fair = <10 - 5 or >30 - 35
- Poor = < 5 or > 35

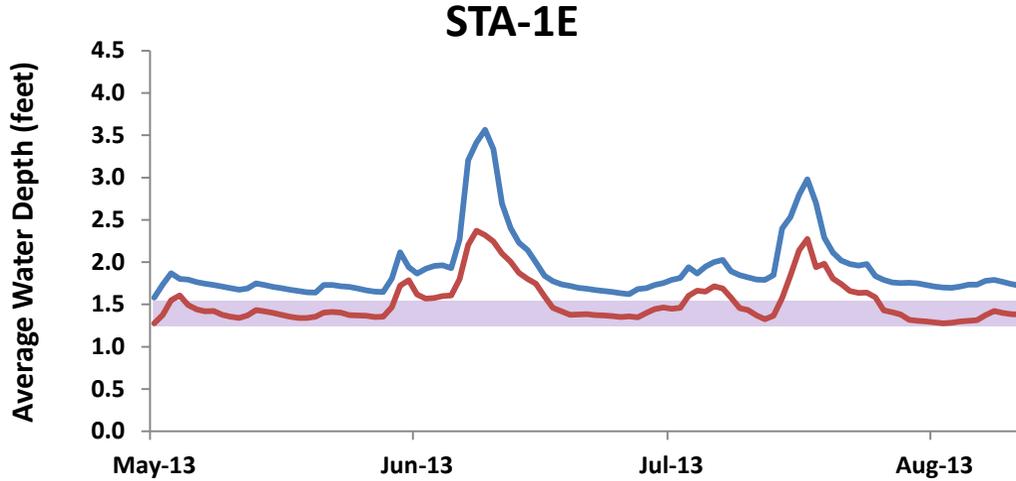
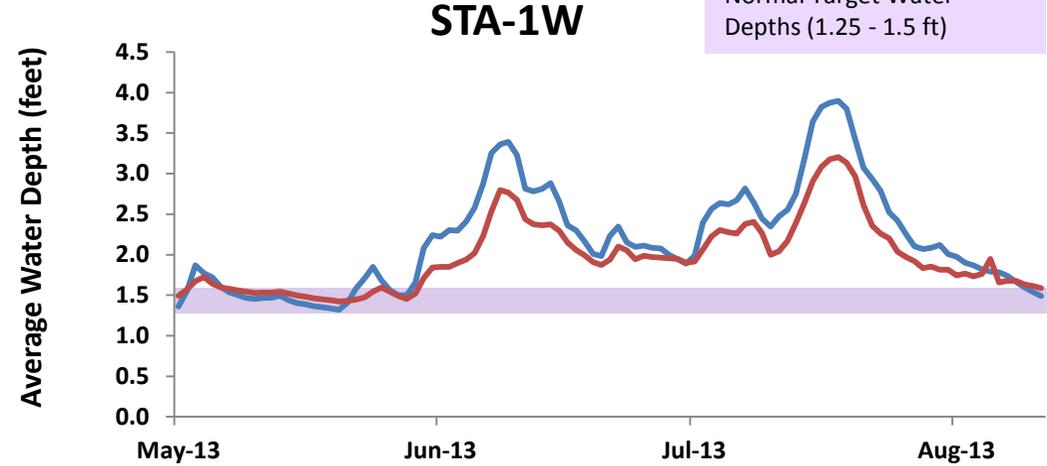
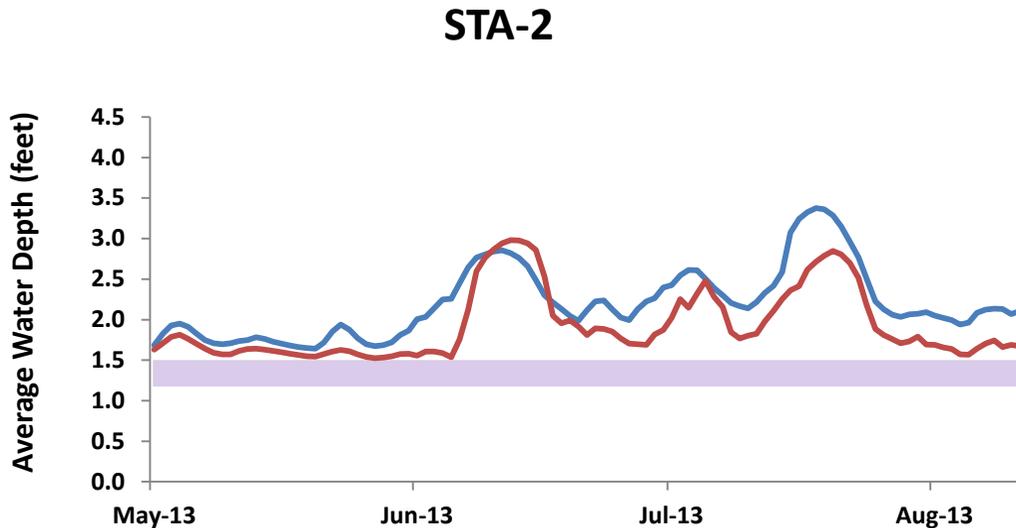
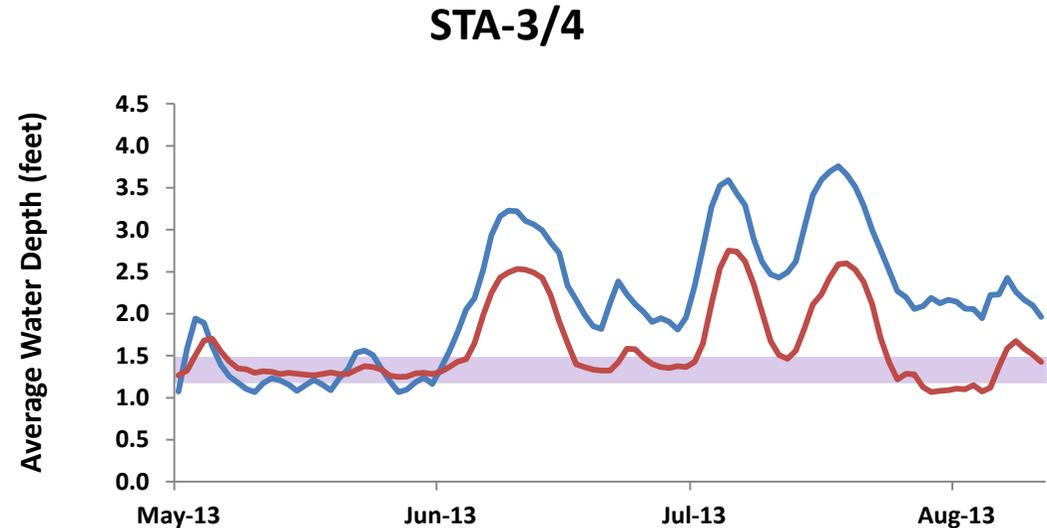
Recent High Water Levels in the STAs

(May 1, 2013 – August 11, 2013)

— EAV
— SAV

Normal Target Water
Depths (1.25 - 1.5 ft)

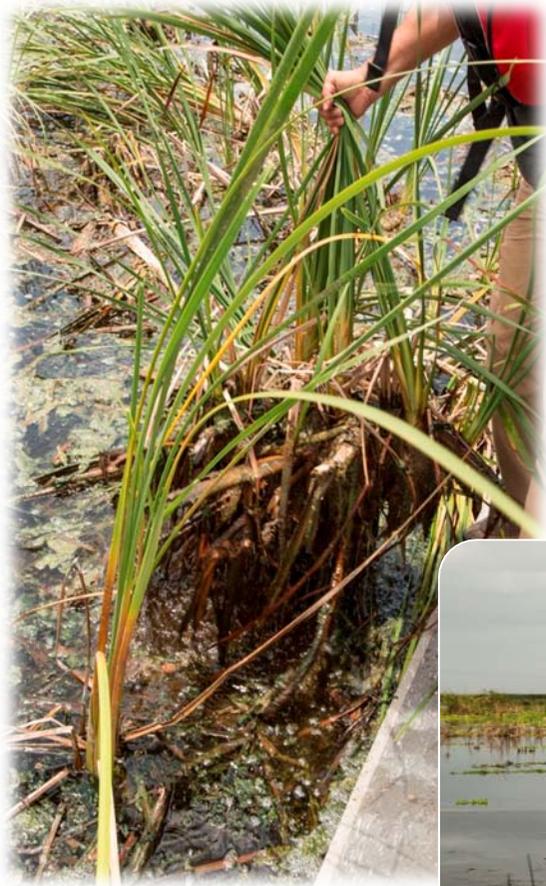
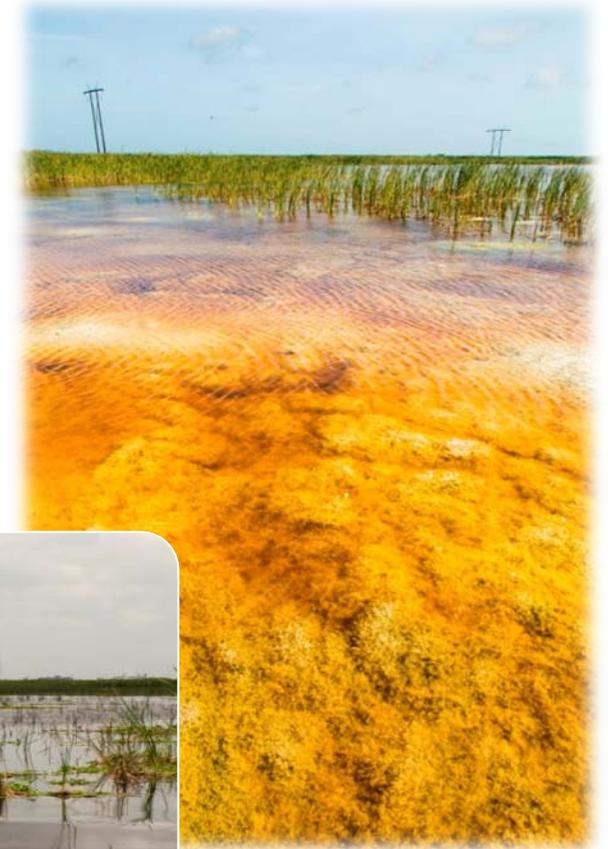
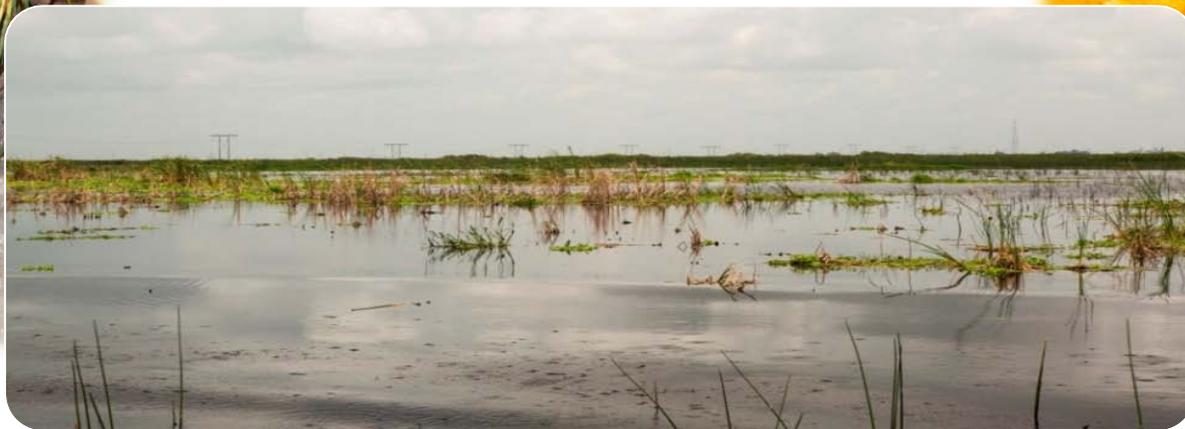
Current Conditions: STA-1W Impaired Vegetation

- Cattail thinning or uprooting
- Submerged Aquatic Vegetation dislodged from substrate
- Un-vegetated open water areas created

*Left: Uprooted and floating cattail in STA-1W , Center: open water areas in the treatment cell;
Right: dying submerged aquatic vegetation in STA-1W*
