Governing Board Meeting
August 15, 2013

ECOLOGICAL CONDITIONS UPDATE

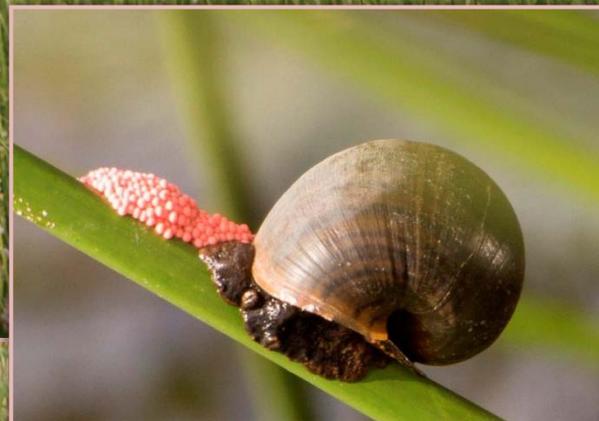
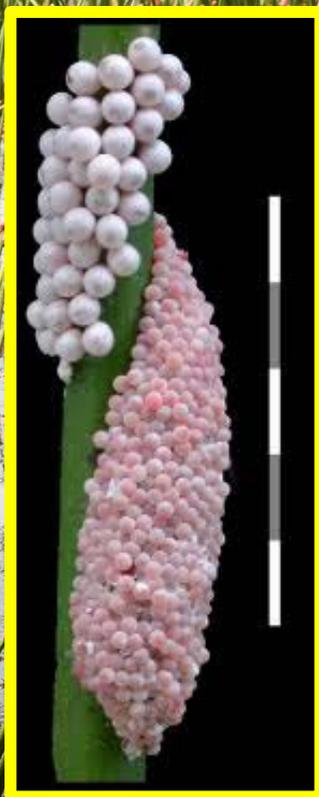
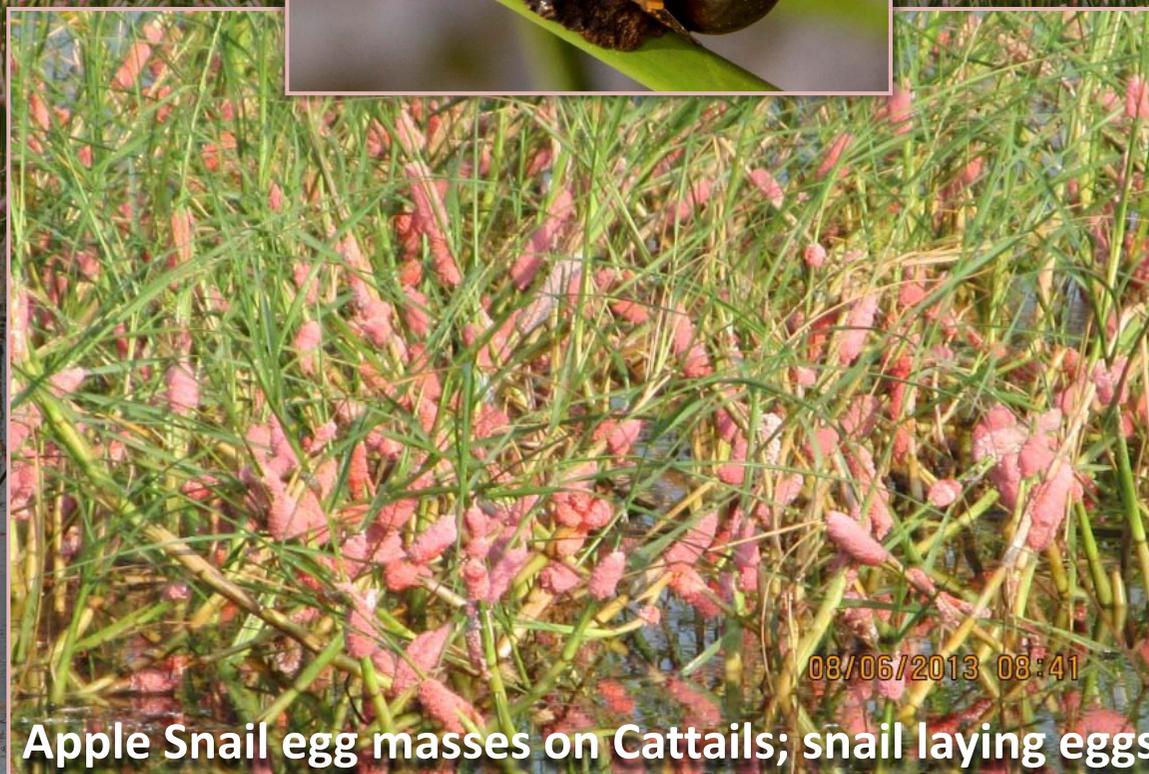
Large number of exotic
Apple Snails recently found
in STA-1E Cell 4S

Apple Snail egg masses on Cattails; snail laying eggs

- Significant loss of submerged aquatic vegetation due to foraging
 - *Leaves stripped from stems*
- STA Performance has declined significantly
 - *365-day outflow average = 35 ppb*
while current 7-day outflow = 131 ppb
- Staff is communicating with Fish & Wildlife about possible control options

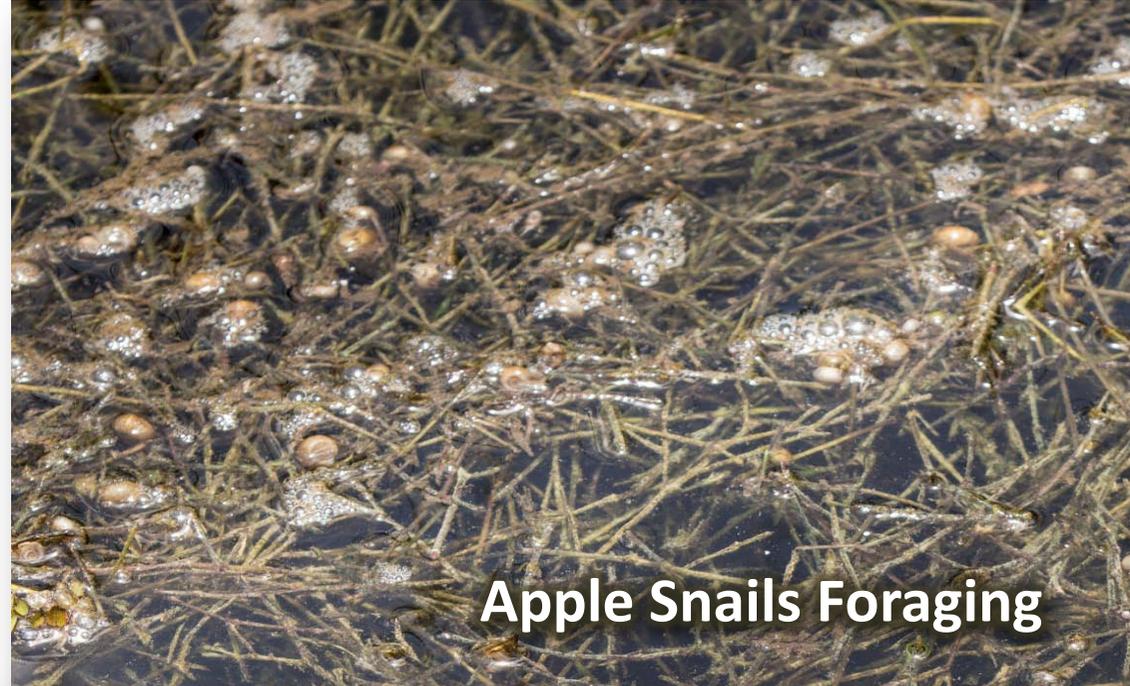
Apple Snails Foraging

**Defoliated Submerged
Aquatic Vegetation**

**Healthy Submerged
Aquatic Vegetation**

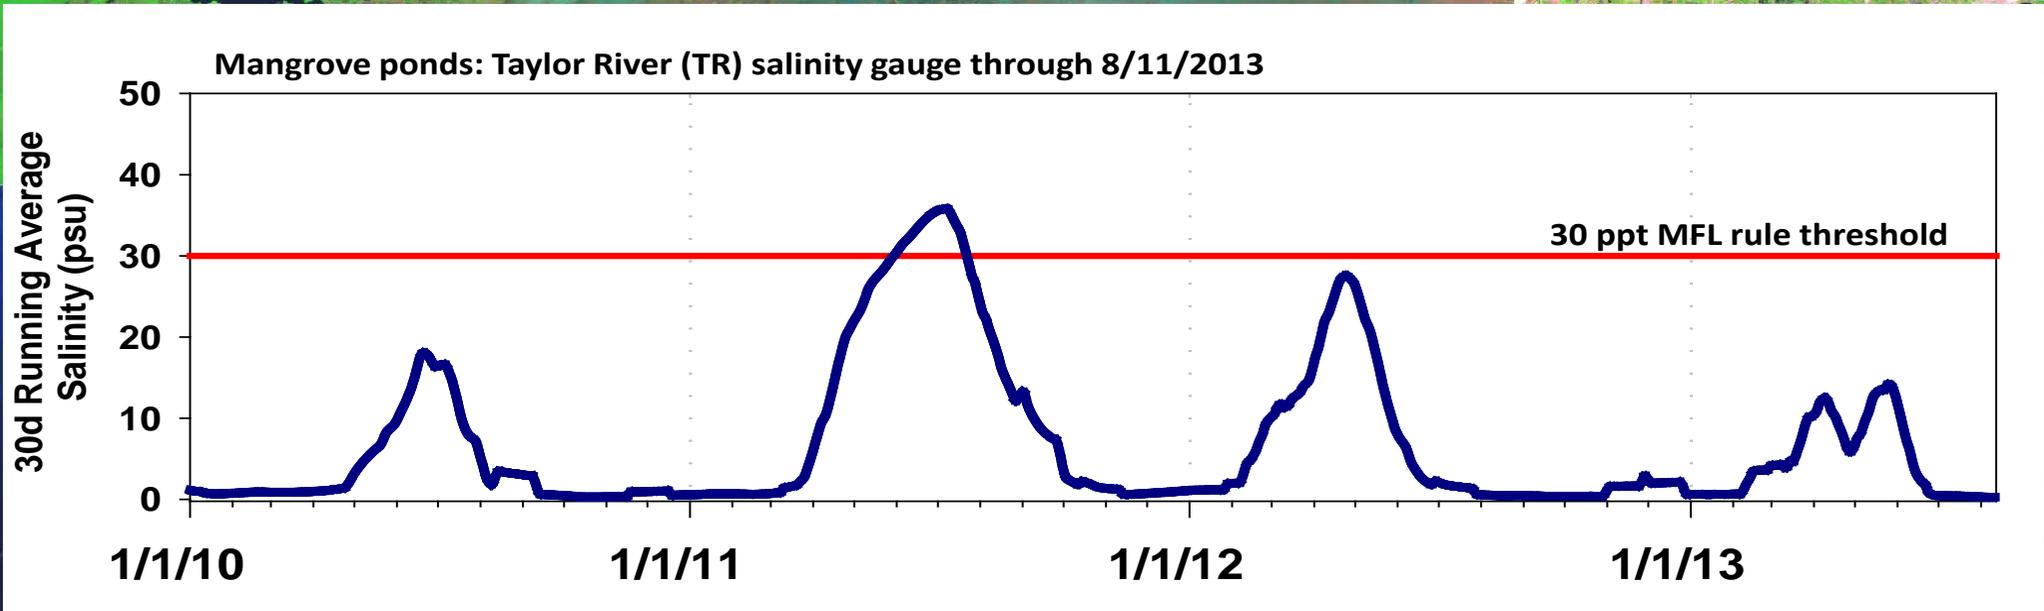
Tracking Salinity in Florida Bay

Florida Bay MFL salinity threshold was exceeded in late June of 2011

- ★ Salinity gauge
- ★ Creek flow gauge
