Governing Board Workshop
April 14, 2010

Ecological Conditions Update

Lawrence Glenn

Director, Kissimmee Division
Restoration Sciences Department

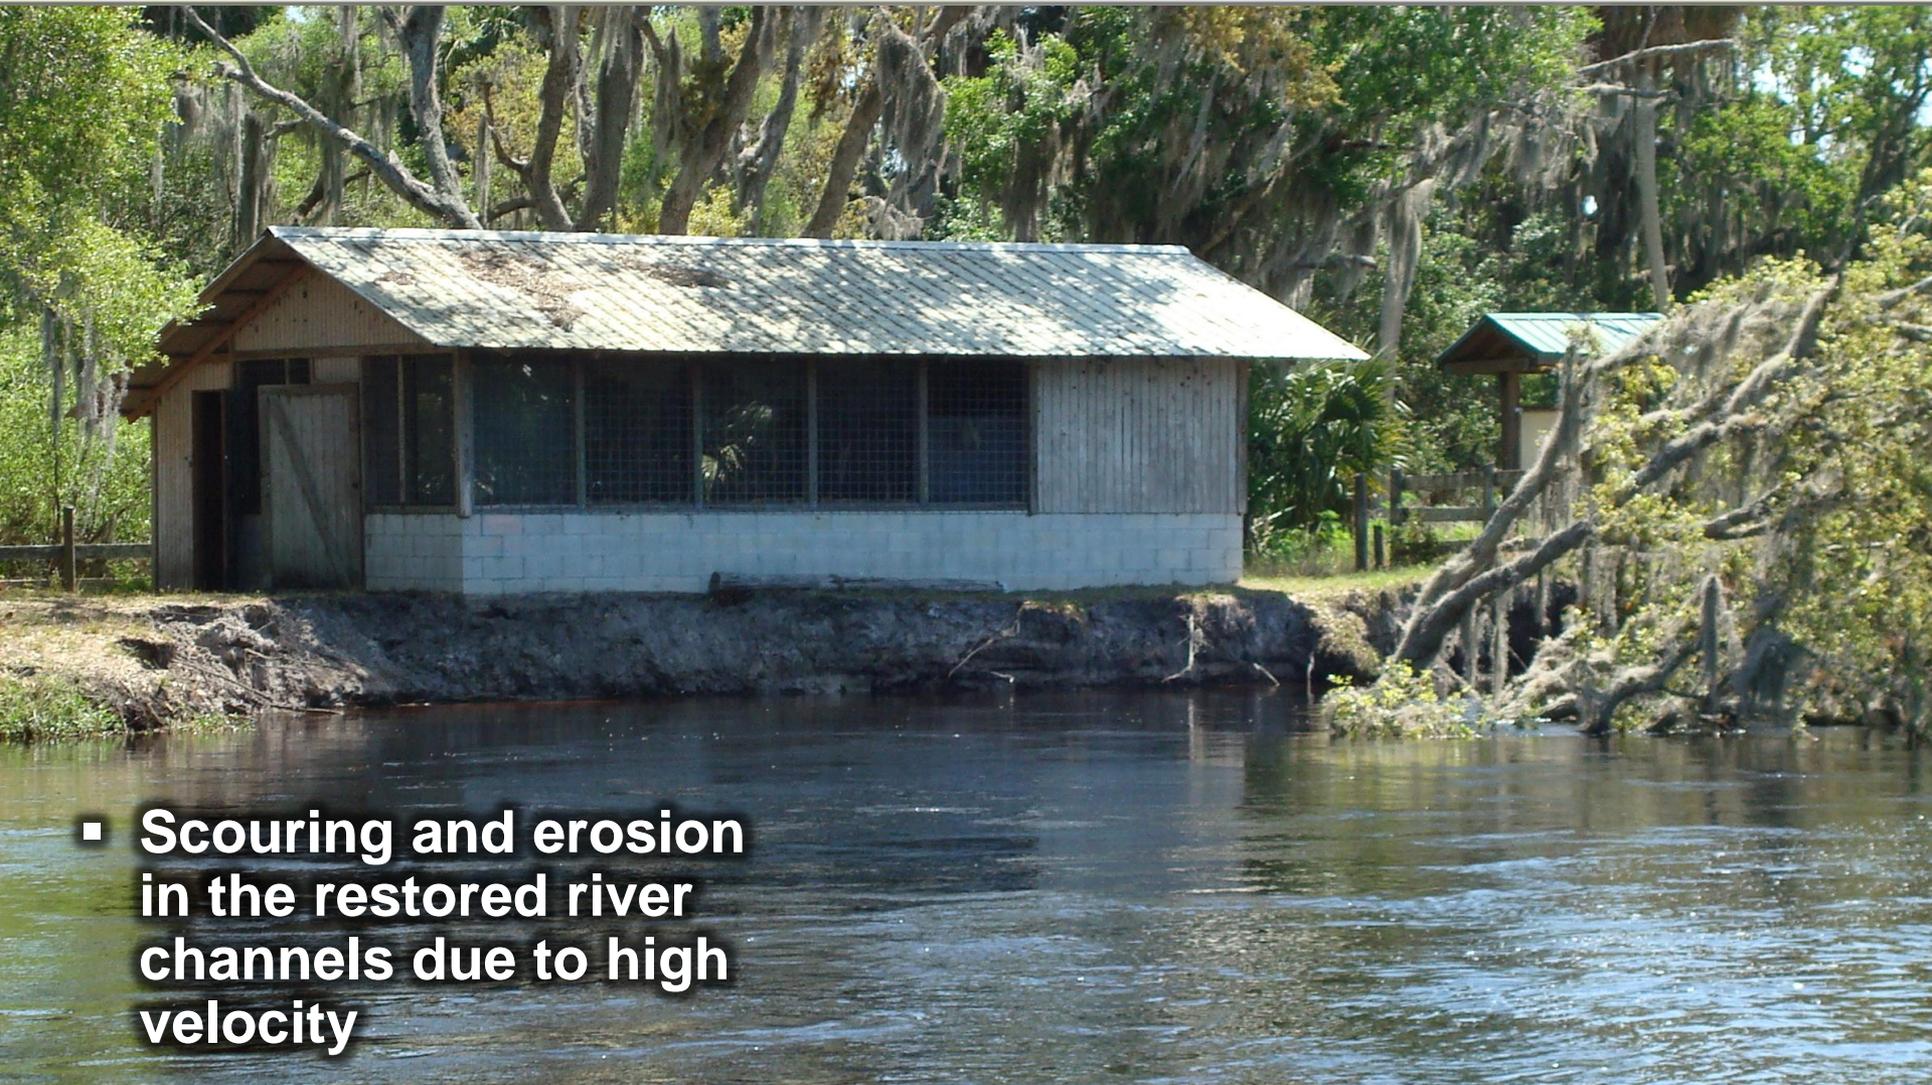
- **Scouring and erosion in the restored river channels due to high velocity**

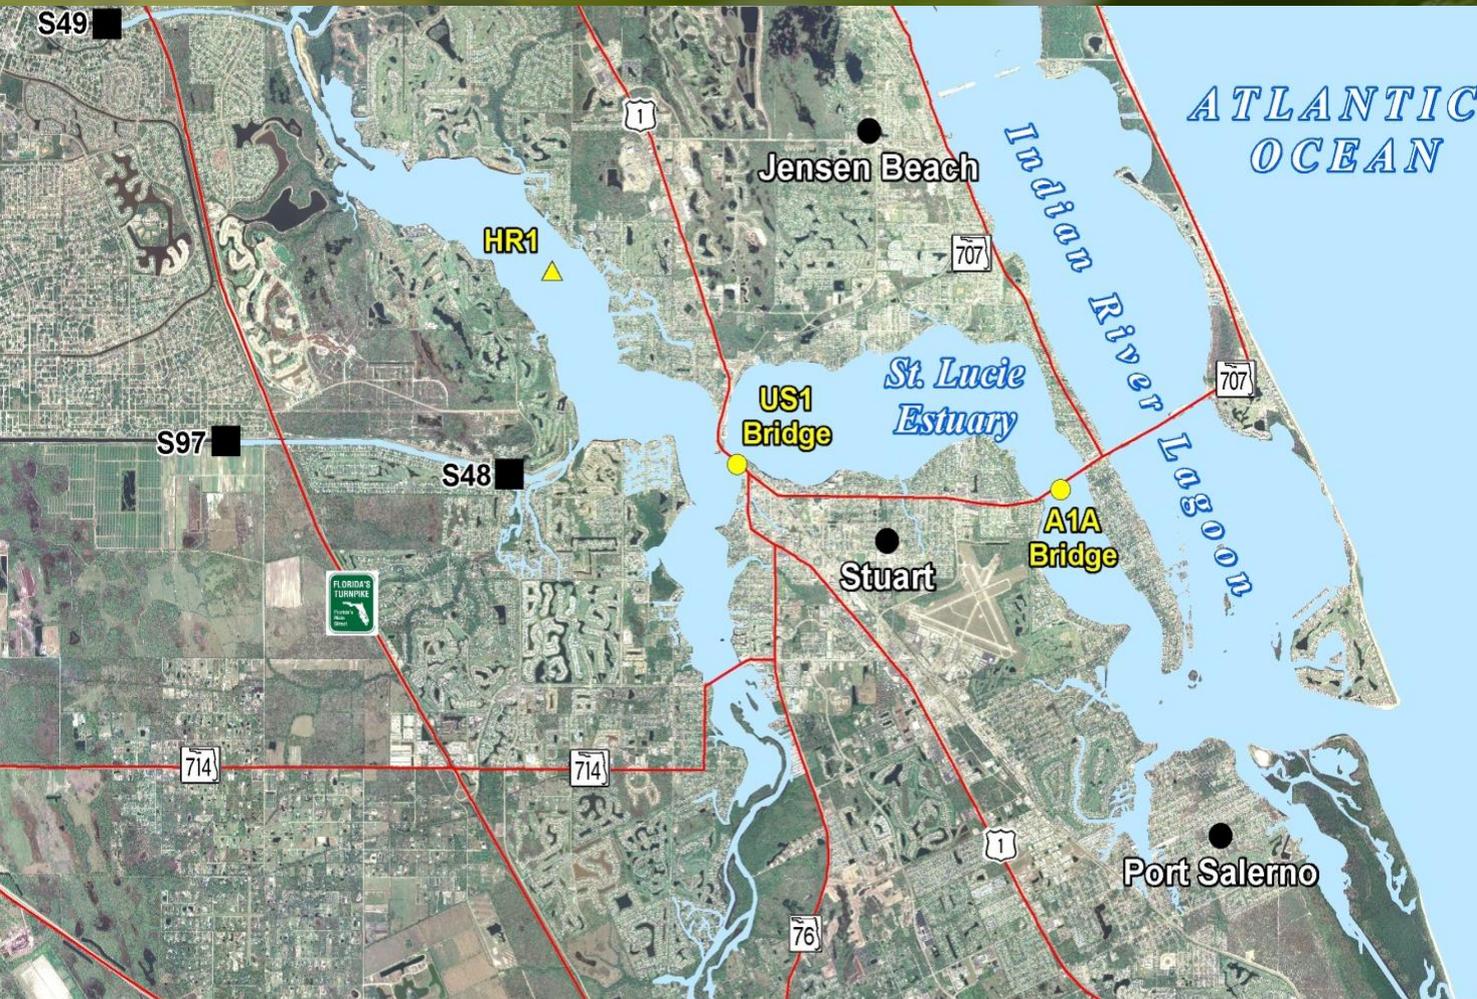
St. Lucie Salinity: US 1 Bridge

In the St. Lucie, the daily salinity at the US1 Bridge was below the salinity envelope, threatening oyster survival

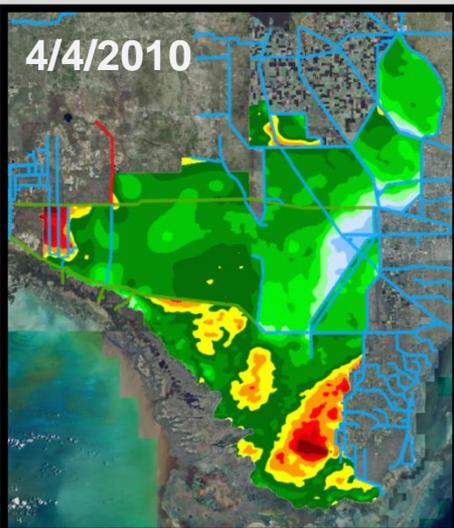
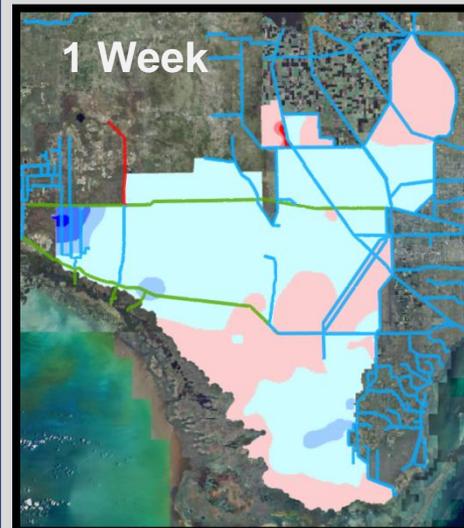
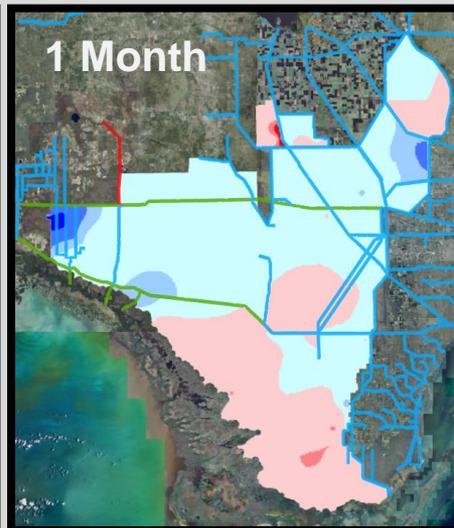
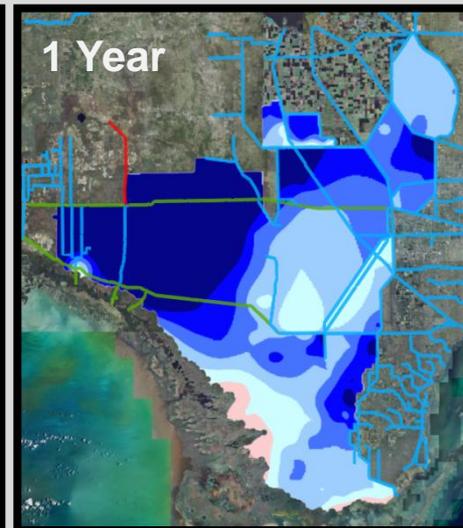
Everglades Water Depths and Difference Maps (Present minus Past)

Water Depth (feet)

Water Depth Difference (feet)

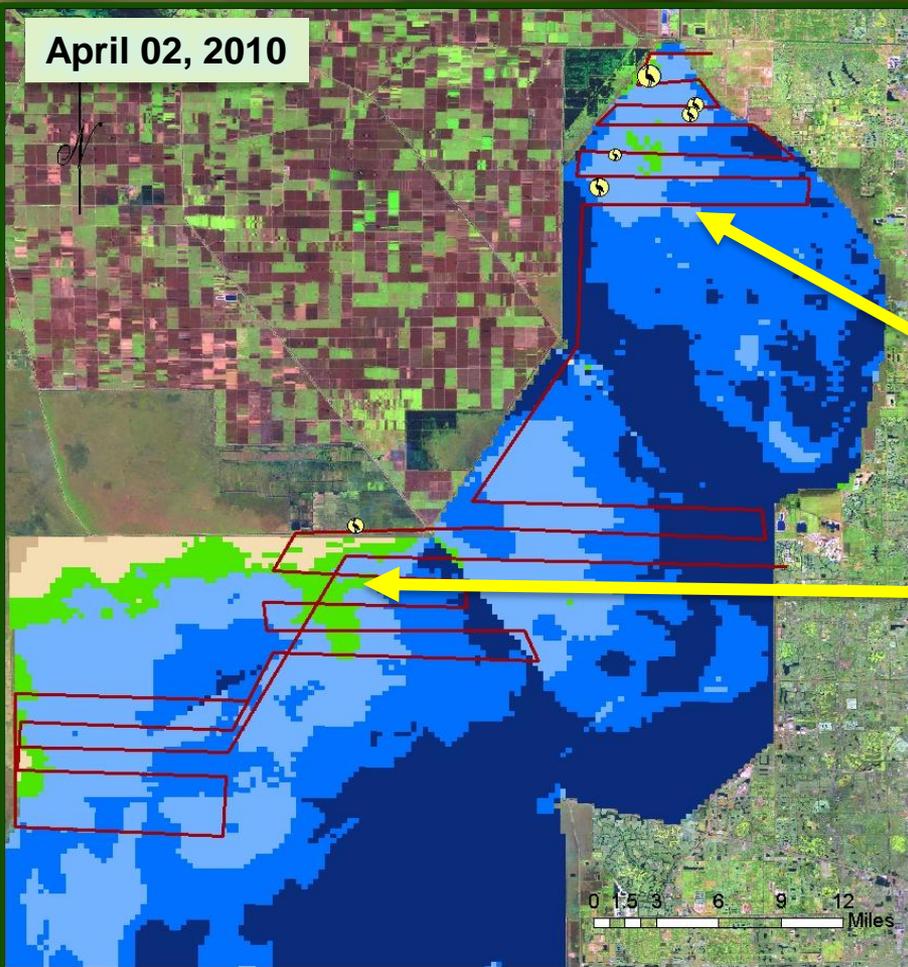
April 02, 2010

Wading Bird Foraging Areas

— Apr 02 Flight Path	☉ 21 - 50	Water Depth (ft)	0.24 - 0.53 (optimal)
☉ Flock	☉ 51 - 100	< -1.67	0.53 - 1.00 (suboptimal wet)
☉ 20	☉ 101 - 150	-1.67 - -0.48 (too dry)	1.00 - 1.45 (too wet)
		-0.48 - 0.24 (suboptimal dry)	> 1.45

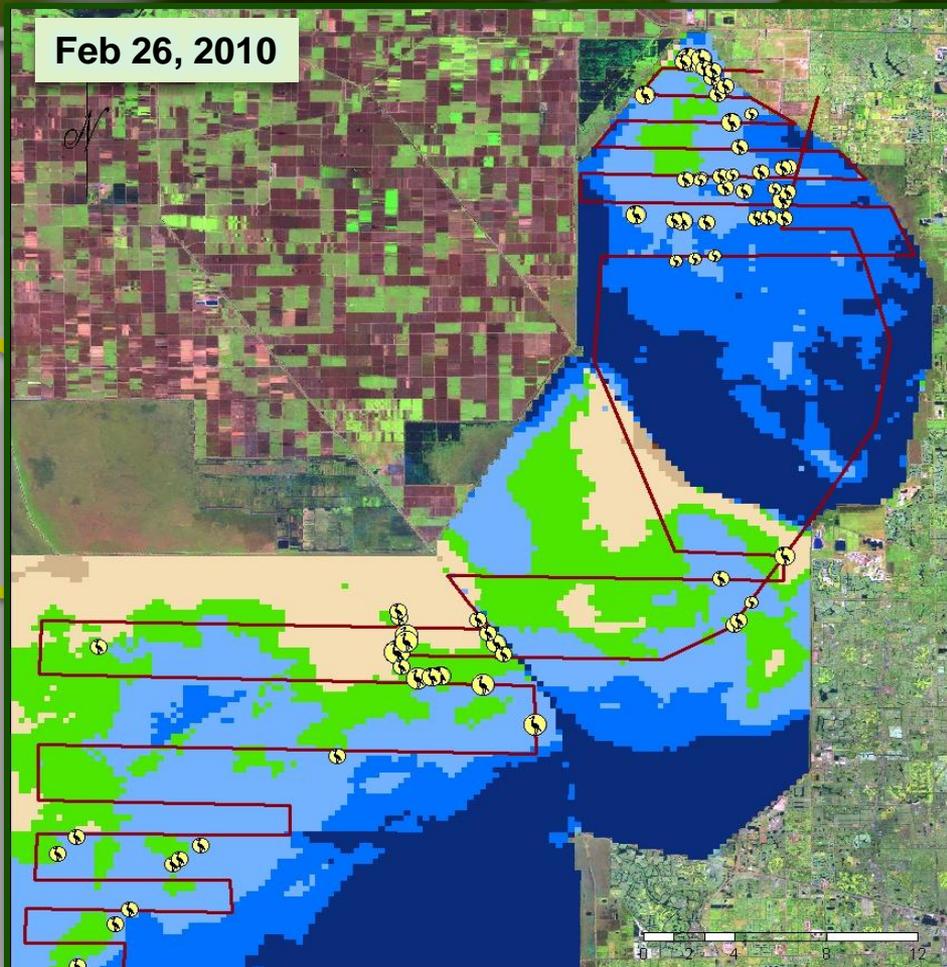
Feb 26, 2010

— Feb 26 Flight Path	☉ 101 - 200	Water Depth (ft)	0.24 - 0.53 (optimal)
☉ Flock	☉ 201 - 500	< -1.67	0.53 - 1.00 (suboptimal wet)
☉ 0 - 20	☉ 501 - 1000	-1.67 - -0.48 (too dry)	1.00 - 1.45 (too wet)
☉ 21 - 100		-0.48 - 0.24 (suboptimal dry)	> 1.45
