Governing Board Meeting
February 9, 2012

Kissimmee River Restoration *Project Update*

Lawrence Glenn

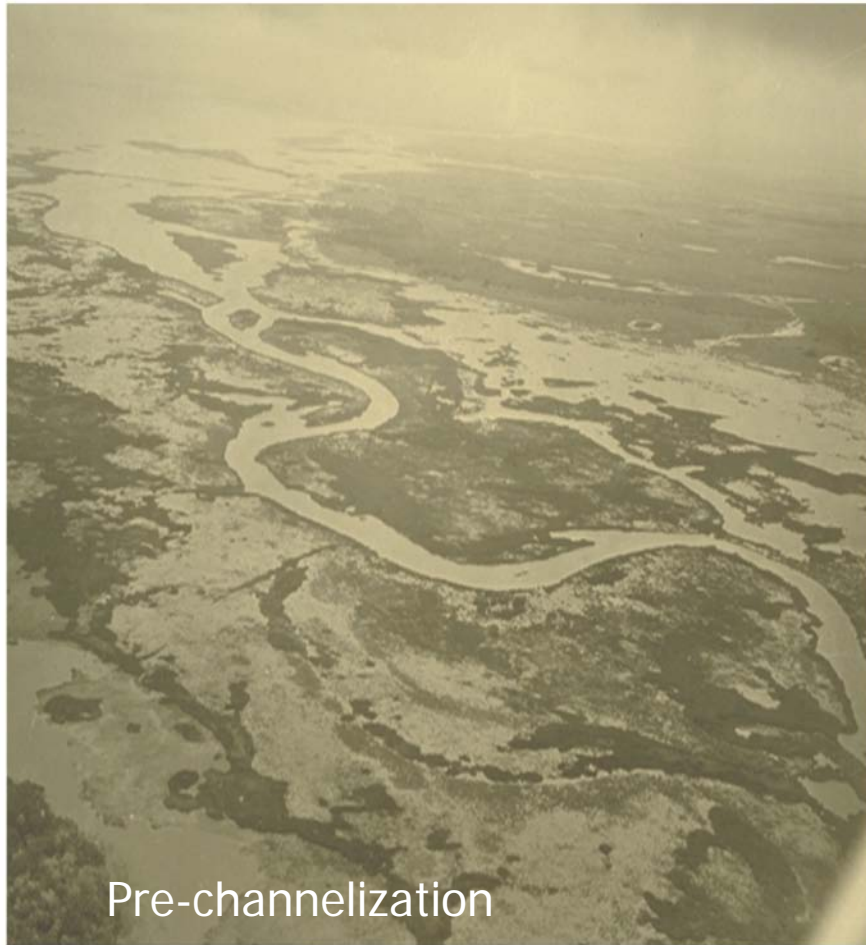
Pre-channelization

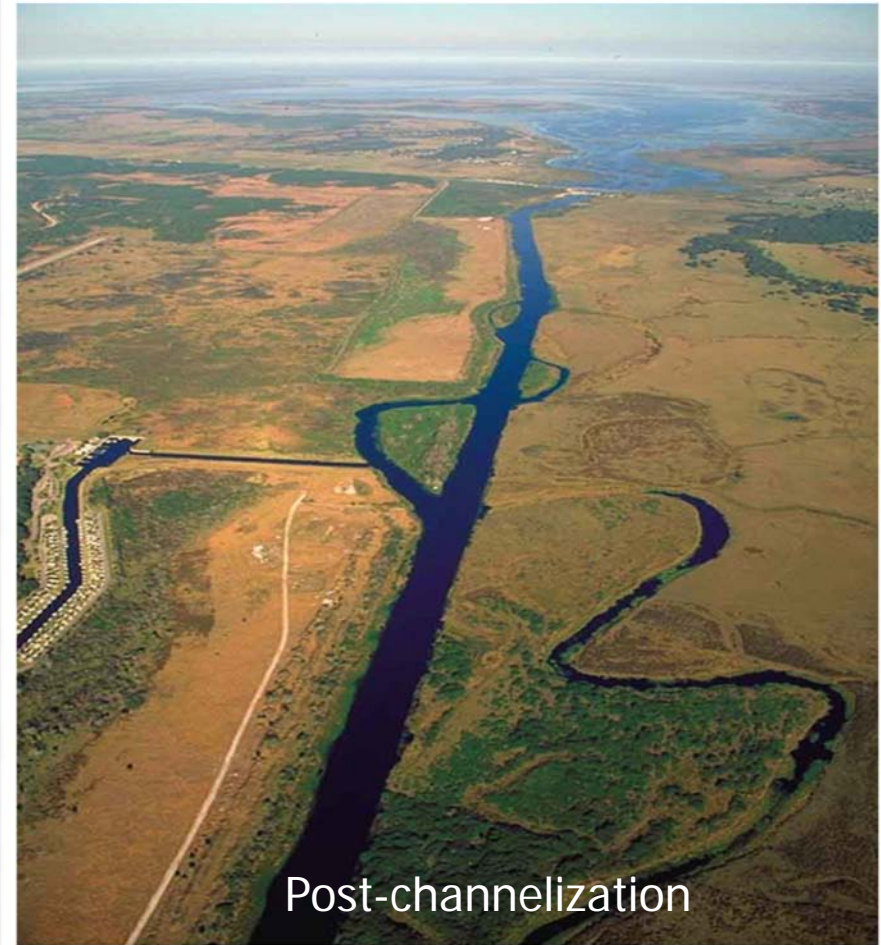
Post-channelization

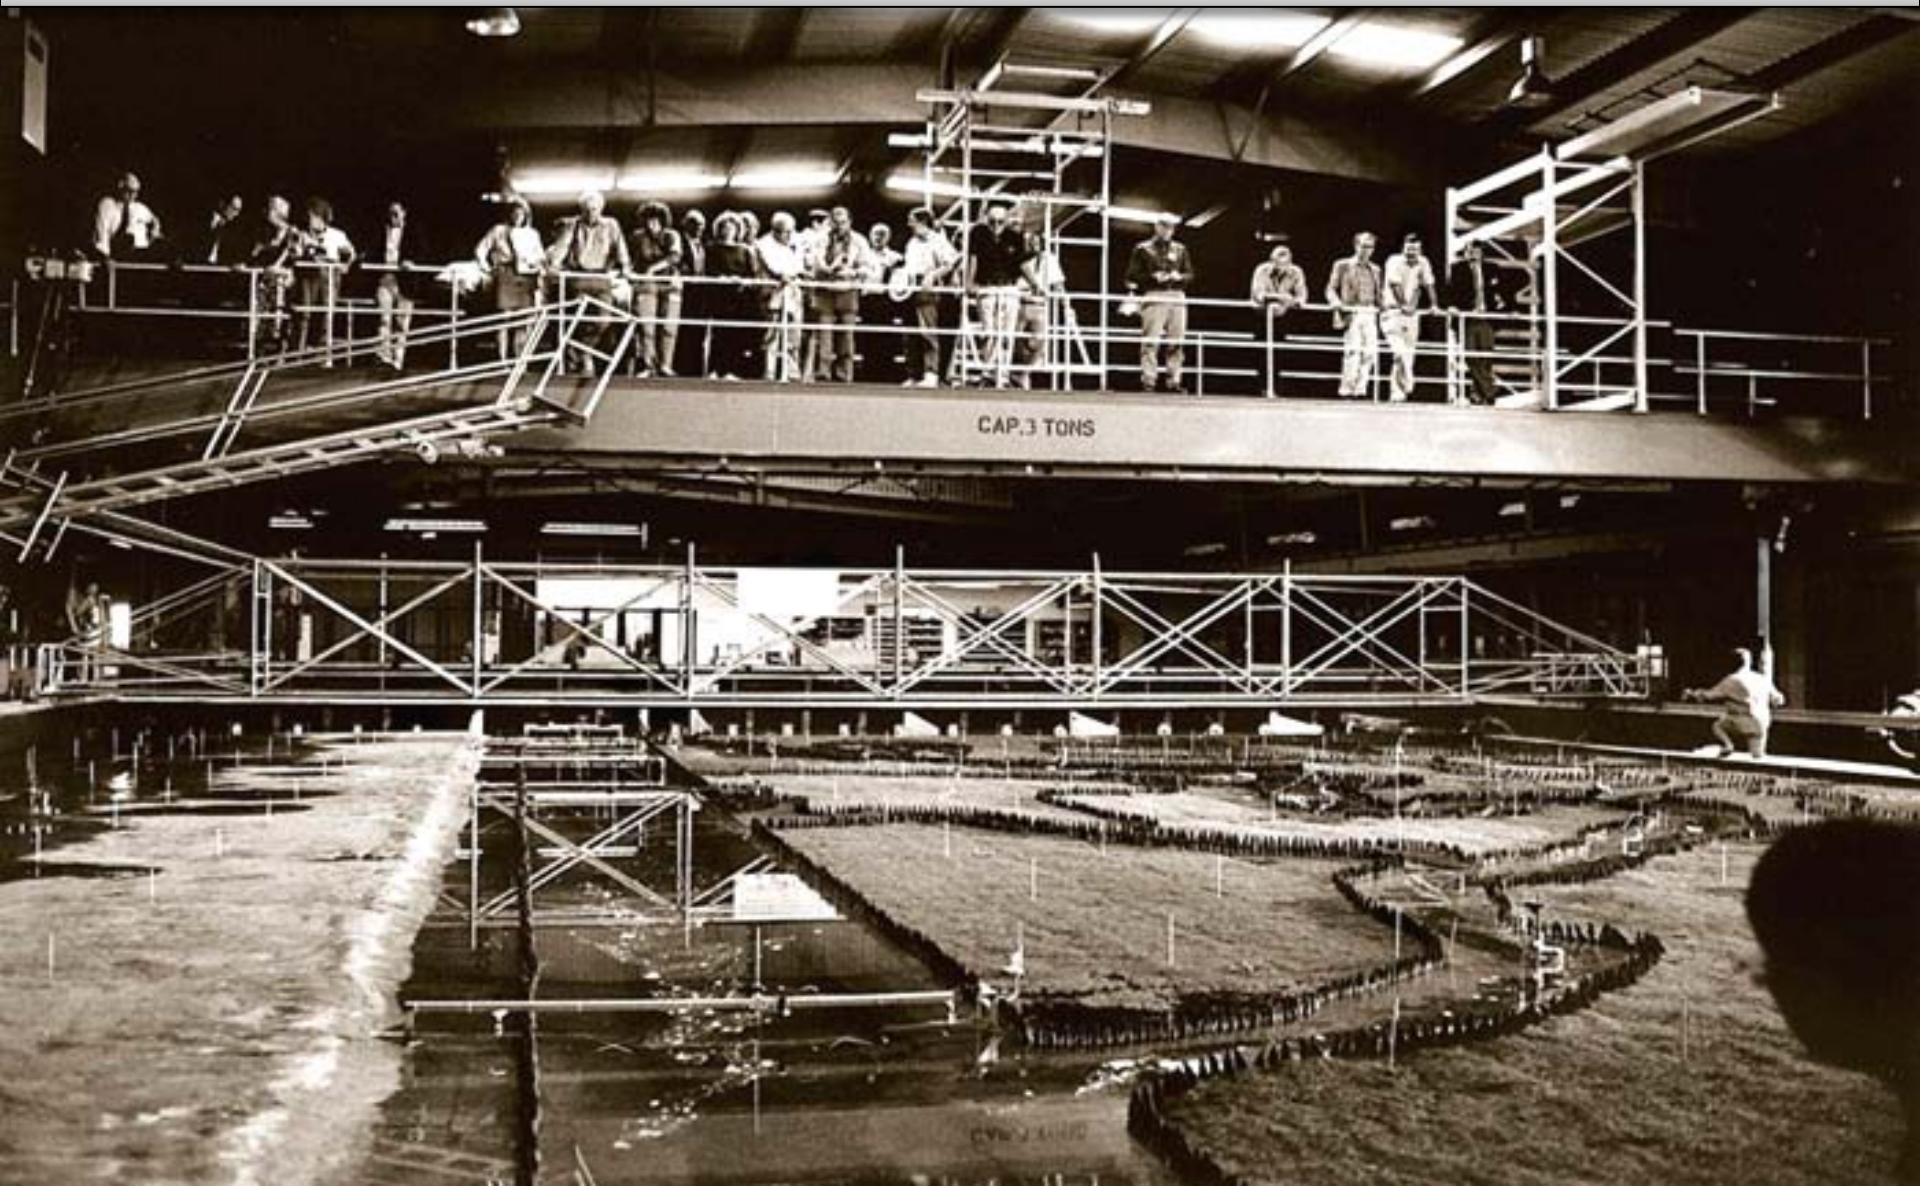
Physical Model at UC Berkeley

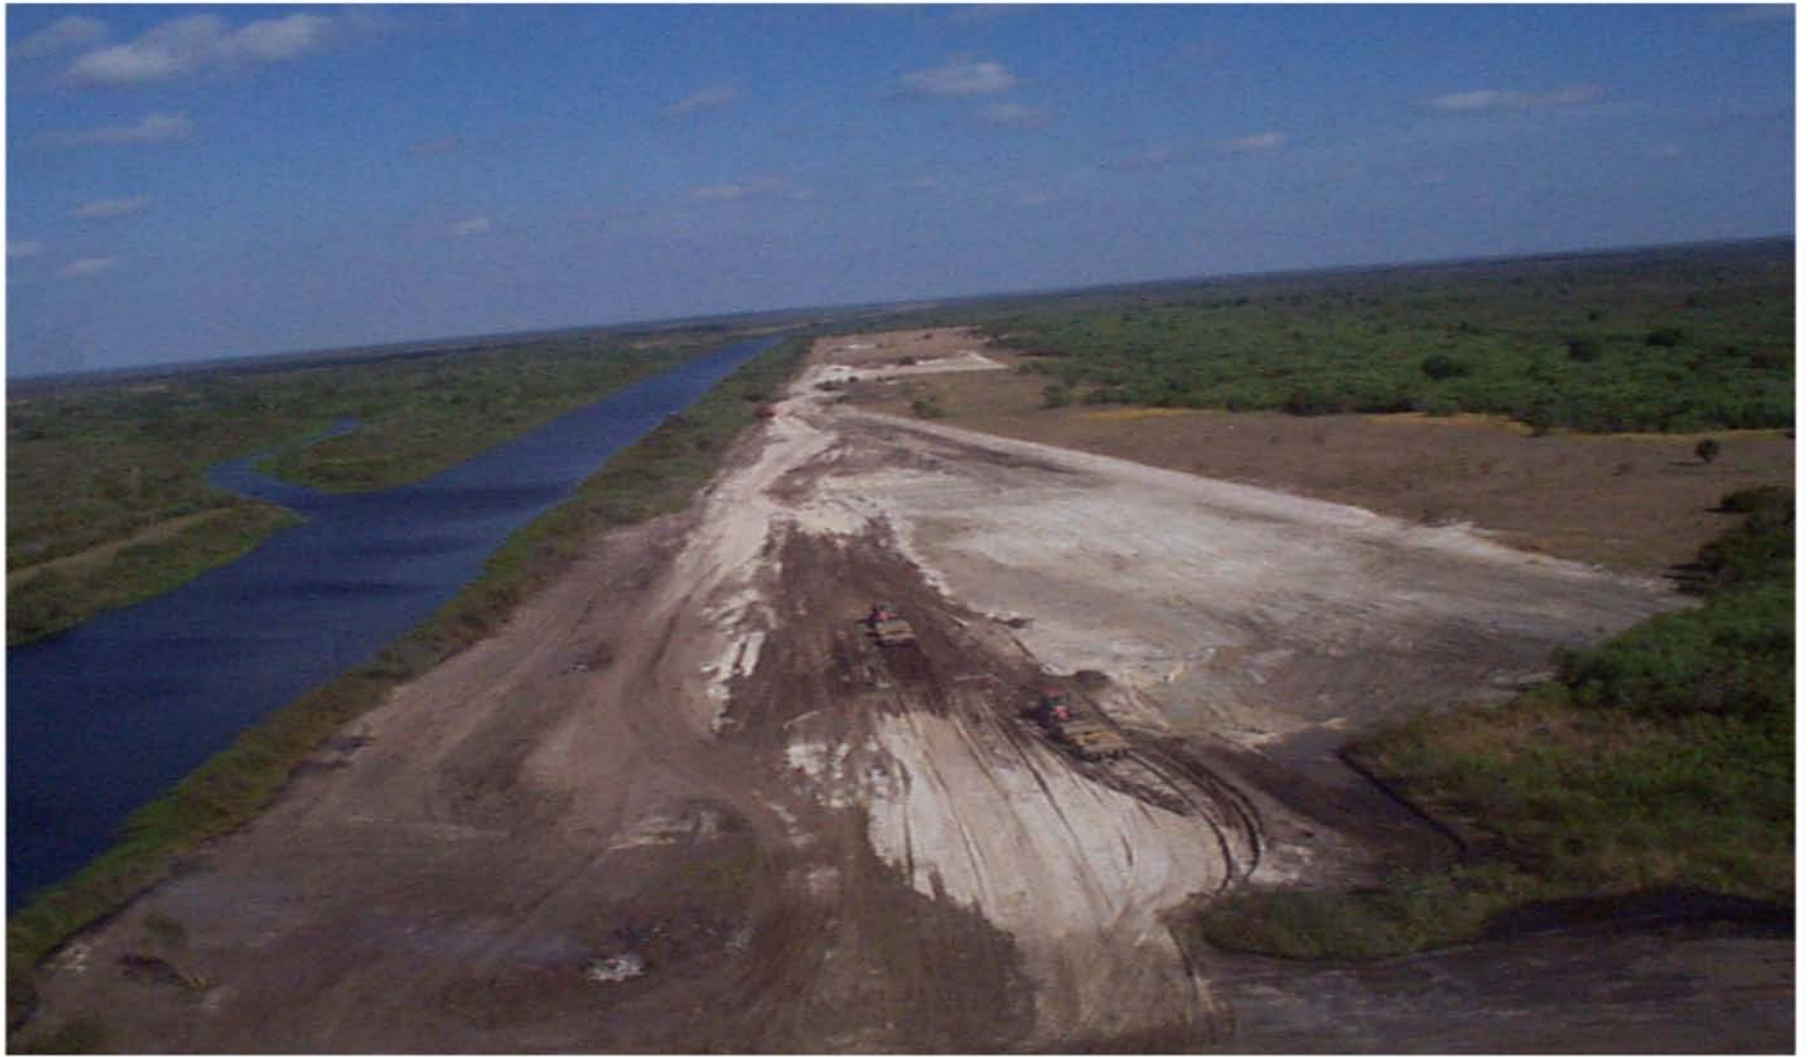
Modifications at S-65A

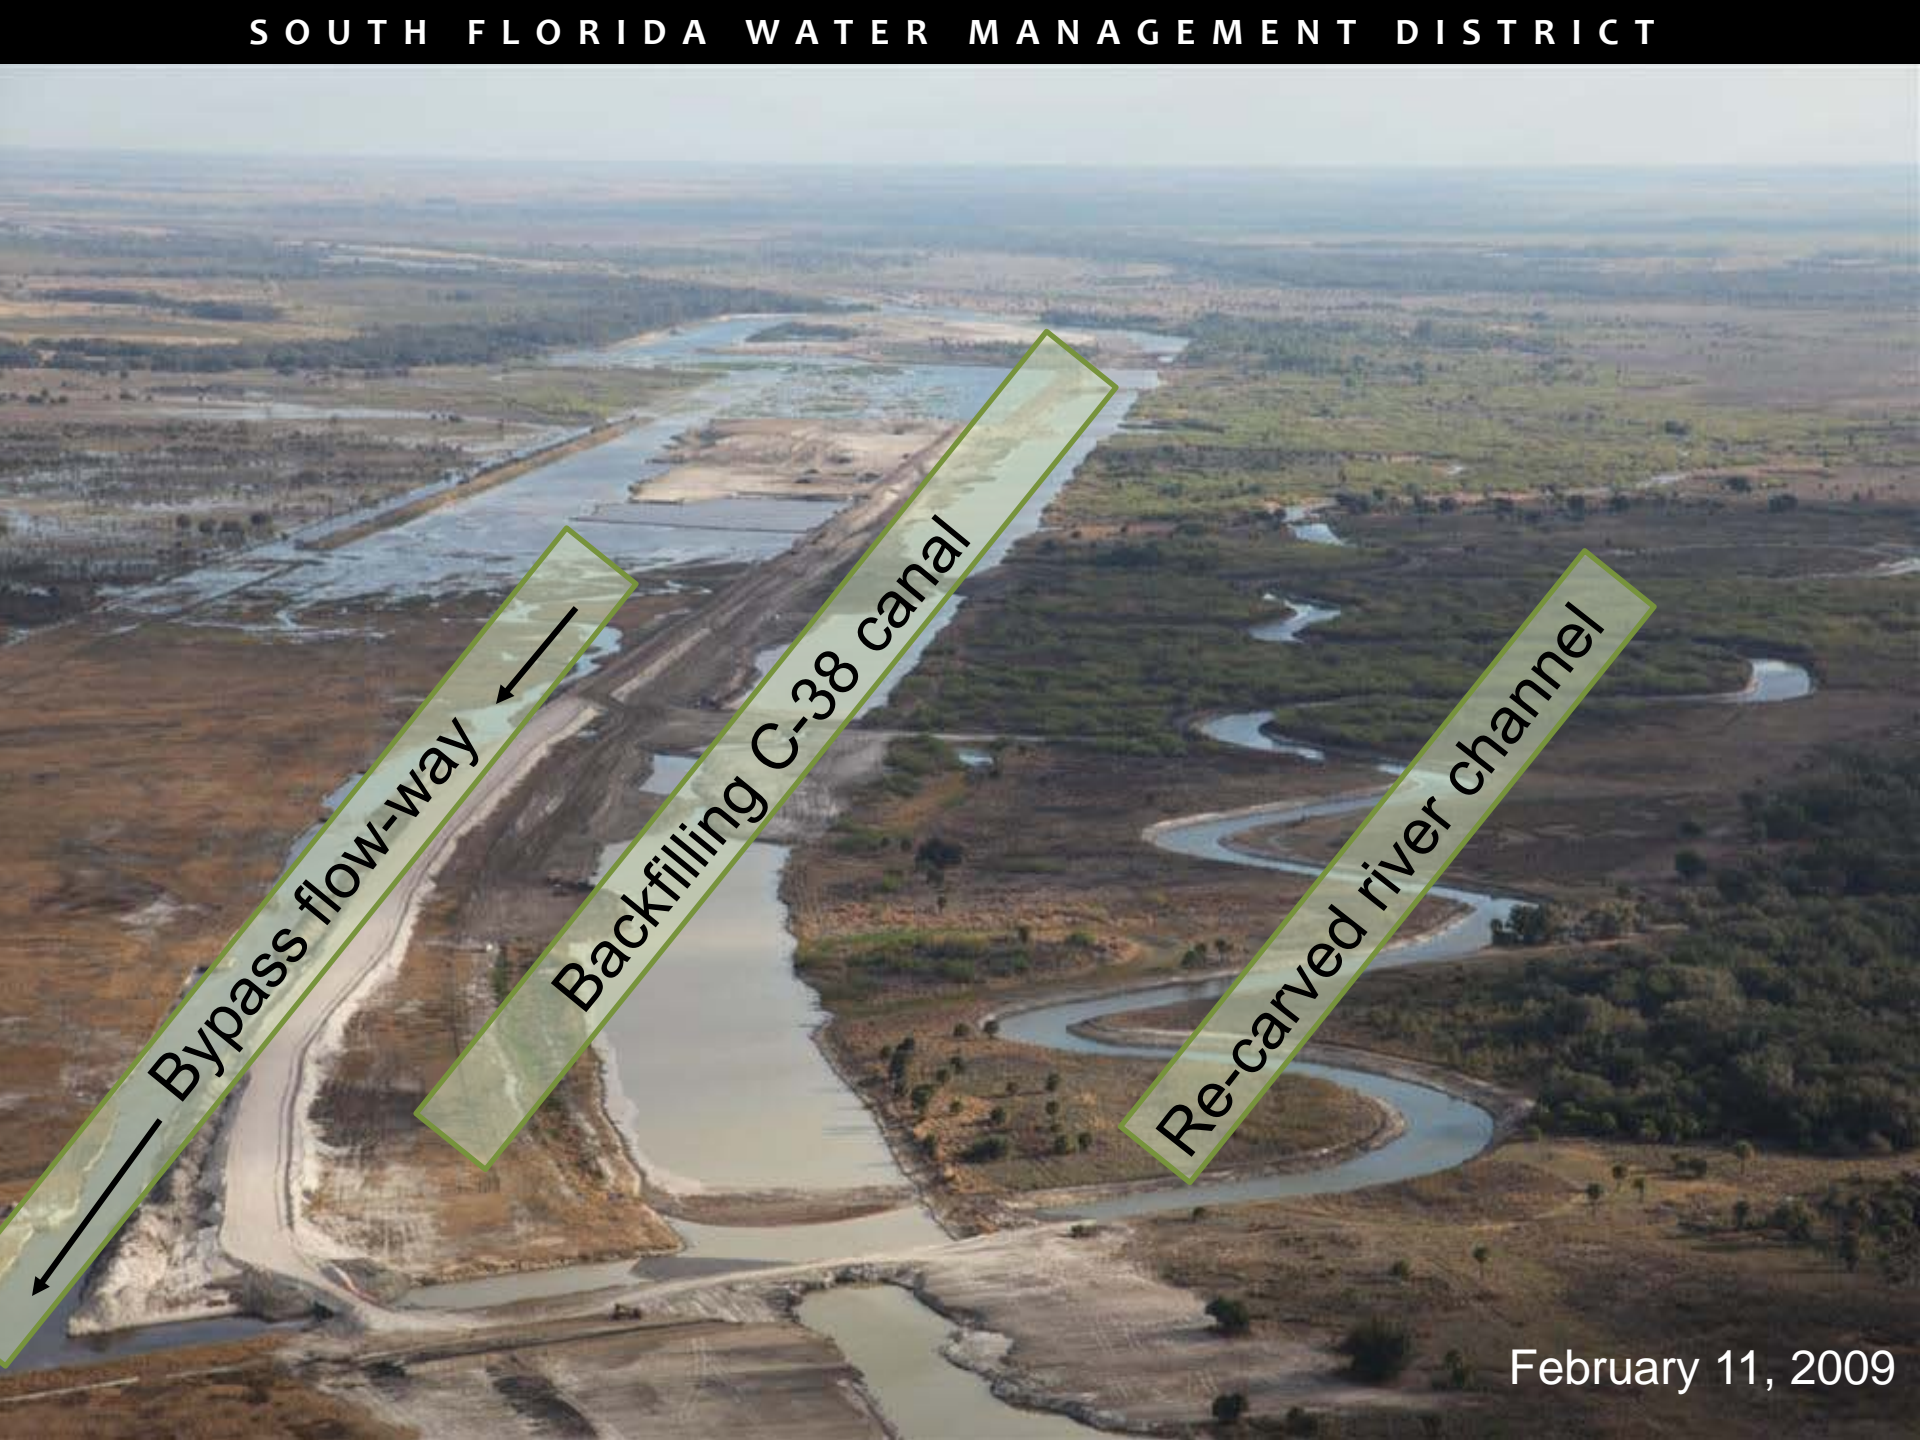
Bypass flow-way

Backfilling C-38 canal

Re-carved river channel

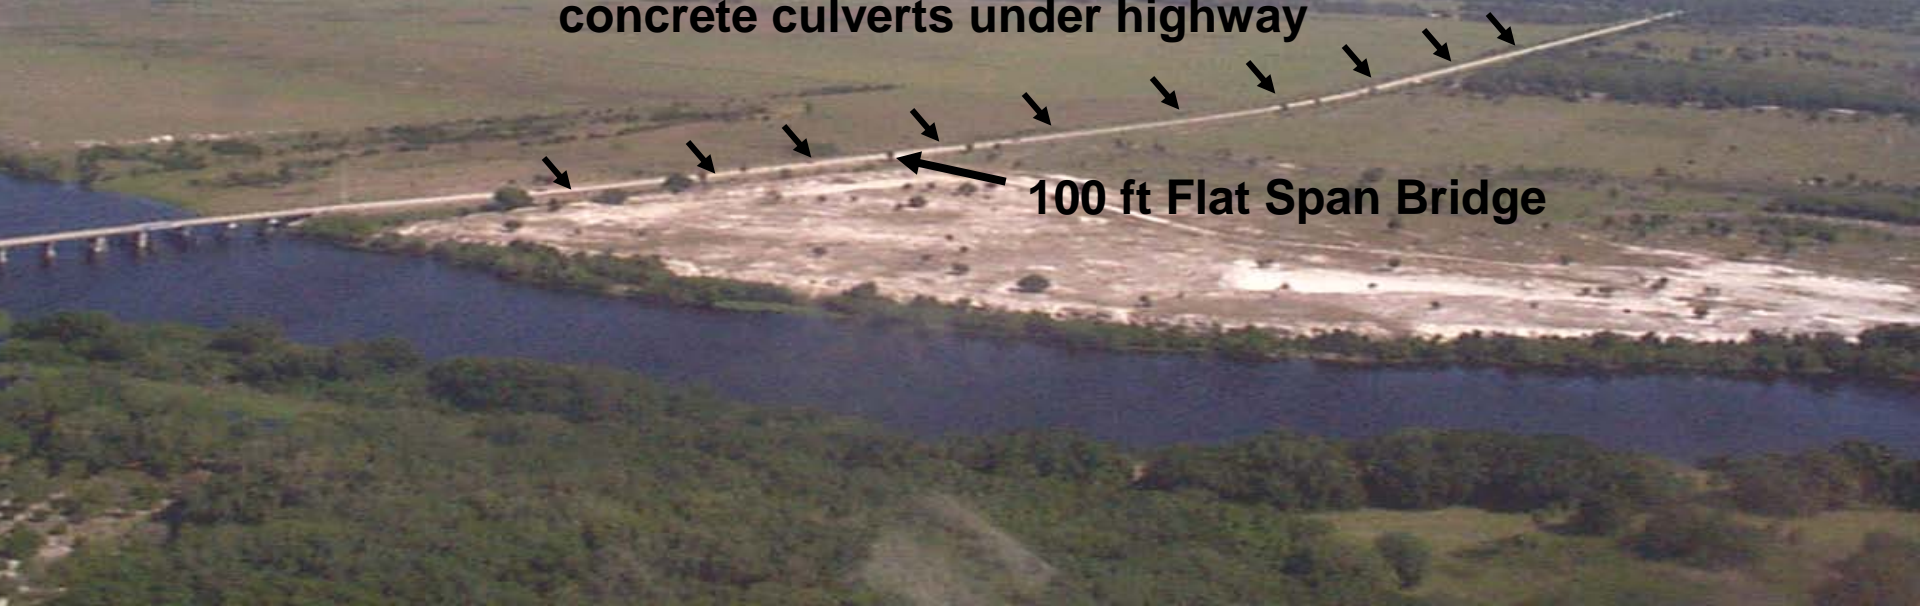
U.S. Highway 98 Modifications

A series of 10 - 2m x 3m x30m
concrete culverts under highway

100 ft Flat Span Bridge

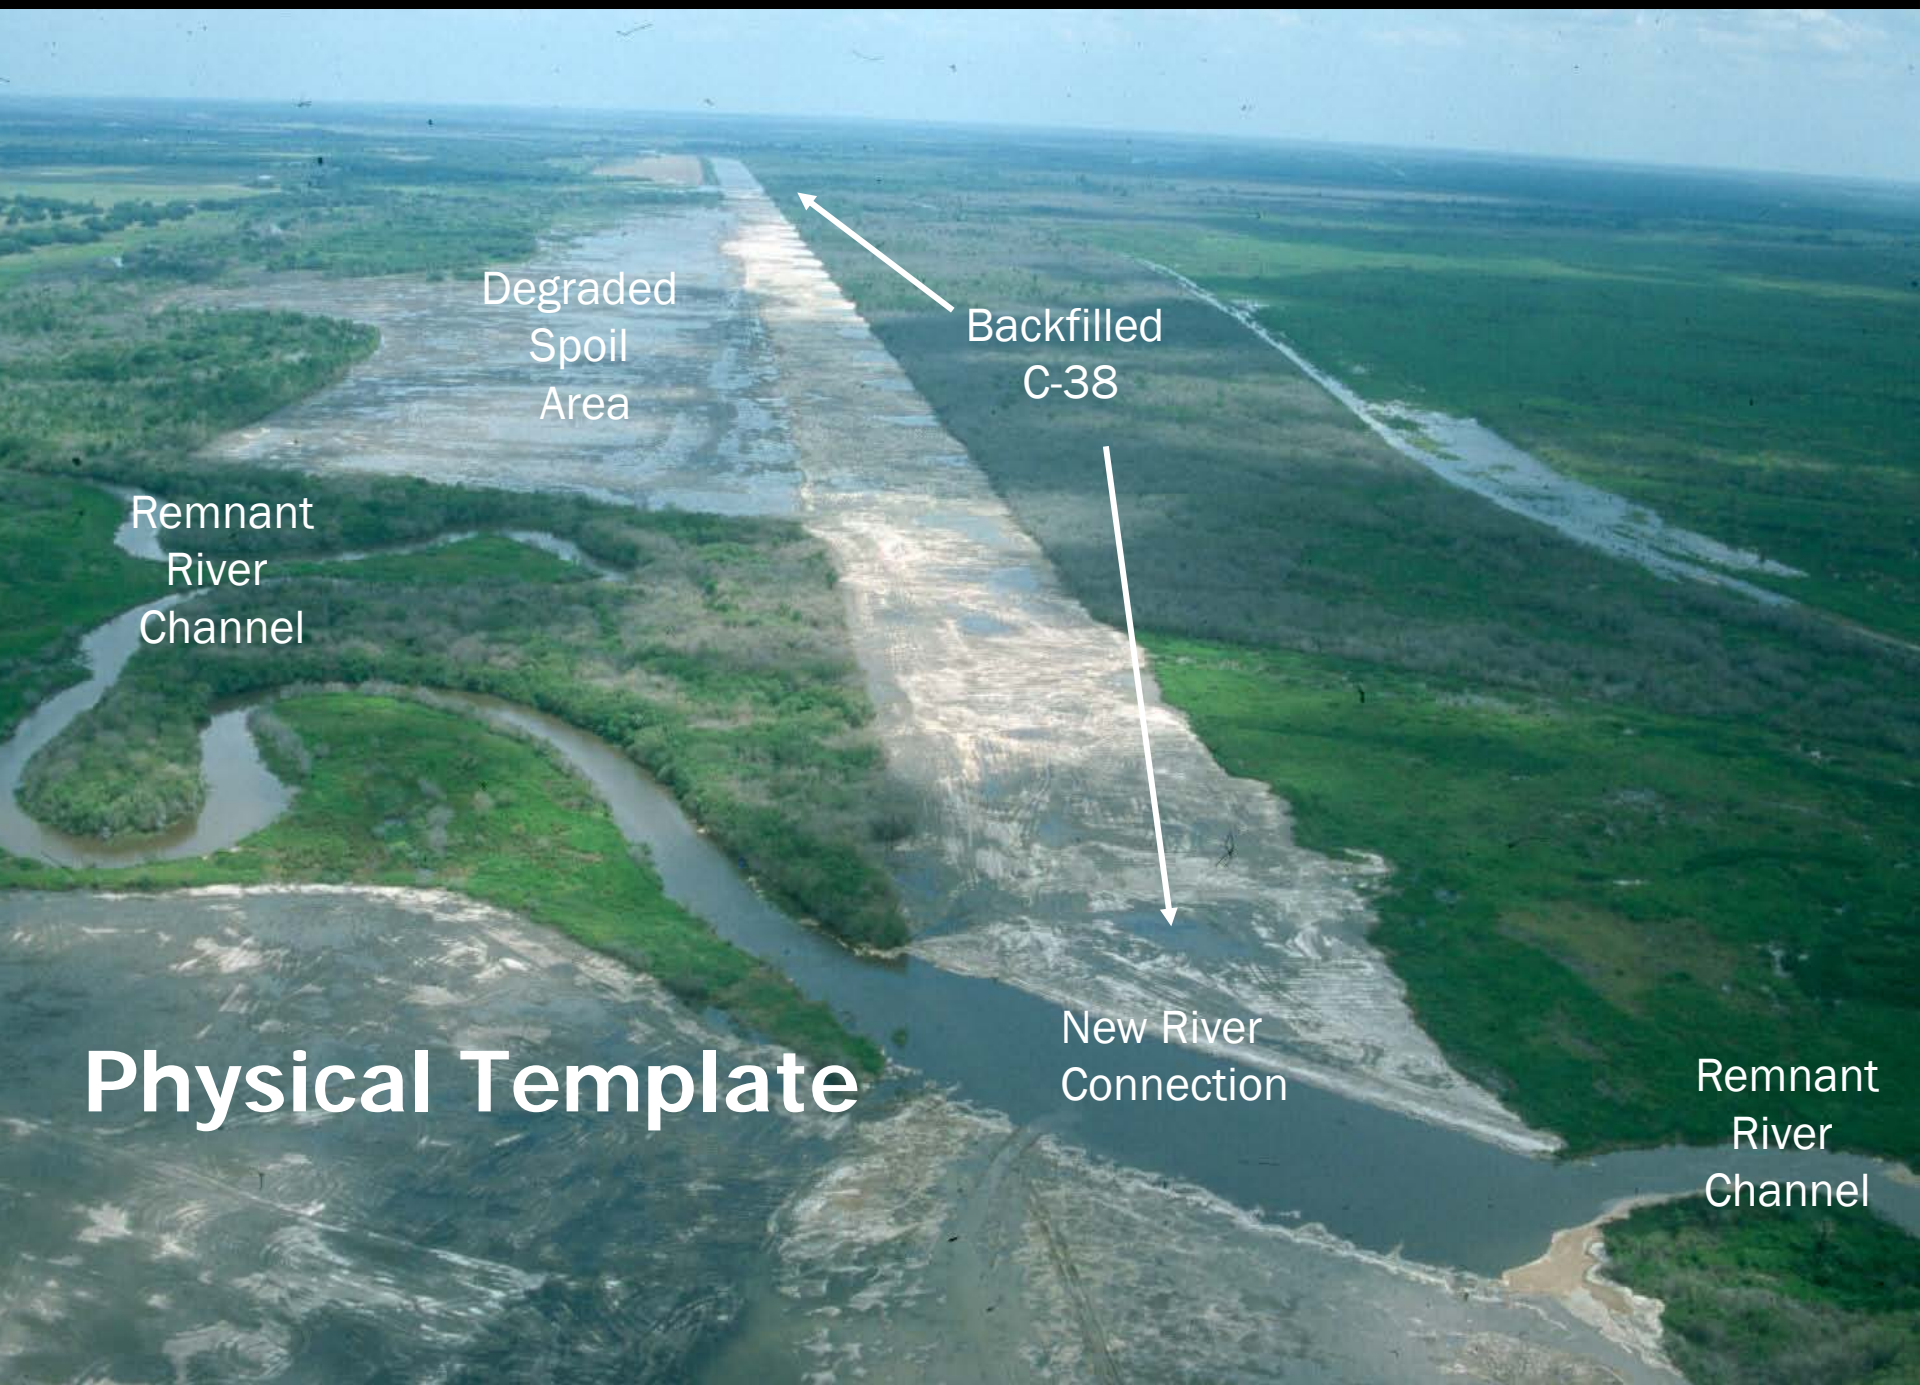
Degraded
Spoil
Area

Backfilled
C-38

Remnant
River
Channel

Physical Template

New River
Connection

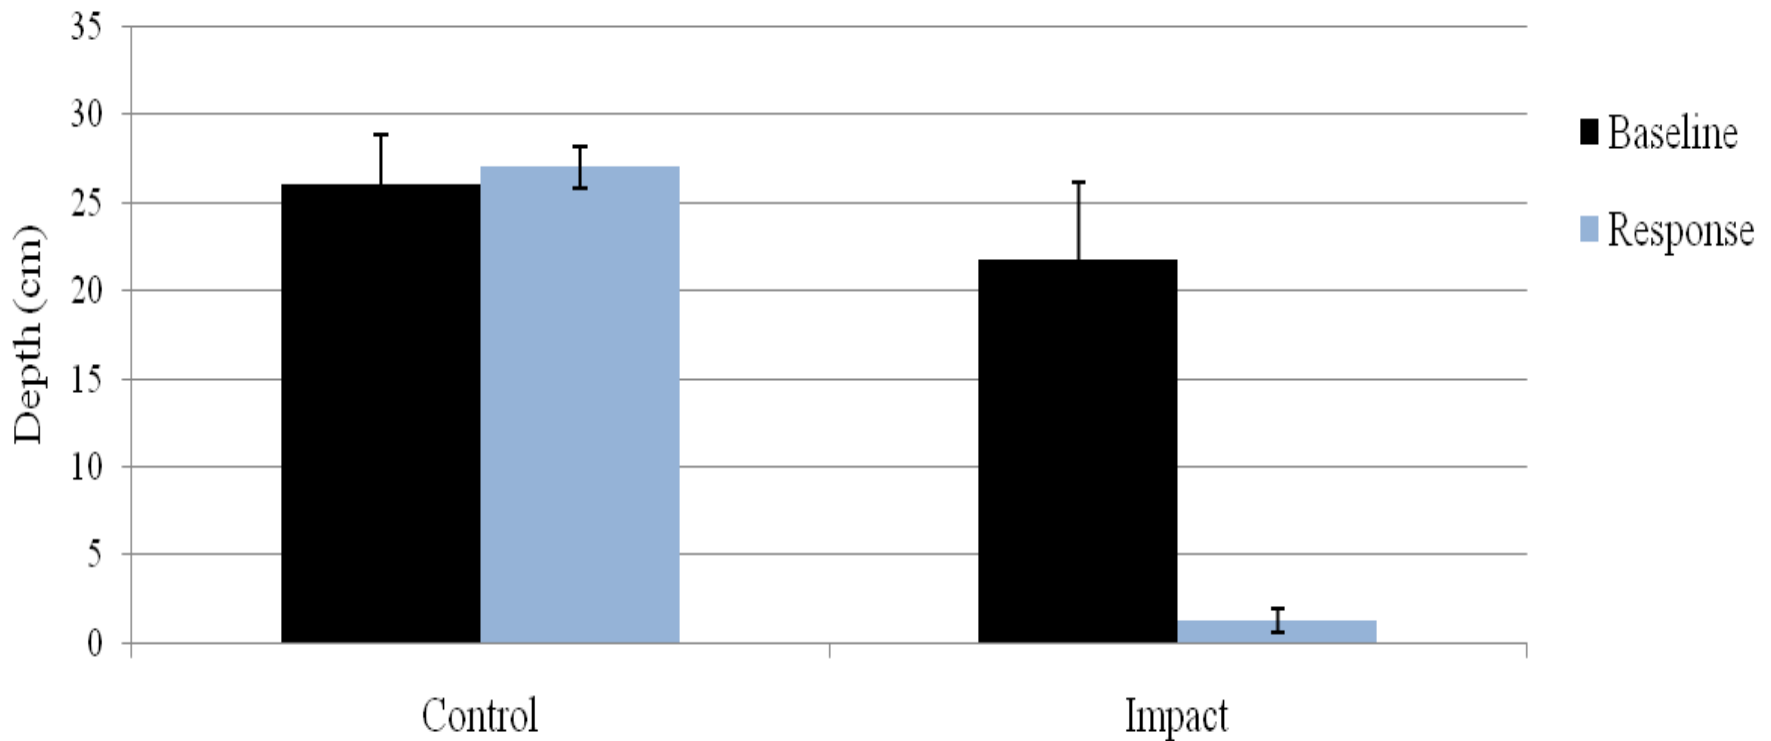
River Channel Bed Deposits

Benthic Organic Matter Depth

River Channel Bed Deposits

Mean thickness of substrate-overlying deposits will decrease by $\geq 65\%$

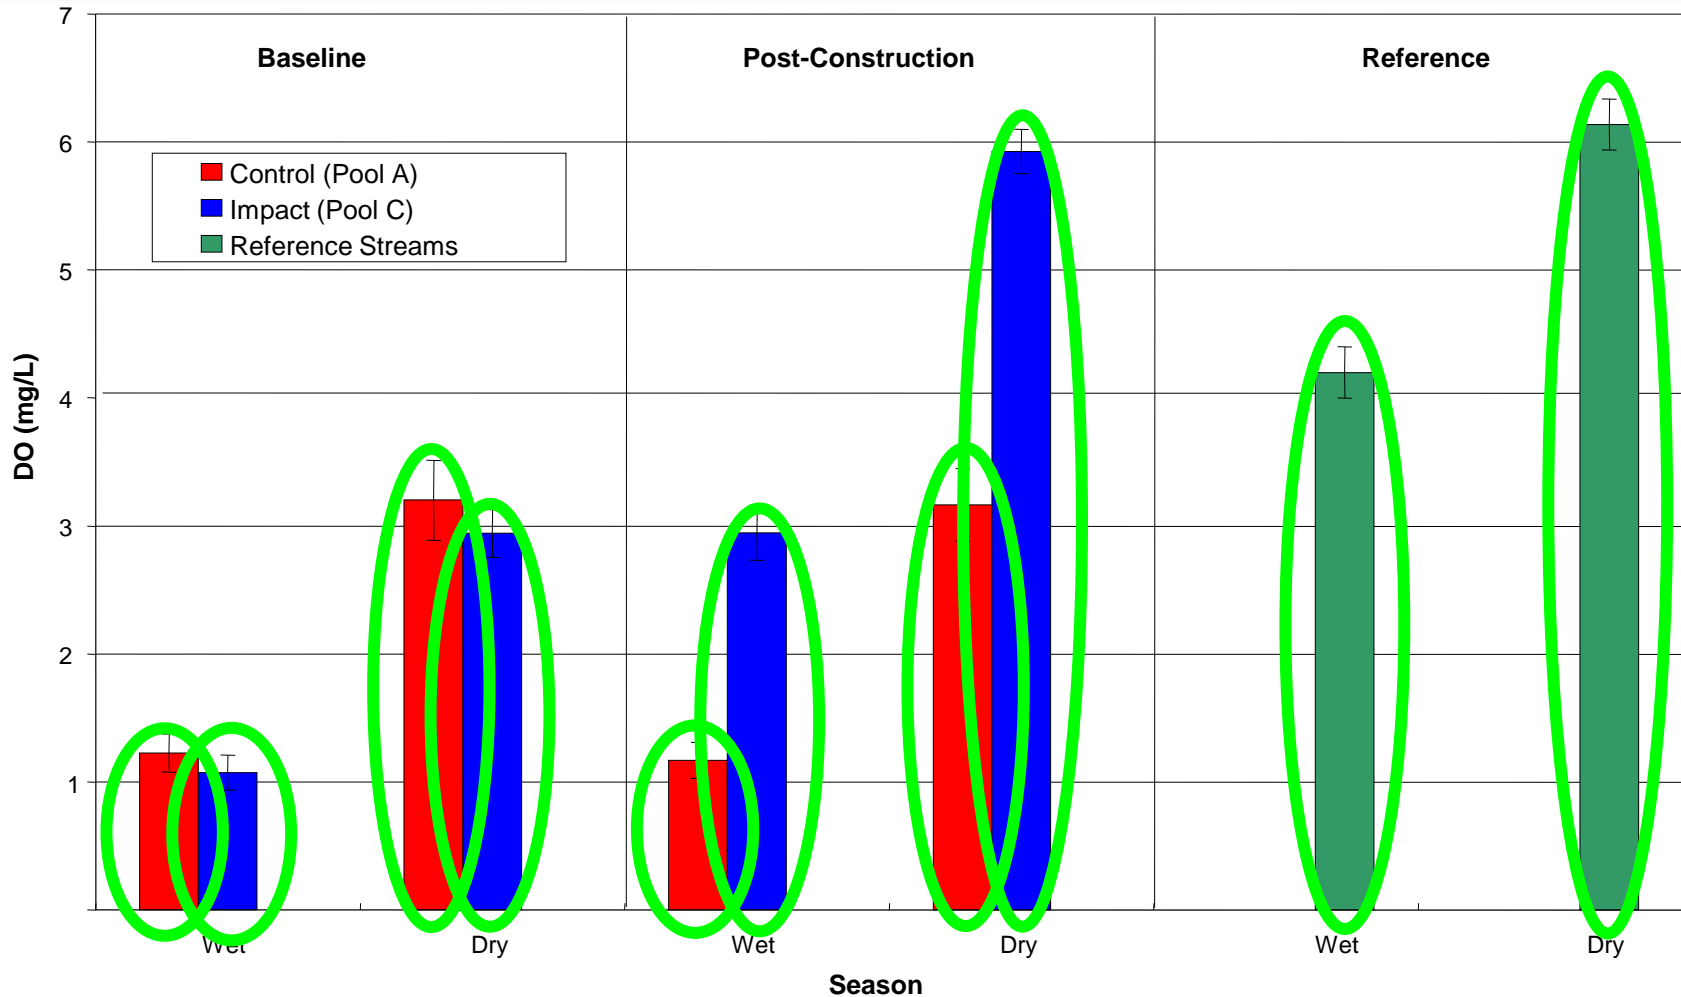
Shifts in Dissolved Oxygen
