Governing Board Meeting
May 13, 2010

Ecological Conditions Update

Peter Doering

Chief Environmental Scientist
Restoration Sciences Department

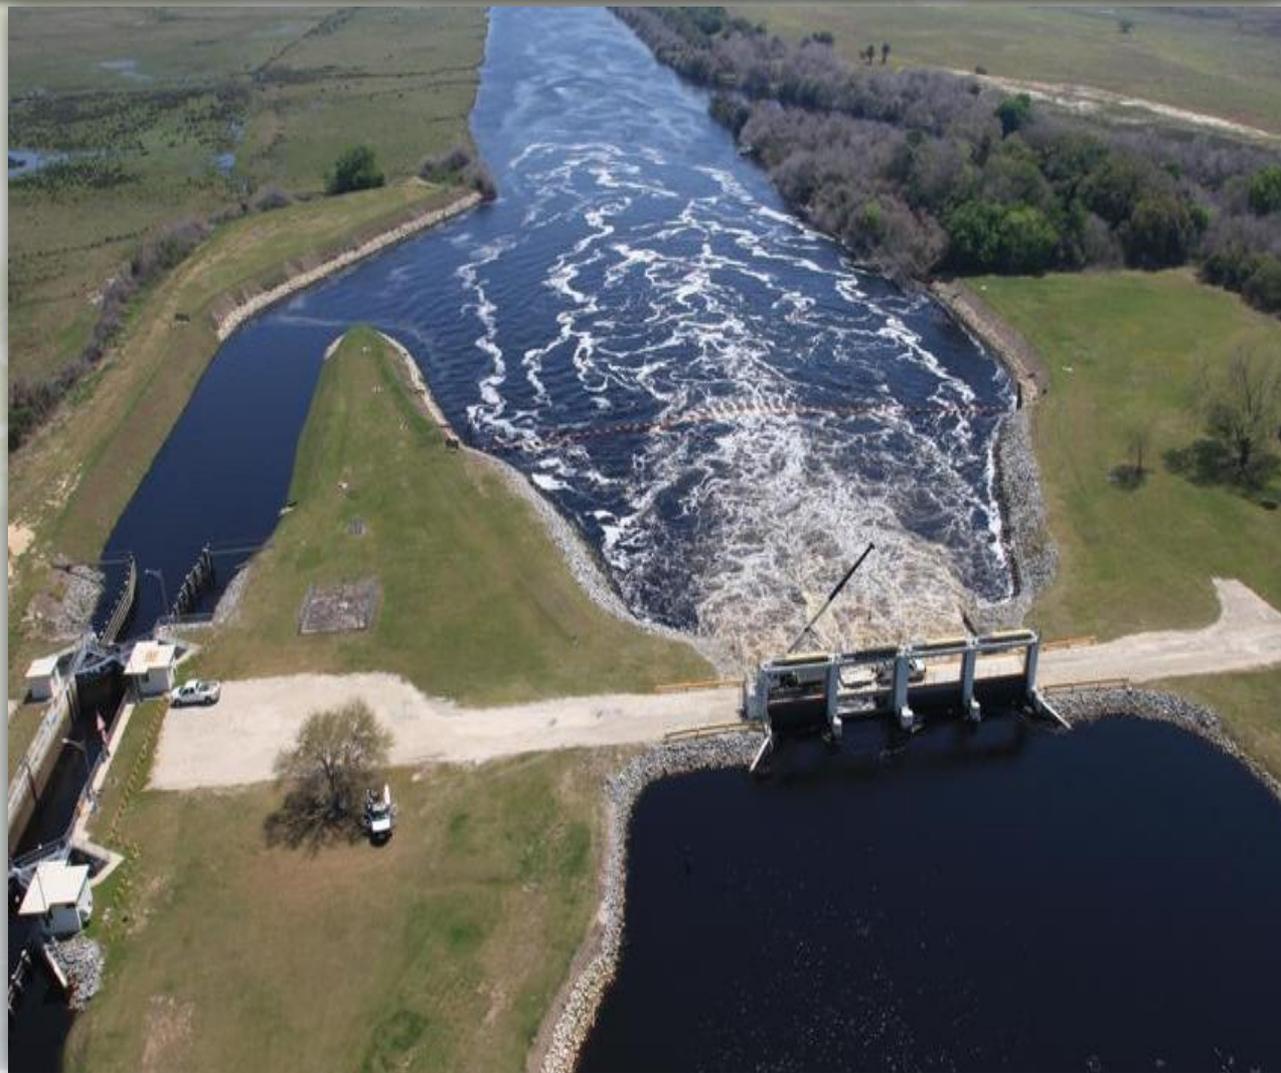
Kissimmee Basin

- High discharges through the Lower Basin in April resulted in high flow velocity in the Phase I restoration area, causing bank erosion
- Dissolved oxygen concentrations in the Phase I river channel have declined but remain above the level of concern of <2 mg/L

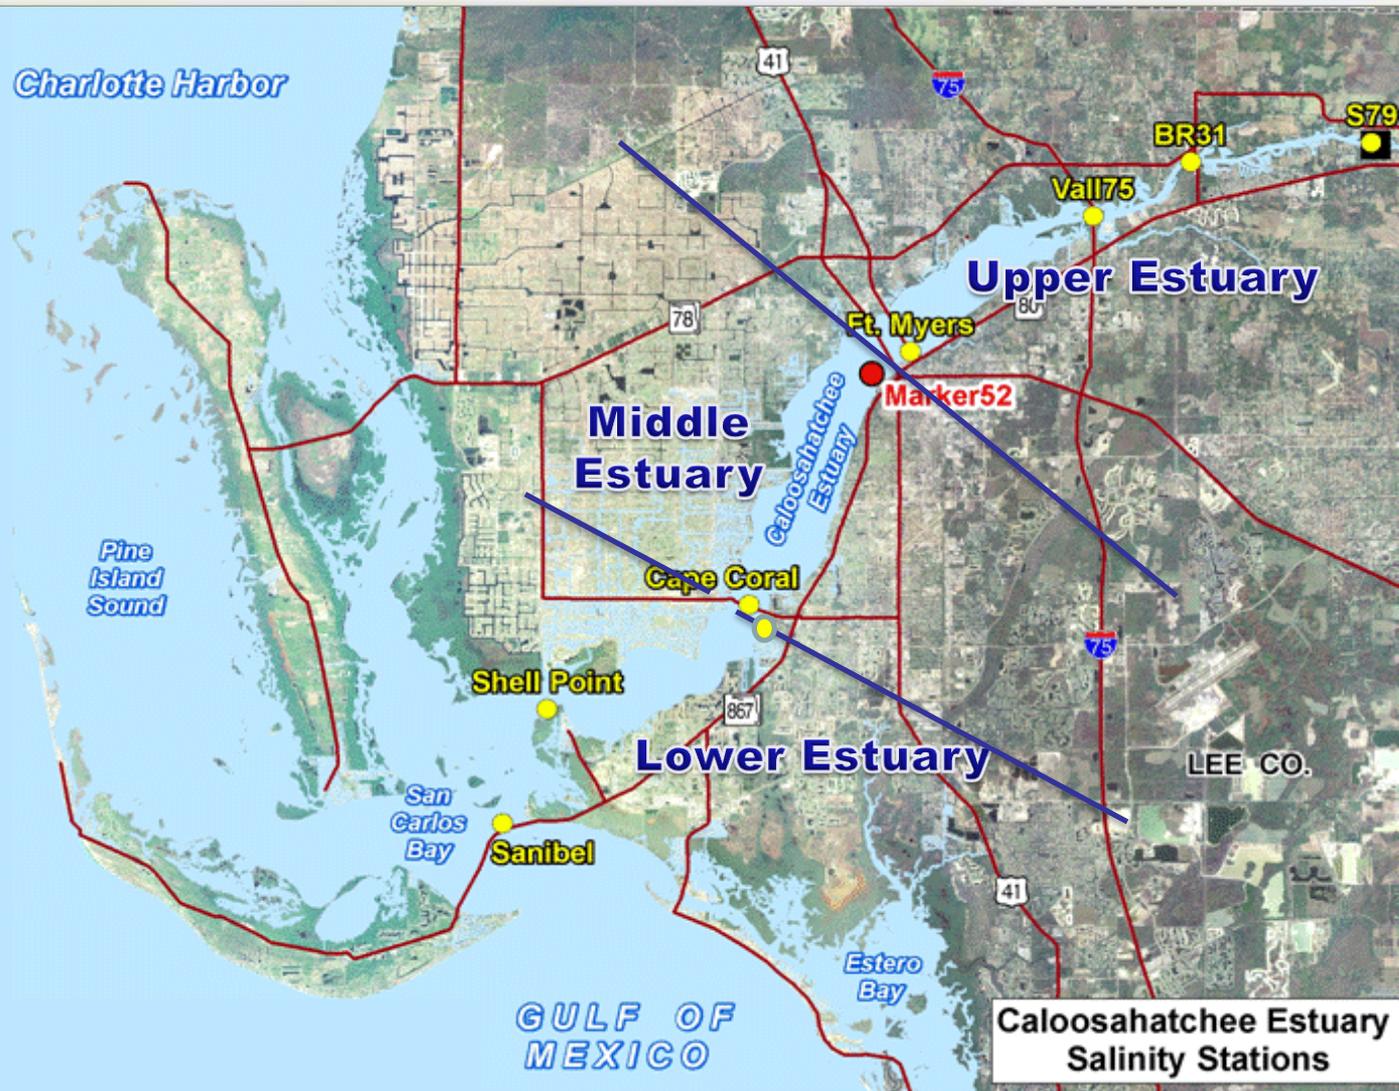
Caloosahatchee Salinity

- Lake releases and local runoff have reduced salinity throughout the Caloosahatchee estuary
- Salinity conditions in the Upper Estuary are favorable for tape grass and associated fauna
- Salinity levels in the Lower Estuary & San Carlos Bay are unfavorably low

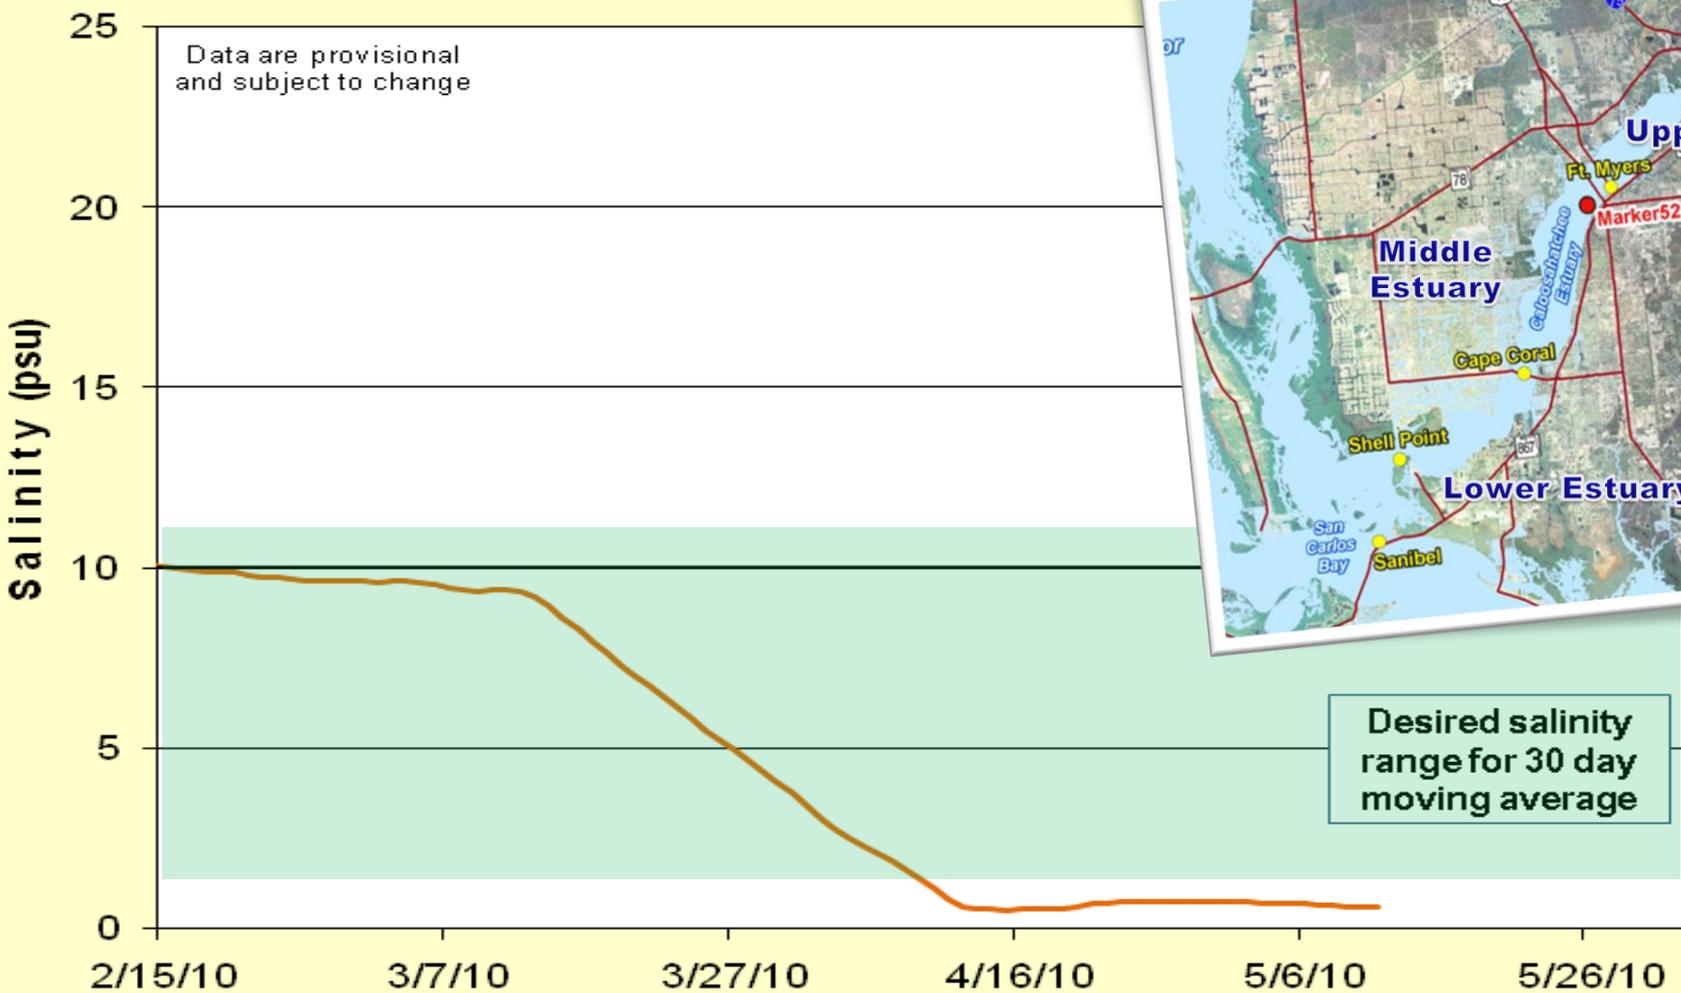
Caloosahatchee Salinity: Upper Estuary - Fort Myers

Desired salinity range for 30 day moving average

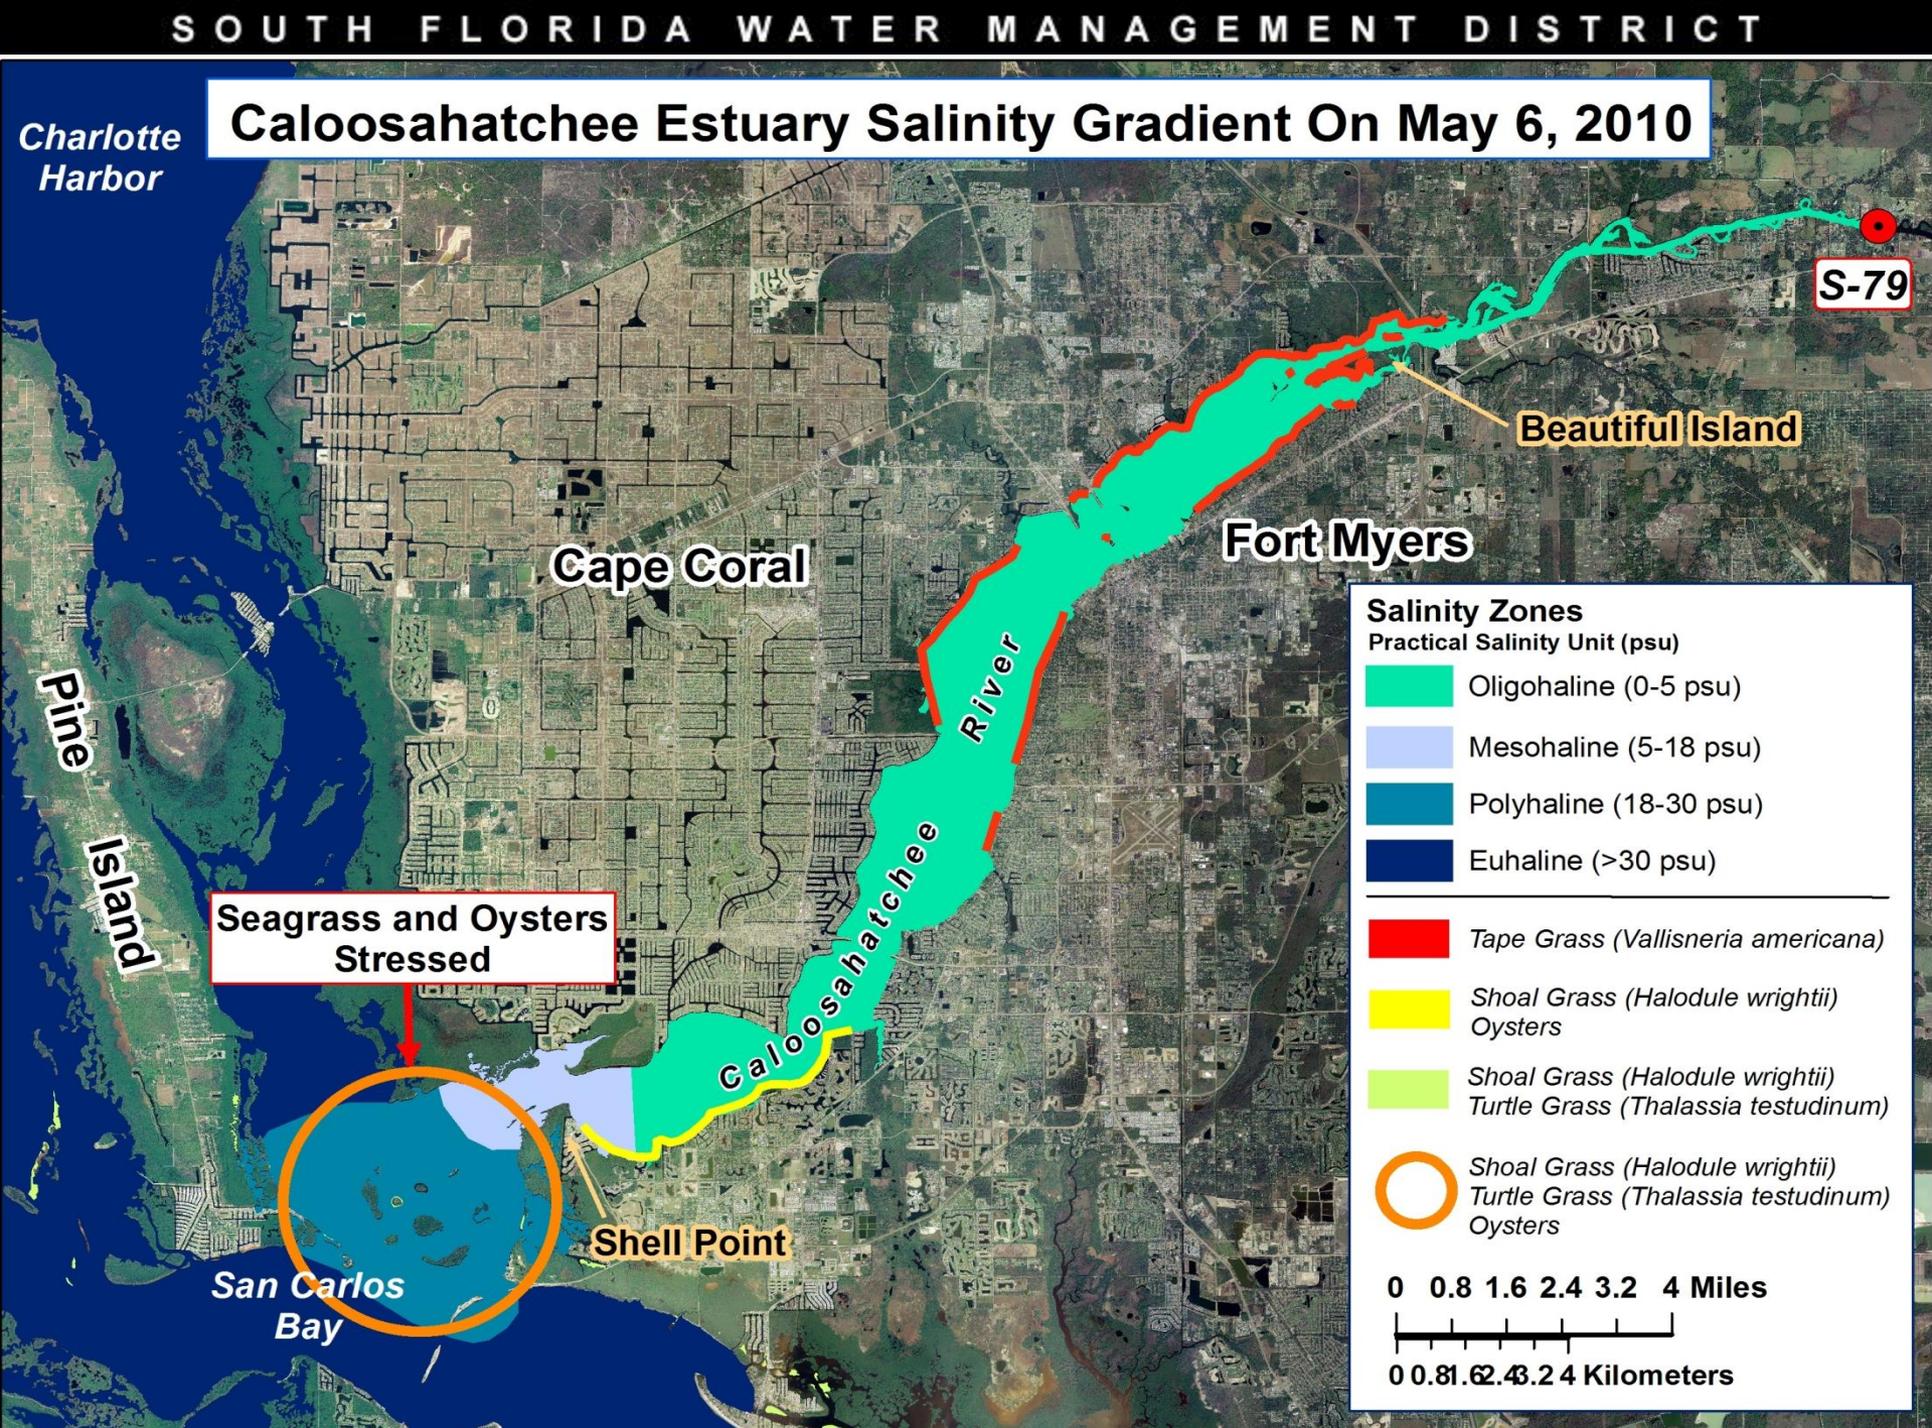
Caloosahatchee Estuary Salinity Gradient On May 6, 2010

Seagrass and Oysters Stressed

Salinity Zones
Practical Salinity Unit (psu)

- Oligohaline (0-5 psu)
- Mesohaline (5-18 psu)
- Polyhaline (18-30 psu)
- Euhaline (>30 psu)

- Tape Grass (*Vallisneria americana*)
- Shoal Grass (*Halodule wrightii*)
Oysters
- Shoal Grass (*Halodule wrightii*)
Turtle Grass (*Thalassia testudinum*)
- Shoal Grass (*Halodule wrightii*)
Turtle Grass (*Thalassia testudinum*)
Oysters

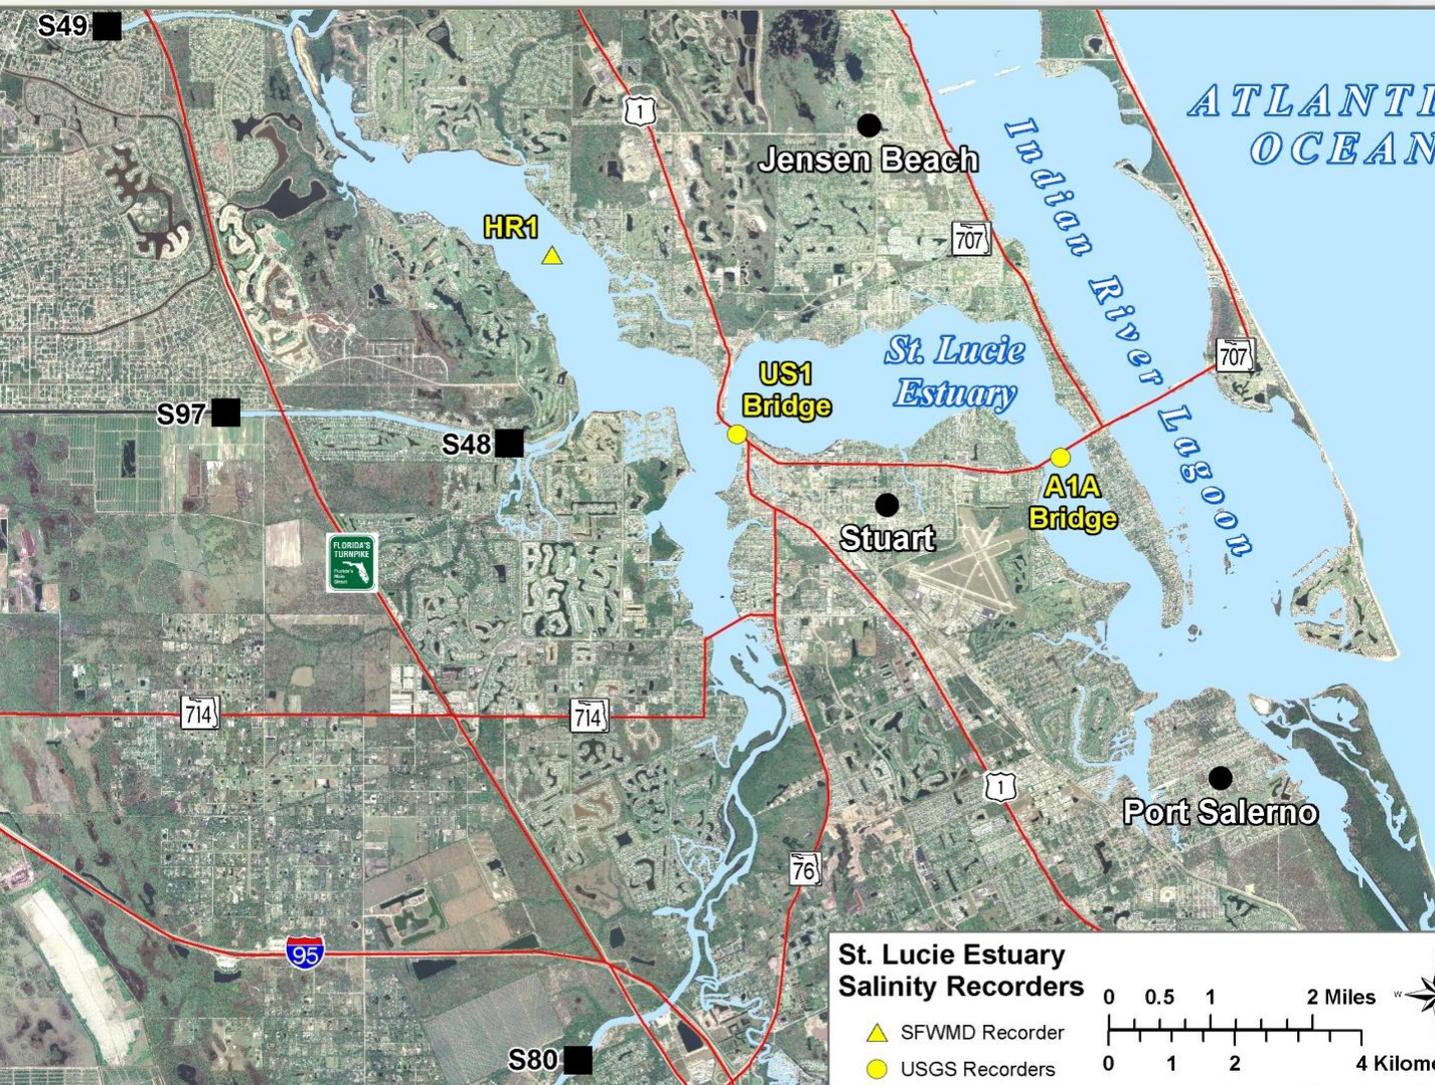
St. Lucie Salinity: US 1 Bridge

In the St. Lucie, the daily salinity at the US1 Bridge was below the salinity envelope, threatening oyster survival

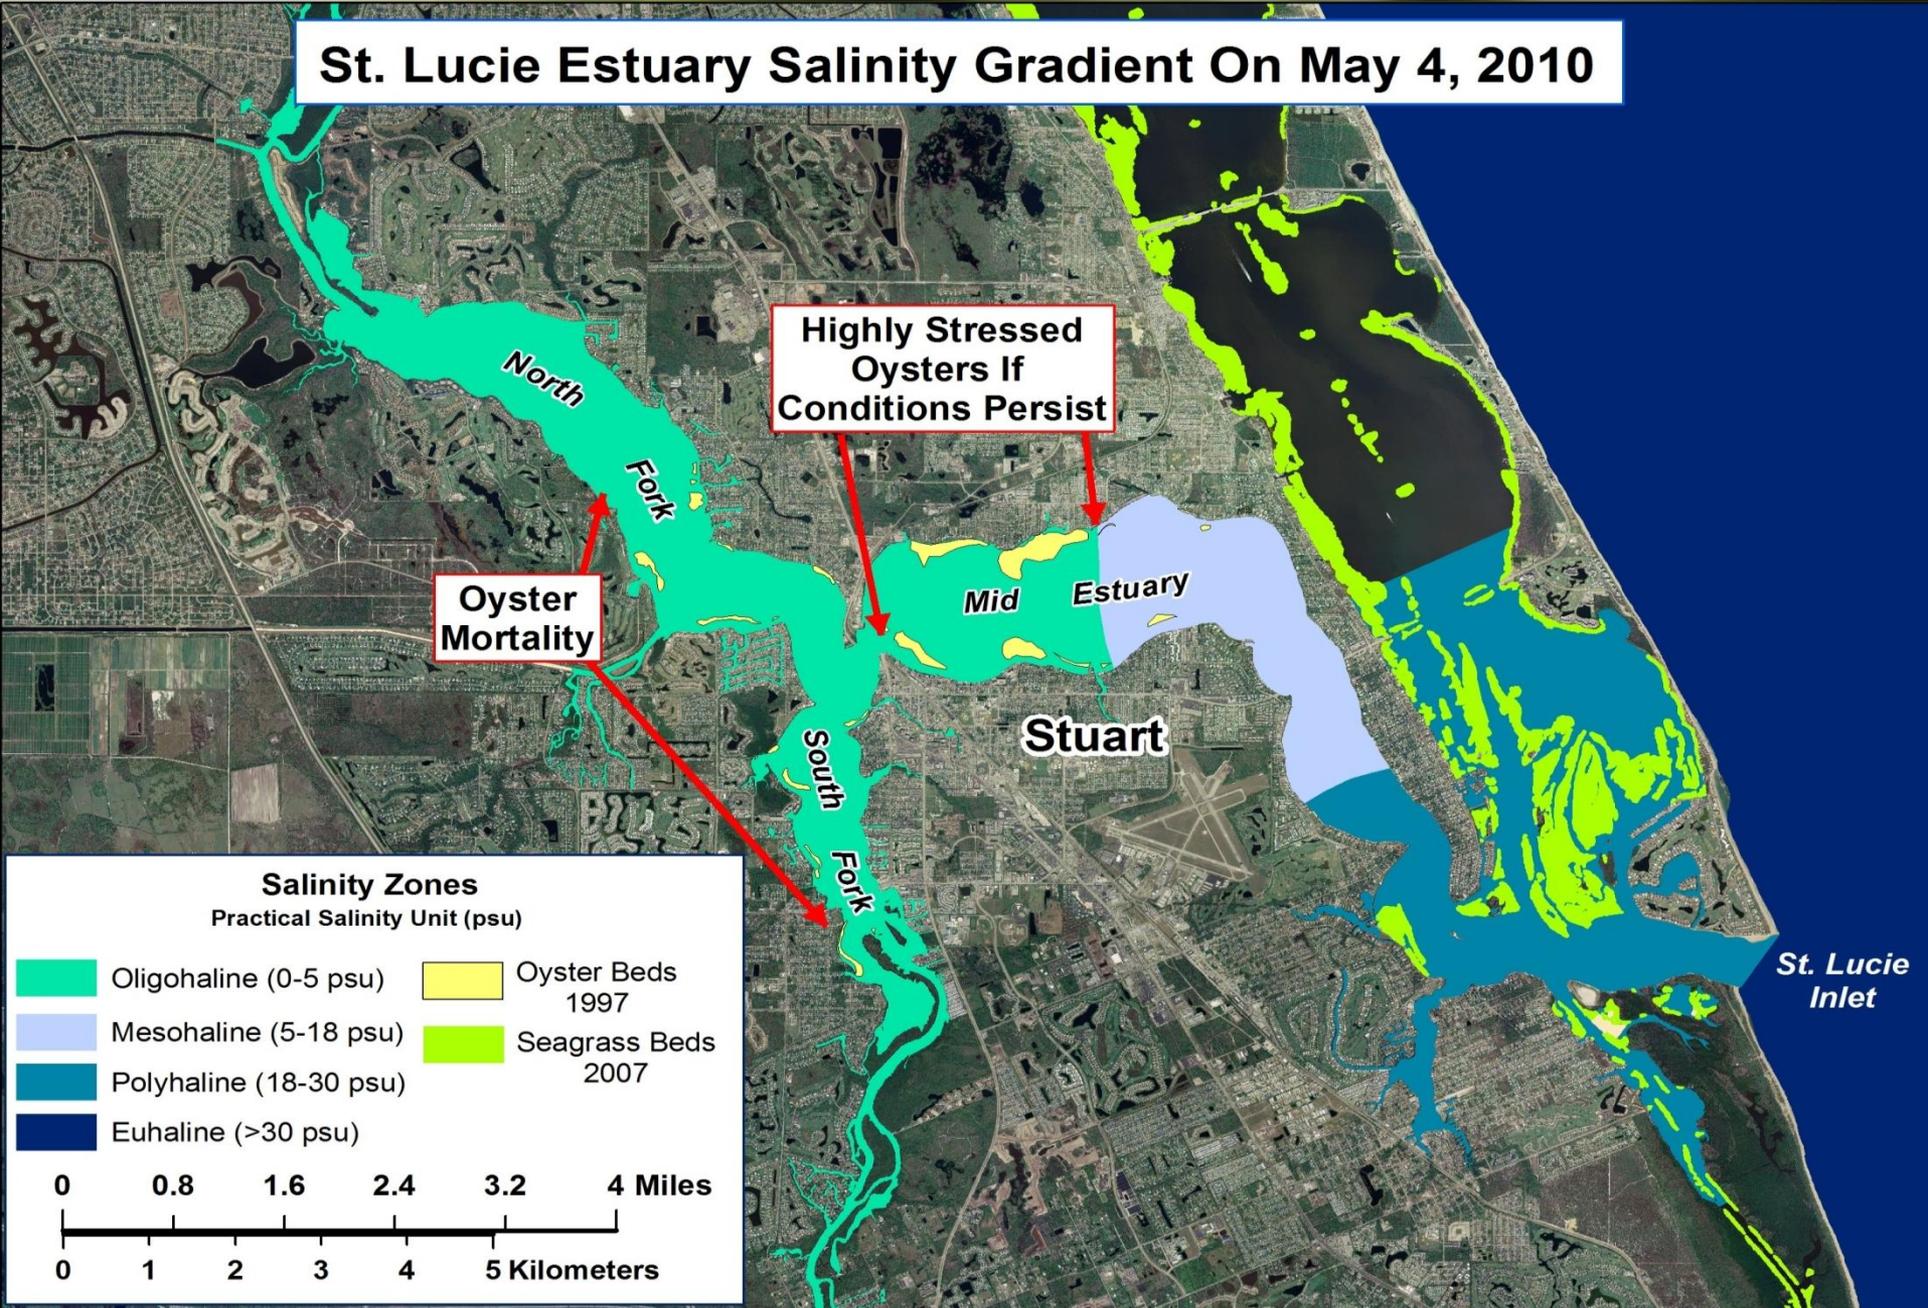
St. Lucie Estuary Salinity Gradient On May 4, 2010

Oyster Mortality

Highly Stressed Oysters If Conditions Persist

Salinity Zones
Practical Salinity Unit (psu)

- Oligohaline (0-5 psu)
- Mesohaline (5-18 psu)
- Polyhaline (18-30 psu)
- Euhaline (>30 psu)
- Oyster Beds 1997
- Seagrass Beds 2007
