REPORT OF SURVEY

**ACOE Survey 09-149**

**C&SF Water Control Structures South  
Topographic Survey  
Central and South Florida**

**Network EastMid**

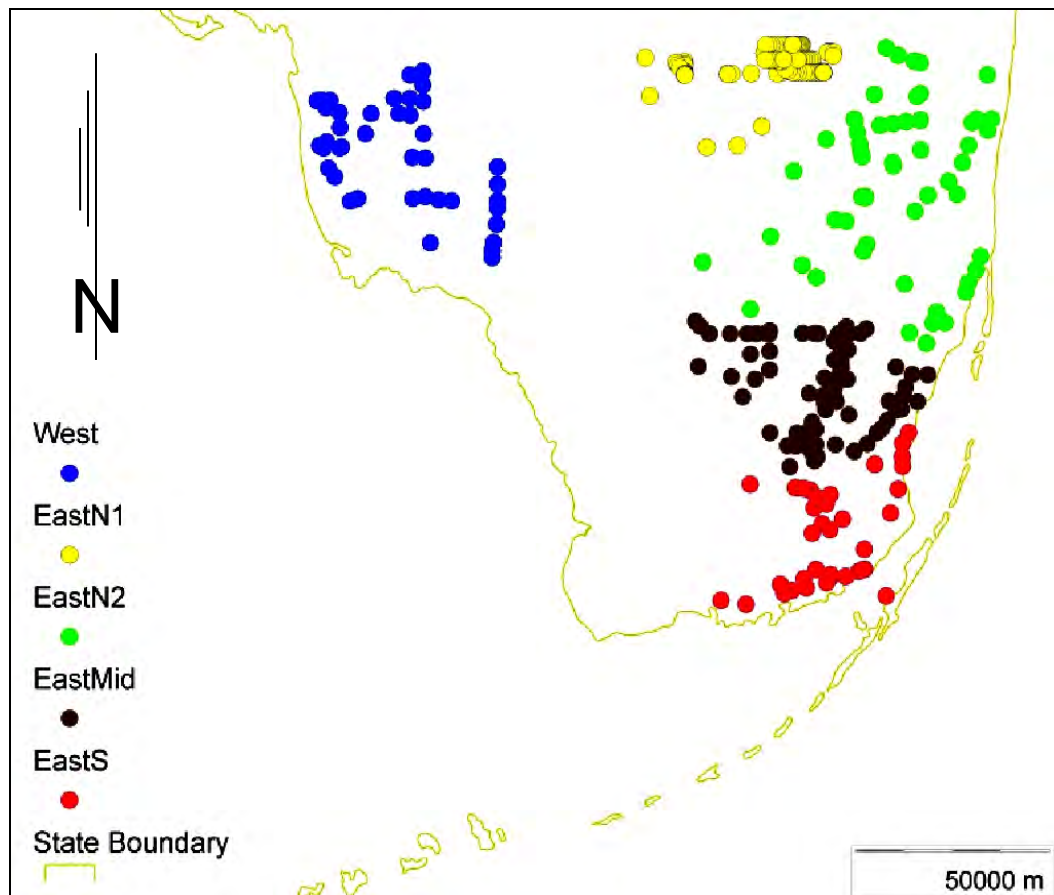
Figure 1: Segmentation of Project into Sub-Projects

As directed in the Scope of Work and subsequently agreed to in pre-field work discussions with Mr. Robert Swilley, PSM, Project Manager of the Jacksonville Geomatics Section of the USACOE, the overall task of determining the elevations of some 326 structures was divided into five different spatially delimited sub-projects called West, EastN1, EastN2, EastMid and EastS respectively, as shown in Figure 1 below: This report is specific to the sub-project EastMid only.

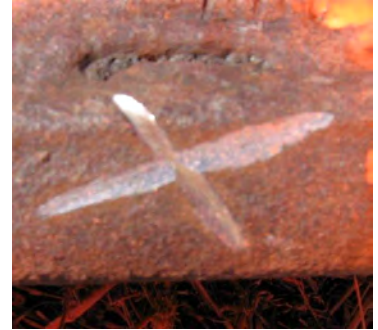
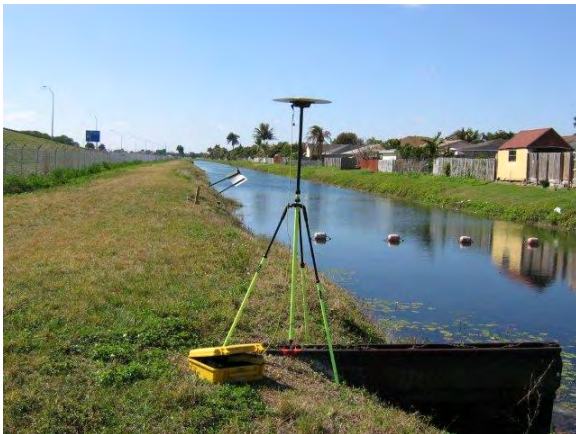
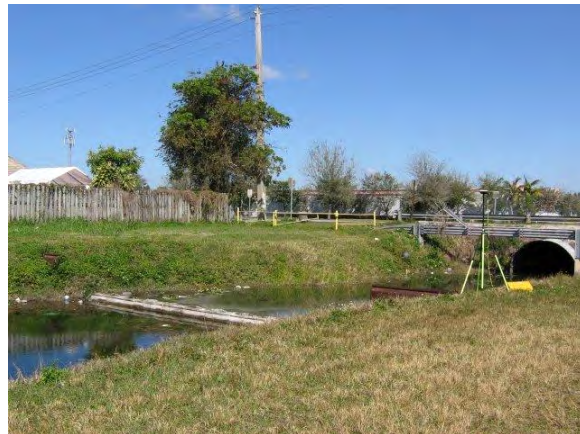
**STRUCTURE NAME**      **G114**

**DESCRIPTION**      X-Cut in Steel Beam

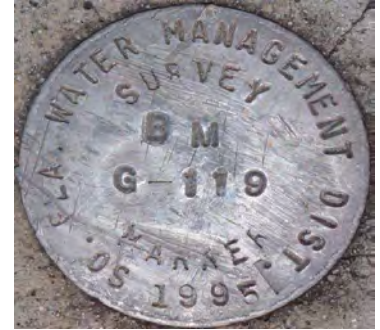
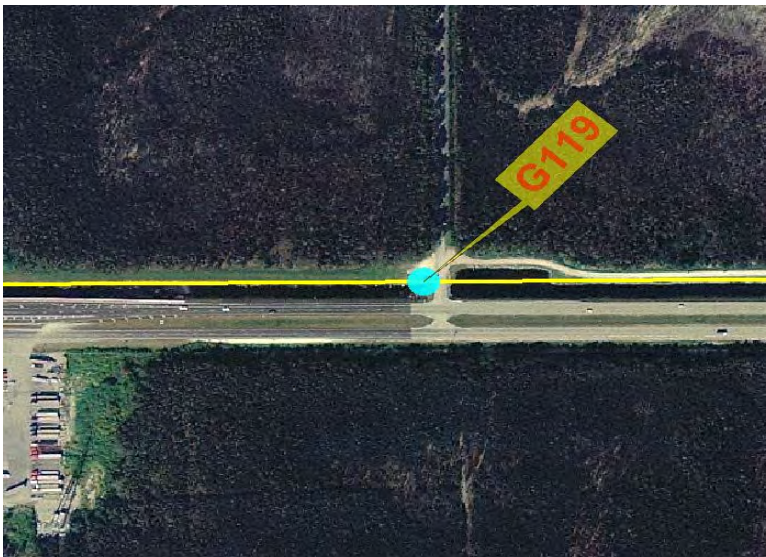
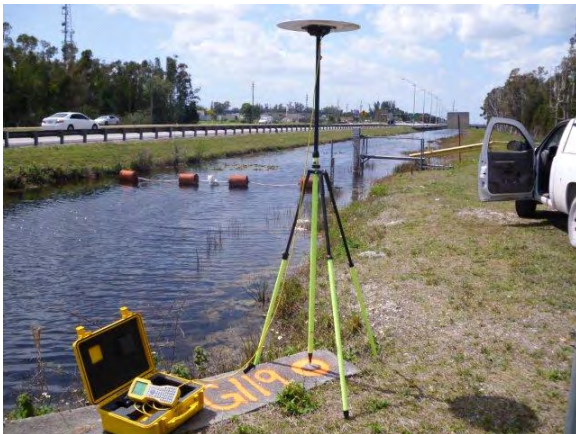
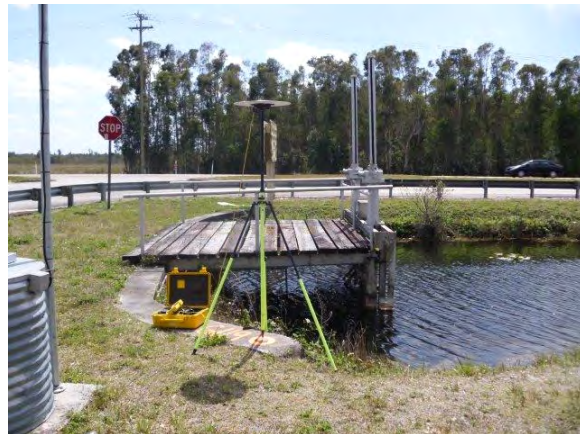
STRUCTURE NAME **G119**

**DESCRIPTION** 2" Aluminum Disk in Concrete

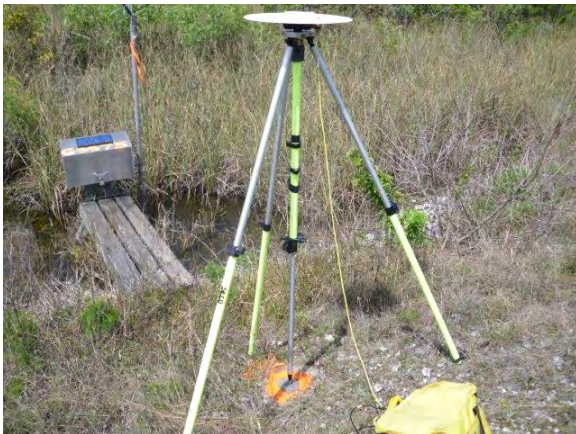
G3575 03-18-10 S1356

# STRUCTURE POINT SURVEY RECORD

**STRUCTURE NAME**      **G3575**

**DESCRIPTION**      2" Aluminum Disk in Concrete

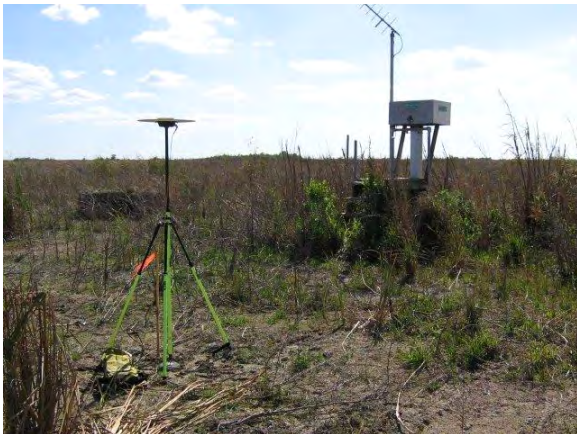
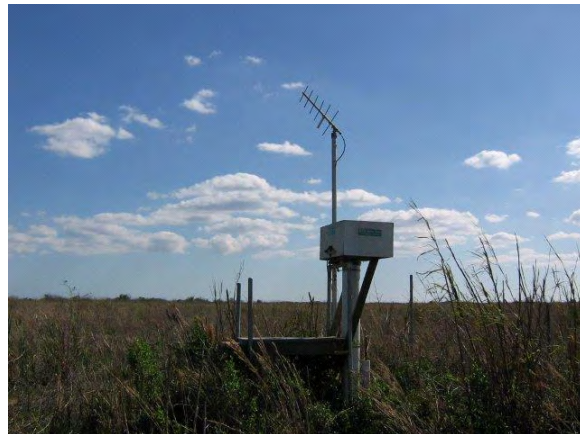
- G3622A 03-19-10 M332
- G3622A 03-19-10 I333
- G3622A 03-19-10 S334

# STRUCTURE POINT SURVEY RECORD

STRUCTURE NAME **G3622A**

**DESCRIPTION** 1/2" Rebar  
**GEODETIC DATUM** NAD83 (2007)  
**ELEVATION DATUM** NAVD 88  
**UNITS USED** US Survey Foot

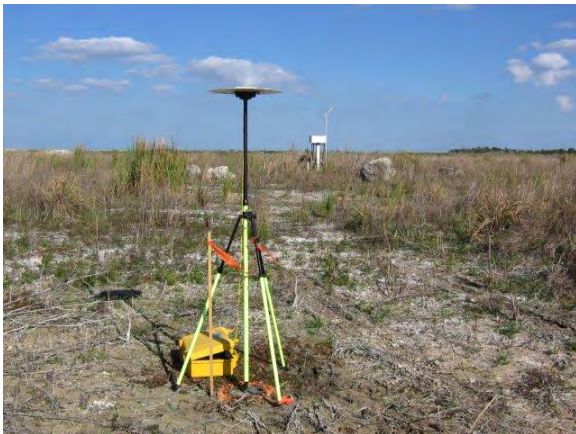
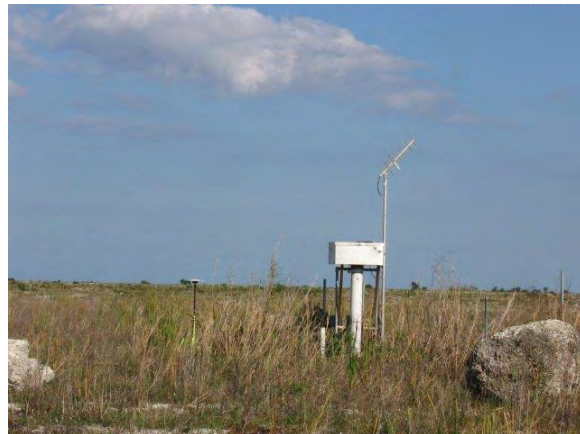
G3622B 03-19-10 I336

# STRUCTURE POINT SURVEY RECORD

**STRUCTURE NAME**      **G3622B**

**DESCRIPTION**      2" Aluminum Disk in Concrete

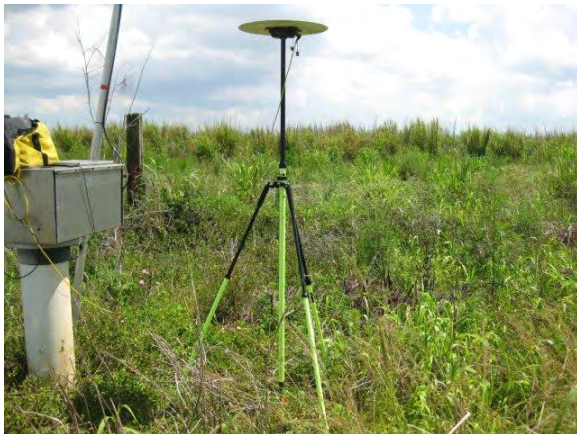
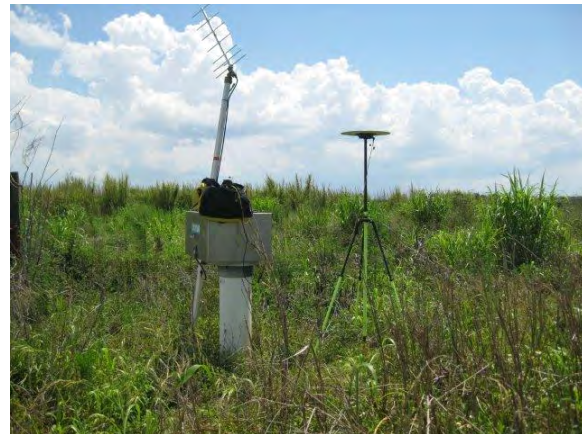
G3628 05-08-10 S0009

# STRUCTURE POINT SURVEY RECORD

**STRUCTURE NAME**            **G3628**

**DESCRIPTION**            2" Aluminum Disk in Concrete

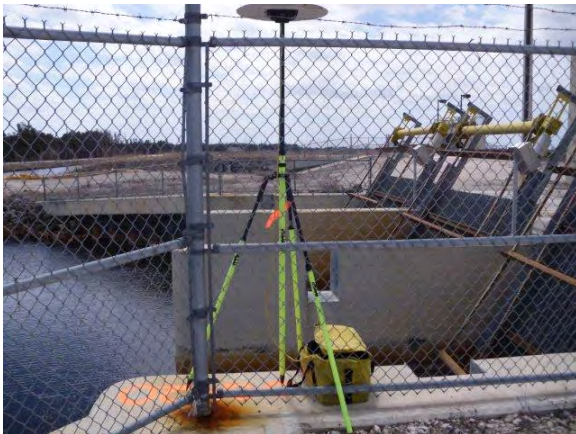
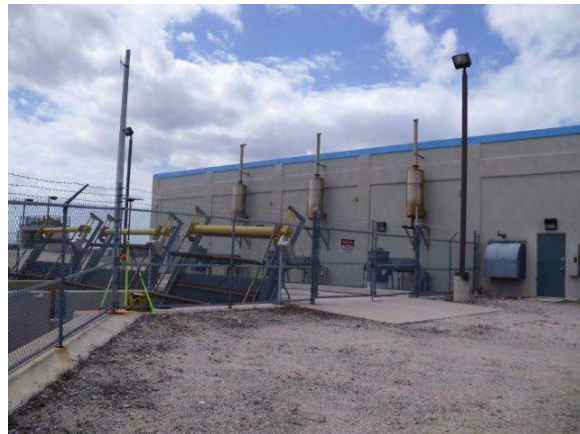
G420 03-14-10 S1307

# STRUCTURE POINT SURVEY RECORD

**STRUCTURE NAME**      **G420**

**DESCRIPTION**      X-Cut in Concrete

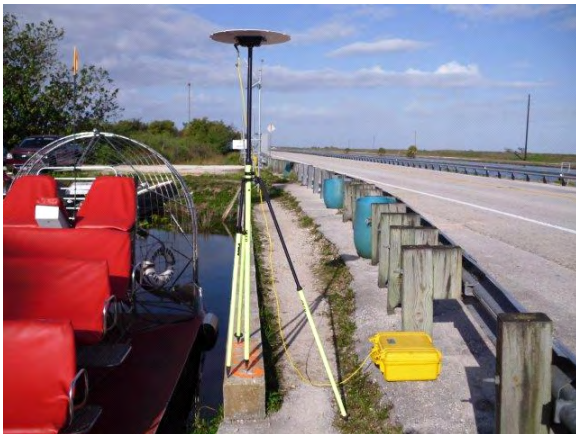
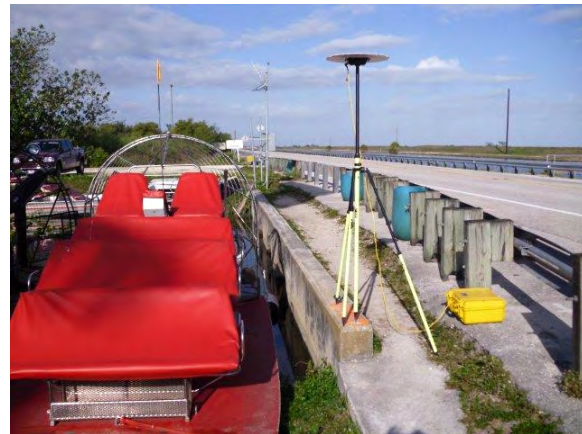
G69 03-14-10 S1284

# STRUCTURE POINT SURVEY RECORD

STRUCTURE NAME **G69**

DESCRIPTION X-Cut in Concrete

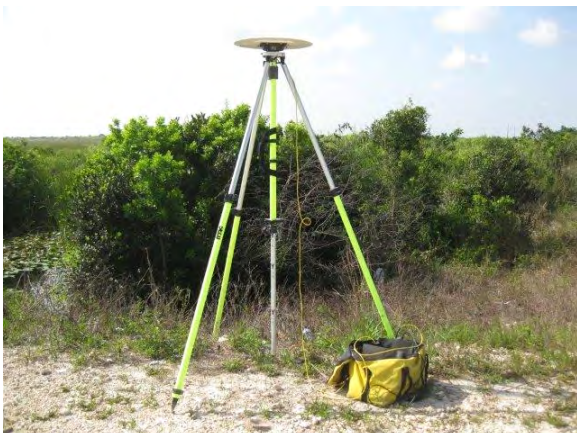
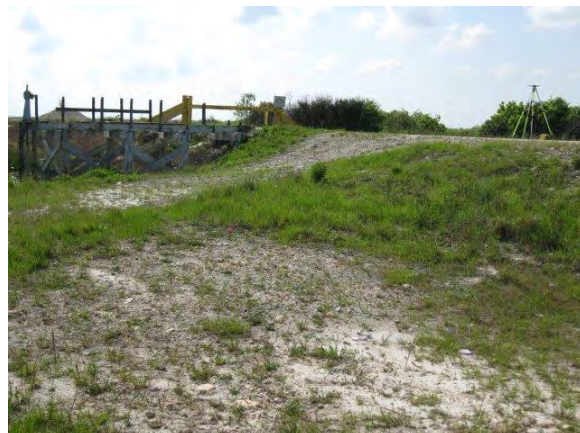
- G70 03-12-10 M296
- G70 03-12-10 I297
- G70 03-12-10 S298
- G70 05-06-10 M0020
- G70 05-06-10 I0021
- G70 05-06-10 S0022

# STRUCTURE POINT SURVEY RECORD

**STRUCTURE NAME**      **G70**

**DESCRIPTION**      2" Aluminum Disk in Concrete

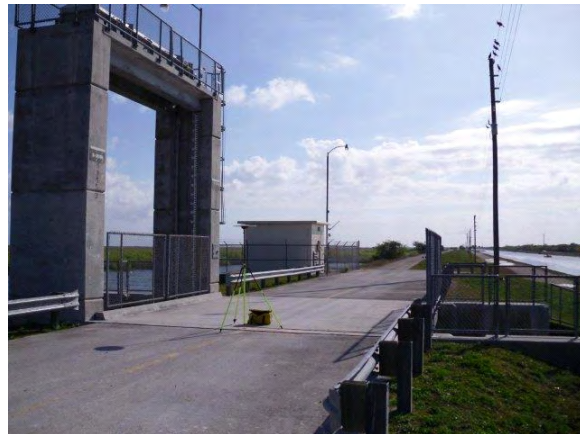
AC4661 03-19-10 I328

# STRUCTURE POINT SURVEY RECORD

**STRUCTURE NAME** AC4661

**DESCRIPTION** Stainless Steel Rod

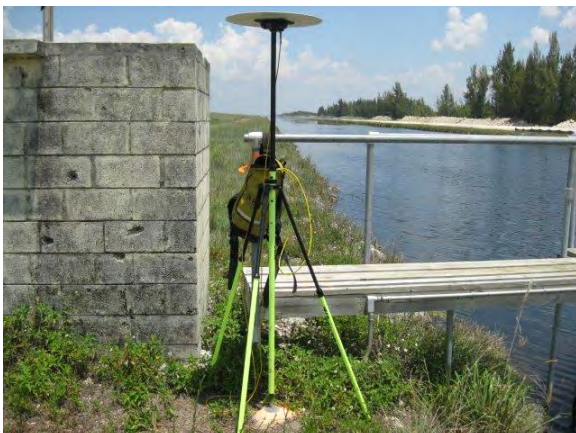
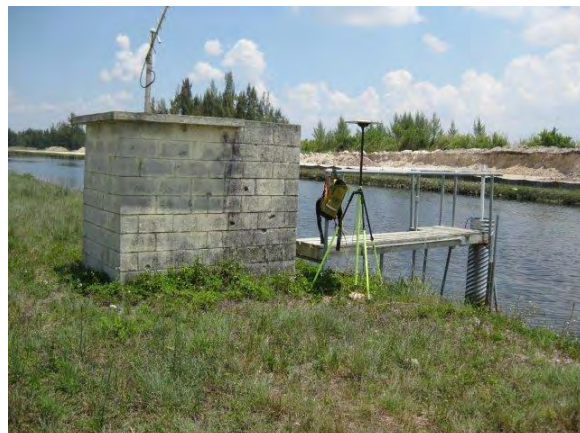
L31 05-07-108 S0010

# STRUCTURE POINT SURVEY RECORD

STRUCTURE NAME **L31**

**DESCRIPTION** 2" Aluminum Disk in Concrete

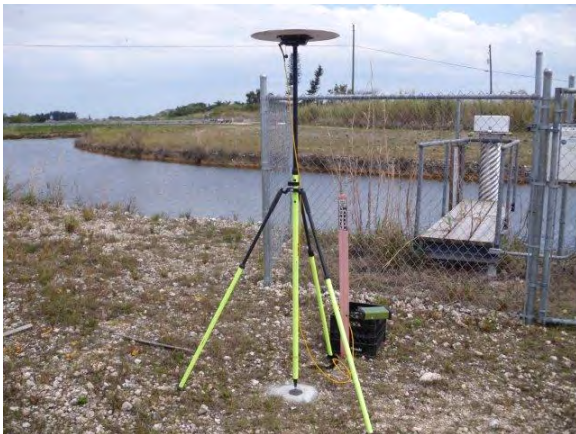
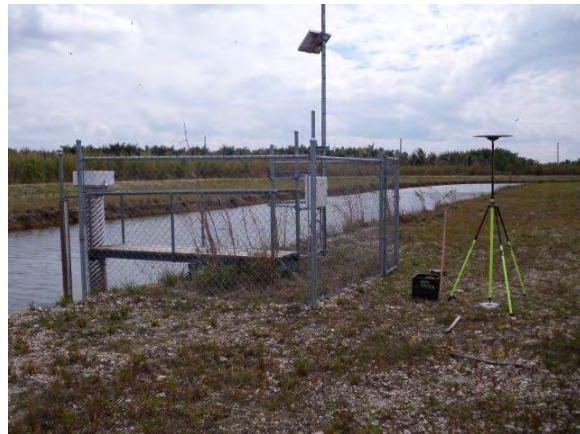
LASPALMASC1 03-18-10 S1371

# STRUCTURE POINT SURVEY RECORD

**STRUCTURE NAME**      **Las Palmas C1**

**DESCRIPTION**      4" Brass Disk in Concrete

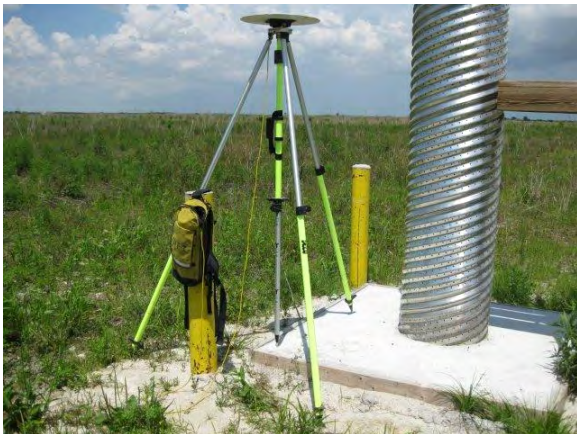
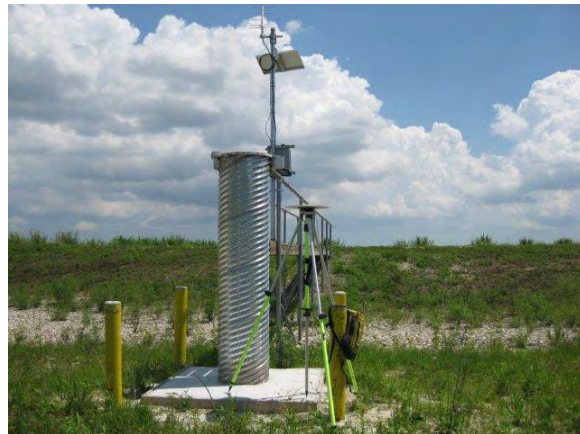
Las Palmas DC1 05-08-10 S000

# STRUCTURE POINT SURVEY RECORD

STRUCTURE NAME **Las Palmas DC1**

DESCRIPTION X-Cut in Concrete

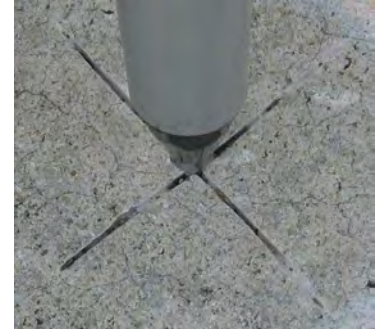
**STRUCTURE NAME**      **S118**

**DESCRIPTION**      X-Cut in Concrete

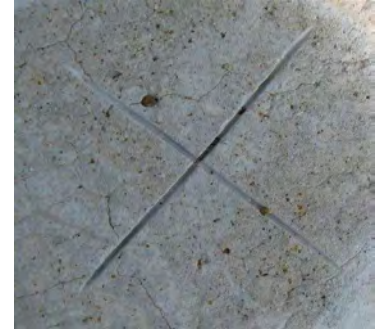
**STRUCTURE NAME**      **S119**

**DESCRIPTION**      X-Cut in Concrete

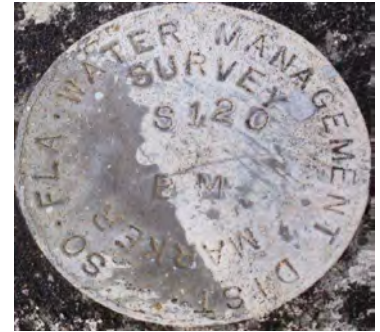
STRUCTURE NAME **S120**

**DESCRIPTION** 2" Aluminum Disk in Concrete

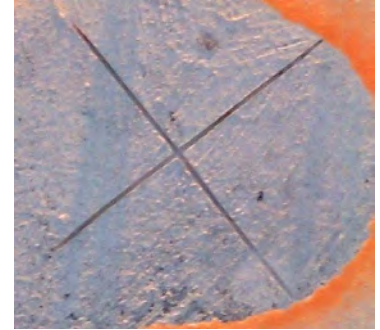
**STRUCTURE NAME**      **S121**

**DESCRIPTION**      X-Cut in Concrete

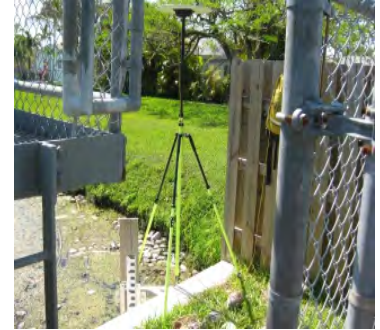
**STRUCTURE NAME**      **S122**

**DESCRIPTION**      4" Brass Disk in Concrete

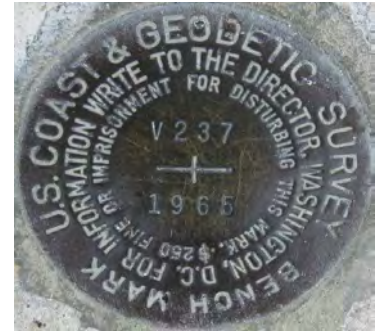
STRUCTURE NAME **S12A**

**DESCRIPTION** Bench Mark Disk in Concrete Retaining Wall

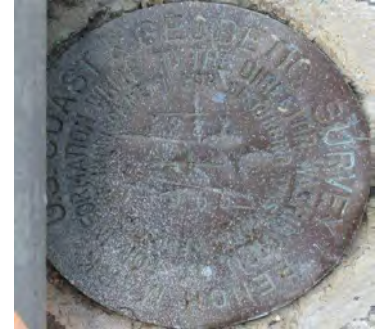
**STRUCTURE NAME**      **S12B**

**DESCRIPTION**      Bench Mark Disk in Concrete Retaining Wall

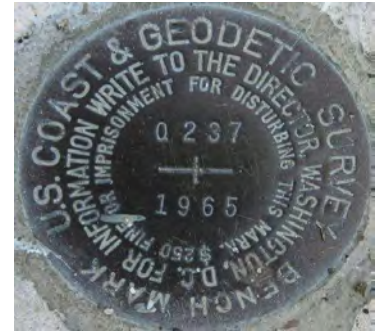
STRUCTURE NAME **S12C**

**DESCRIPTION** Bench Mark Disk in Concrete Retaining Wall

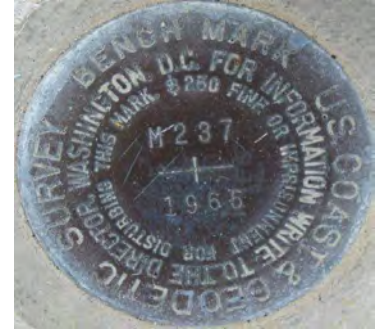
STRUCTURE NAME **S12D**

**DESCRIPTION** Bench Mark Disk in Concrete Retaining Wall

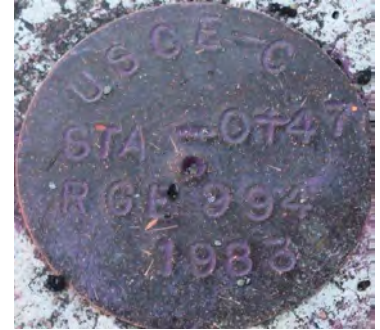
STRUCTURE NAME **S12E**

**DESCRIPTION** 2" Disk in Concrete

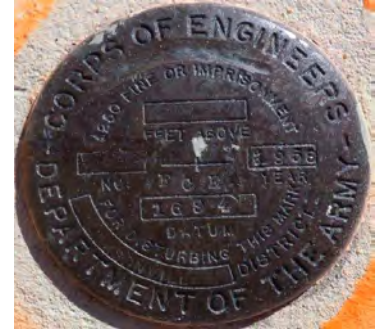
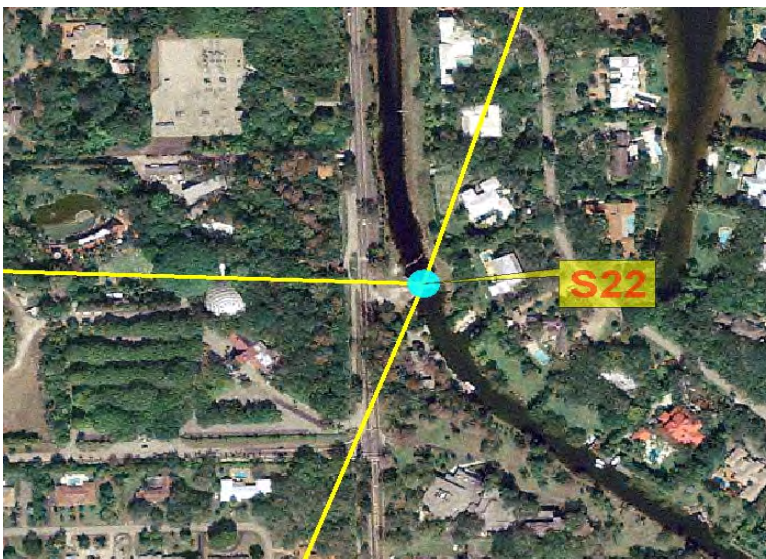
**STRUCTURE NAME**      **S22**

**DESCRIPTION**      4" Brass Disk in Concrete

COORDINATES				Estimated Errors at 95% Confidence Level			
N	E	El. Ht	Elev.	N	E	El. Ht	Elev
486255.271	892082.585	-76.061	6.983	0.062	0.059	0.059	0.102

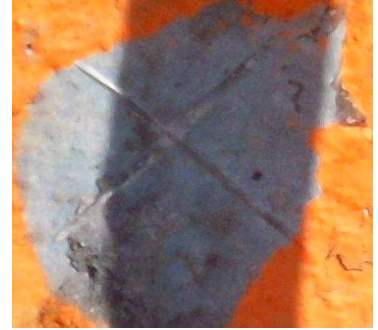
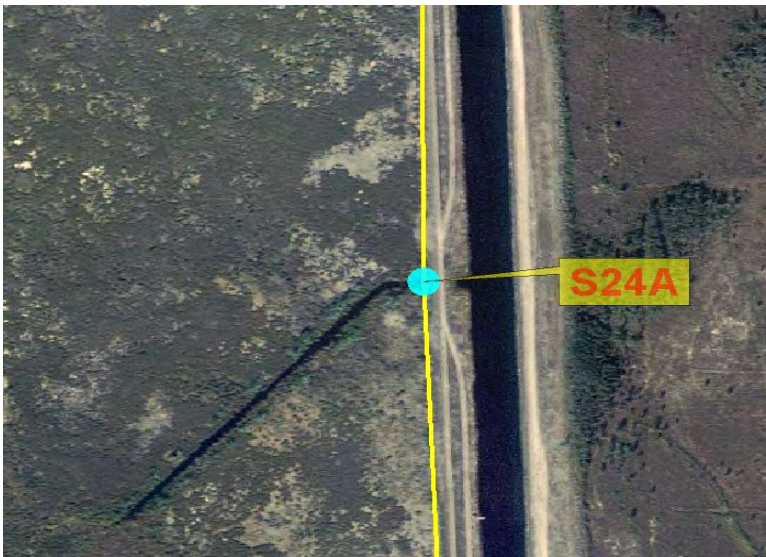
**STRUCTURE NAME**      **S24A**

**DESCRIPTION**      X-Cut in Concrete

COORDINATES				Estimated Errors at 95% Confidence Level			
N	E	El. Ht	Elev.	N	E	El. Ht	Elev
504024.510	821772.553	-75.347	5.493	0.098	0.095	0.052	0.098

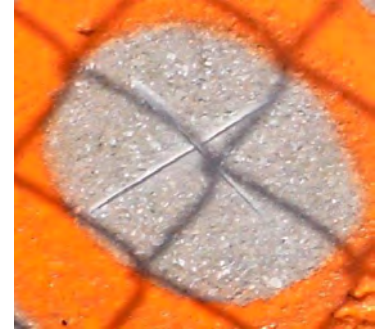
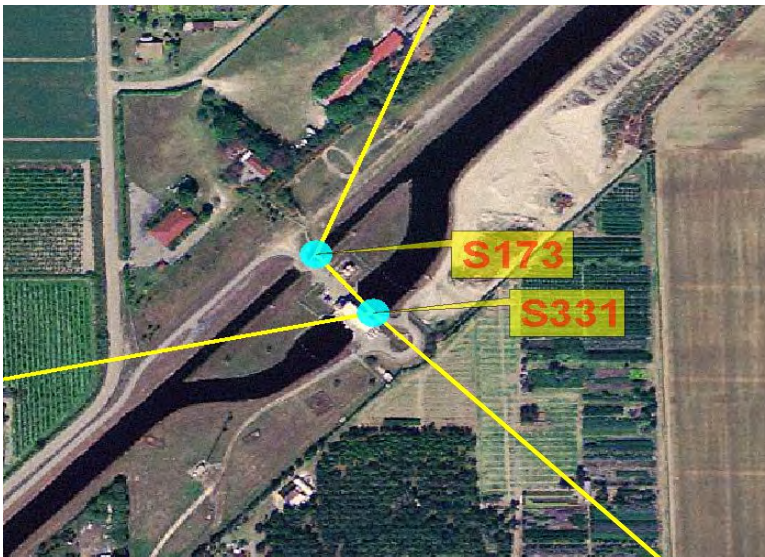
STRUCTURE NAME **S331**

**DESCRIPTION** X-Cut in Concrete

COORDINATES				Estimated Errors at 95% Confidence Level			
N	E	El. Ht	Elev.	N	E	El. Ht	Elev
464646.853	817901.667	-70.233	10.754	0.072	0.066	0.049	0.098

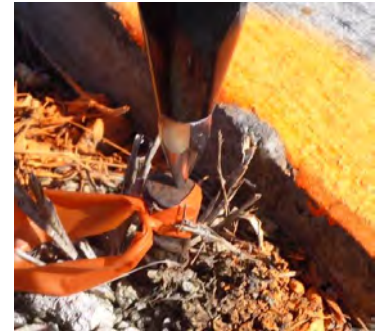
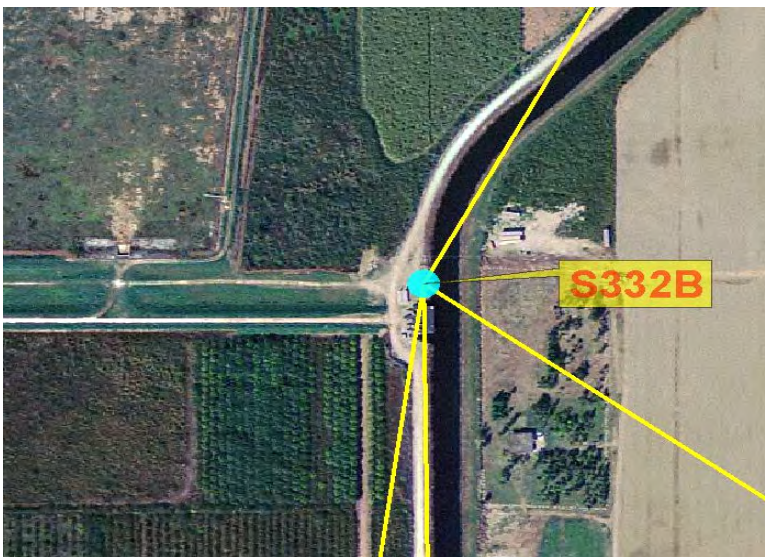
STRUCTURE NAME **S332B**

**DESCRIPTION** 1/2" Rebar  
**GEODETTIC DATUM** NAD83 (2007)  
**ELEVATION DATUM** NAVD 88  
**UNITS USED** US Survey Foot

COORDINATES				Estimated Errors at 95% Confidence Level			
N	E	El. Ht	Elev.	N	E	El. Ht	Elev
442310.247	801082.868	-70.524	10.118	0.062	0.062	0.049	0.098

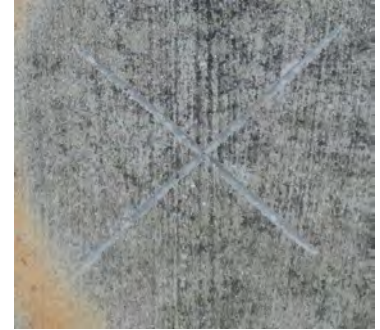
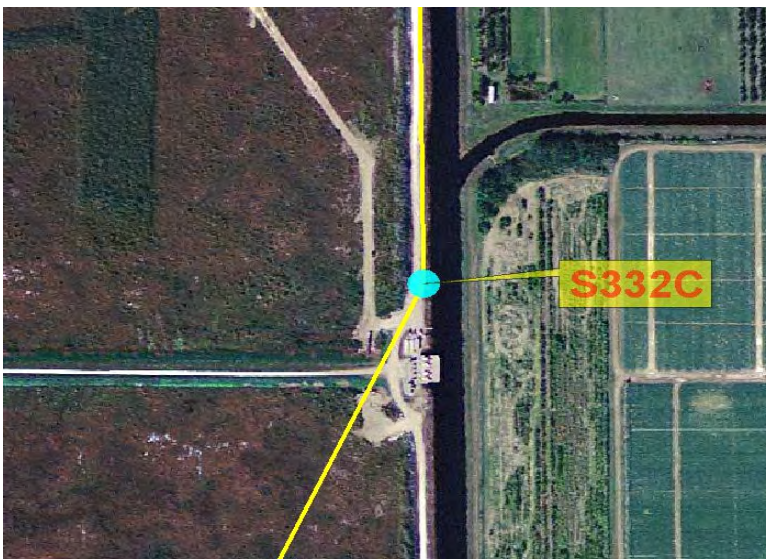
**STRUCTURE NAME**      **S332C**

**DESCRIPTION**      X-Cut in Concrete

COORDINATES				Estimated Errors at 95% Confidence Level			
N	E	El. Ht	Elev.	N	E	El. Ht	Elev
429947.639	801228.639	-71.111	9.600	0.085	0.085	0.066	0.108

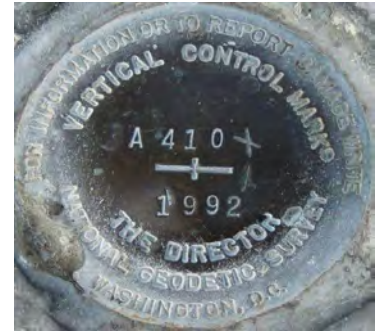
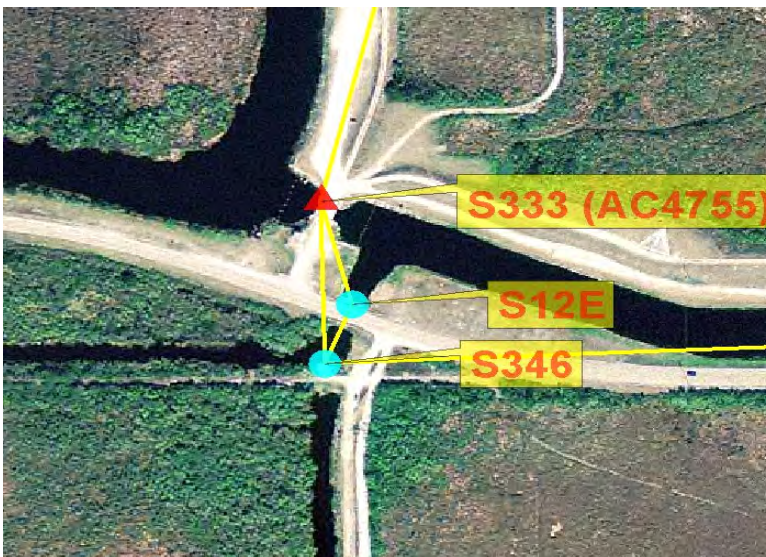
STRUCTURE NAME **S333**

**DESCRIPTION** Vertical Control Disk in Retaining Wall

COORDINATES				Estimated Errors at 95% Confidence Level			
N	E	El. Ht	Elev.	N	E	El. Ht	Elev
519343.379	763458.911	-66.817	12.940	0.000	0.000	0.000	0.000

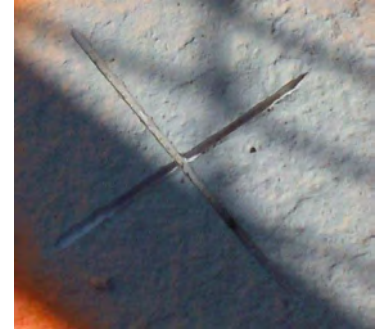
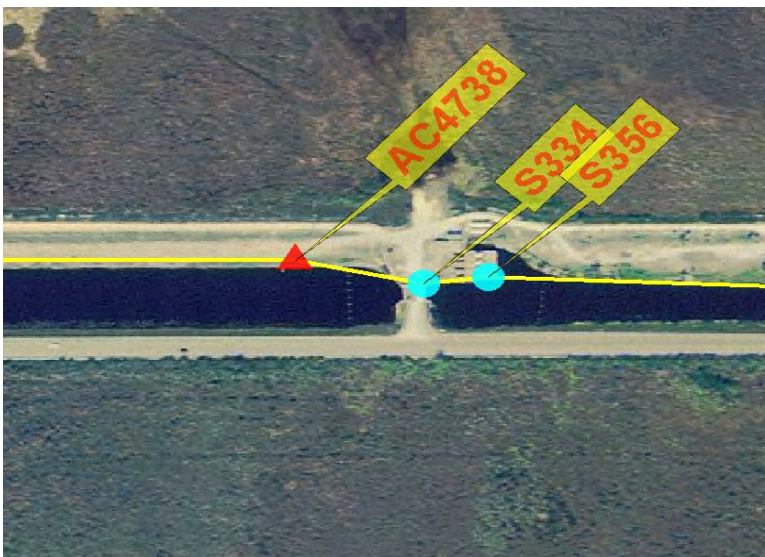
STRUCTURE NAME **S334**

**DESCRIPTION** X-Cut in Concrete

COORDINATES				Estimated Errors at 95% Confidence Level			
N	E	El. Ht	Elev.	N	E	El. Ht	Elev
519271.929	819957.988	-68.708	12.104	0.066	0.066	0.036	0.092

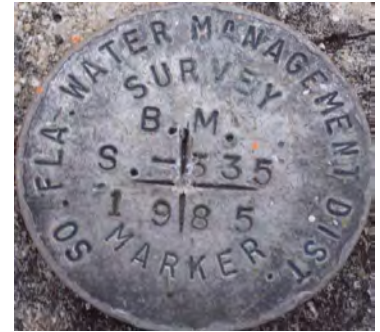
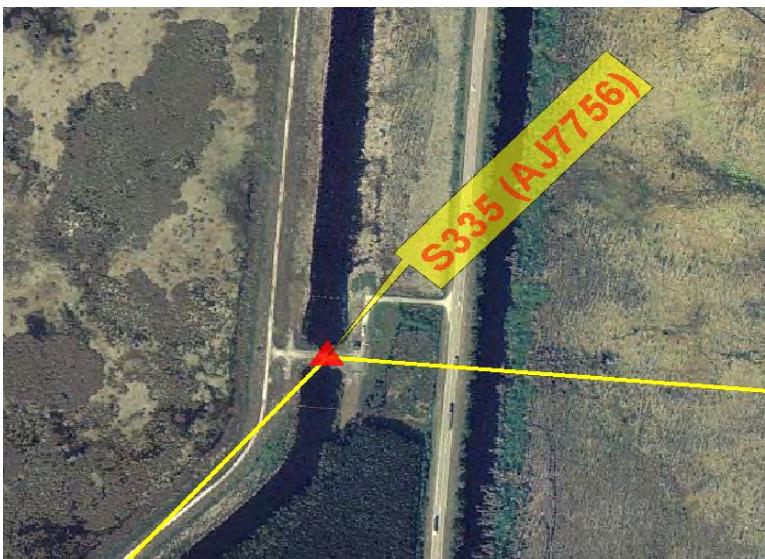
**STRUCTURE NAME**      **S335**

**DESCRIPTION**      Survey Disk in Concrete Bridge Abutment

COORDINATES				Estimated Errors at 95% Confidence Level			
N	E	El. Ht	Elev.	N	E	El. Ht	Elev
524589.834	826301.393	-71.069	9.856	0.000	0.000	0.000	0.000

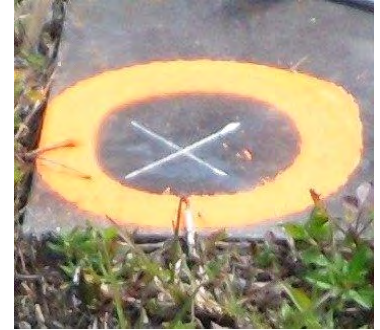
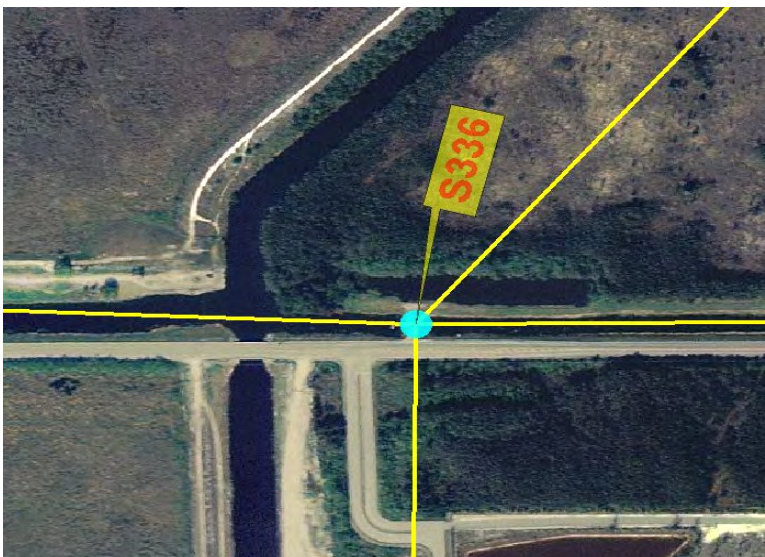
STRUCTURE NAME **S336**

**DESCRIPTION** X-Cut in Concrete

COORDINATES				Estimated Errors at 95% Confidence Level			
N	E	EI. Ht	Elev.	N	E	EI. Ht	Elev
519221.573	821769.654	-71.533	9.315	0.056	0.056	0.049	0.098

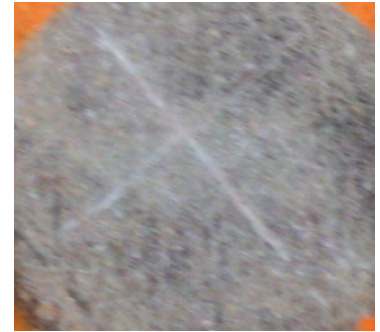
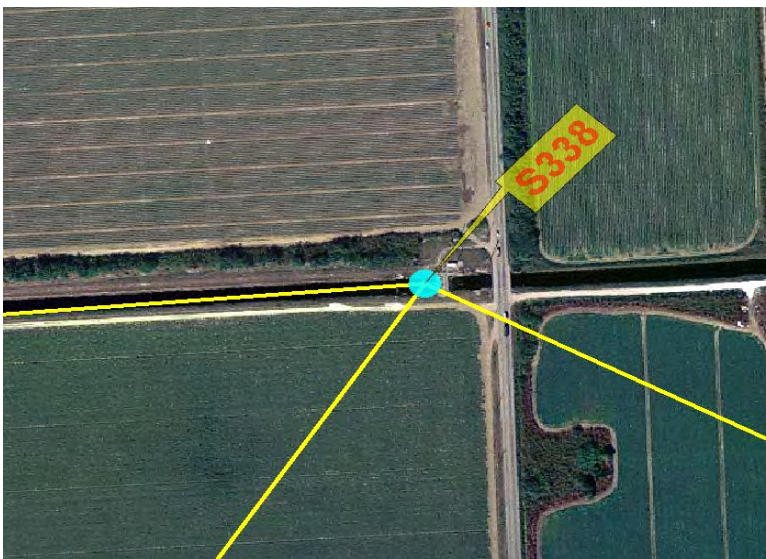
STRUCTURE NAME **S338**

**DESCRIPTION** X-Cut in Concrete

COORDINATES				Estimated Errors at 95% Confidence Level			
N	E	El. Ht	Elev.	N	E	El. Ht	Elev
482786.341	826984.091	-71.306	9.784	0.049	0.049	0.030	0.092

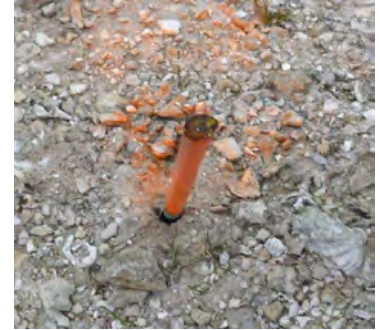
**DESCRIPTION** Brass Rod  
**GEODETTIC DATUM** NAD83 (2007)  
**ELEVATION DATUM** NAVD 88  
**UNITS USED** US Survey Foot

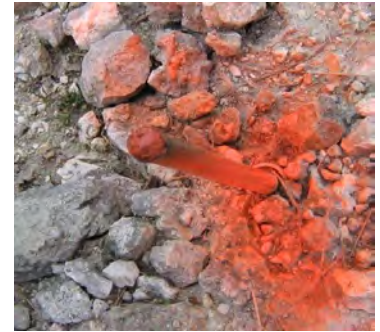
**STRUCTURE NAME**      **S343B**

**DESCRIPTION**      Brass Rod  
**GEODETTIC DATUM**      **NAD83 (2007)**  
**ELEVATION DATUM**      **NAVD 88**  
**UNITS USED**      **US Survey Foot**

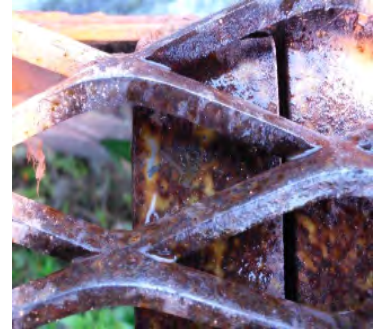
**STRUCTURE NAME**      **S346**

**DESCRIPTION**      Punch Mark on Angle Iron

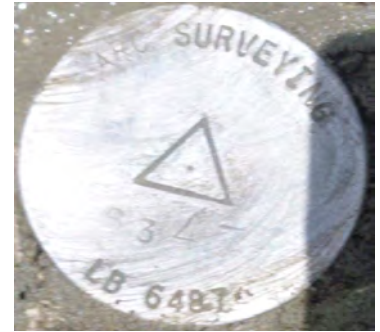
STRUCTURE NAME **S347**

**DESCRIPTION** 2" Aluminum Disk in Concrete

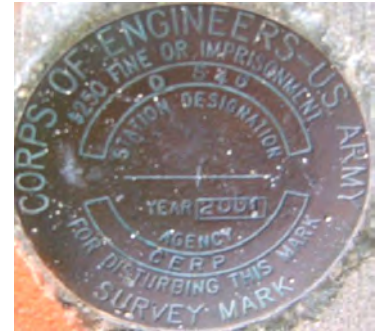
**STRUCTURE NAME**      **S355A**

**DESCRIPTION**      Survey Disk in Concrete Bridge Abutment

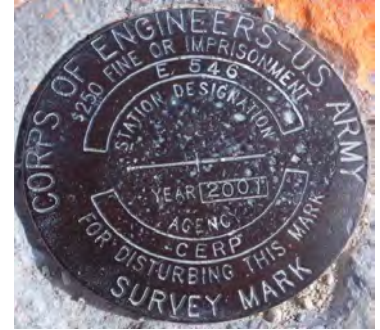
**STRUCTURE NAME**      **S355B**

**DESCRIPTION**      Survey Disk in Concrete Bridge Abutment

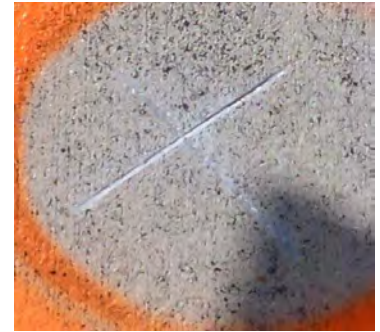
STRUCTURE NAME **S356**

**DESCRIPTION** X-Cut in Concrete

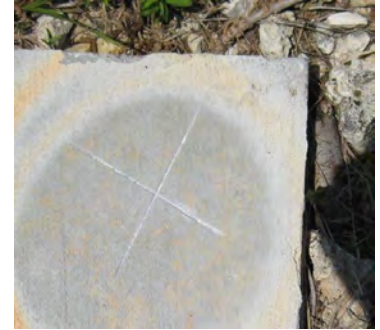
**STRUCTURE NAME**      **S357**

**DESCRIPTION**      X-Cut in Concrete

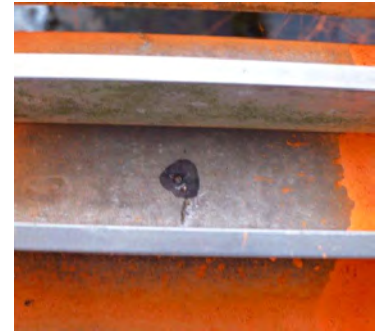
**STRUCTURE NAME**      **S380**

**DESCRIPTION**      Punch Mark in Cross Member
