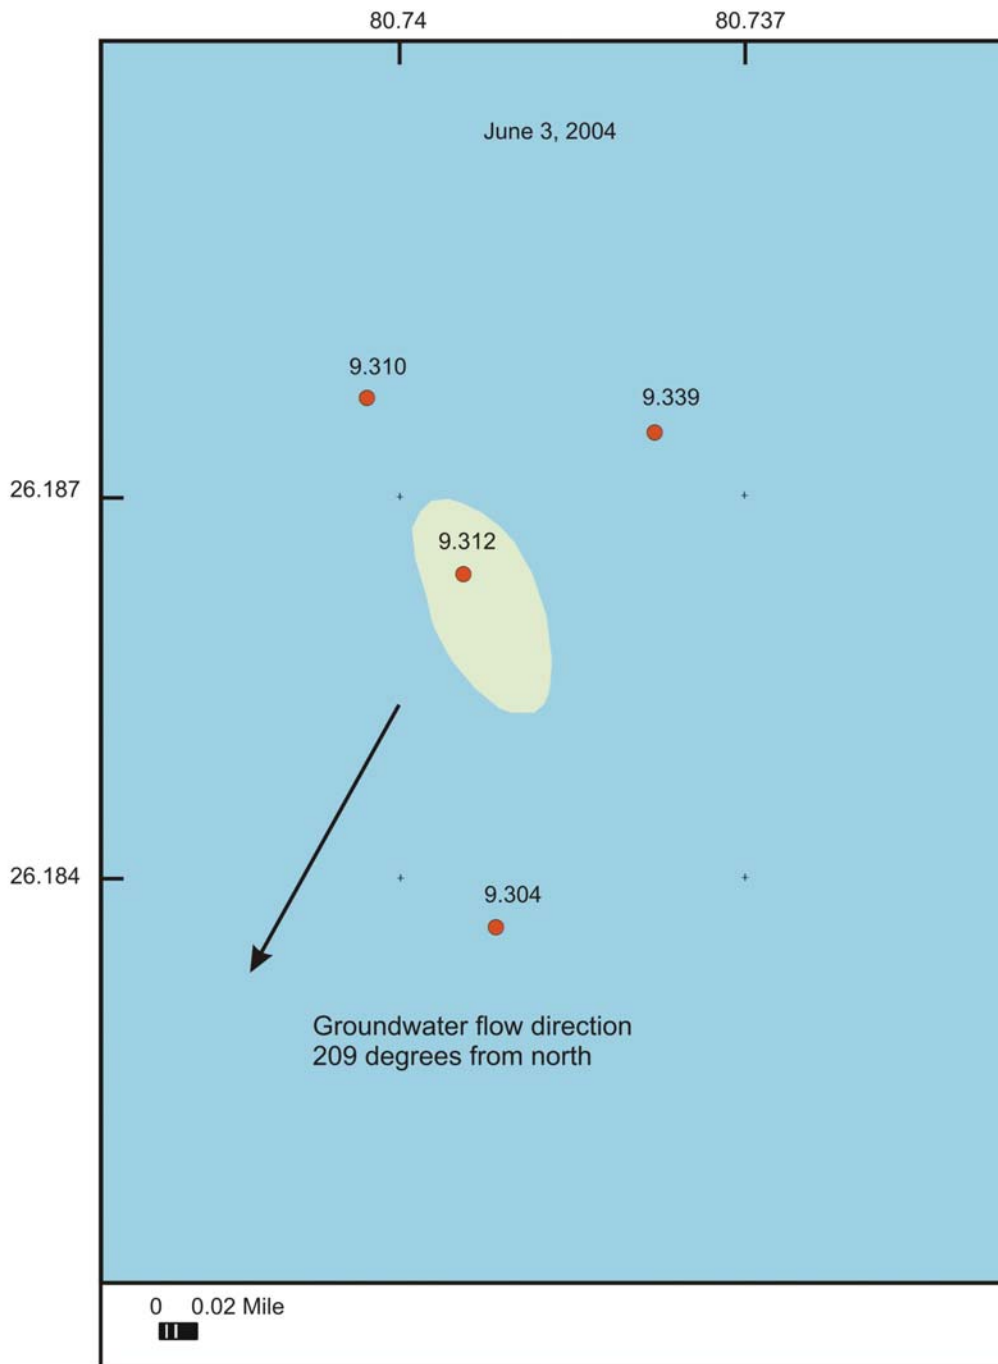
Figure 1 Water levels (ft above NGVD29) in piezometers at 3AN1 on June 3, 2004 (annual minimum).

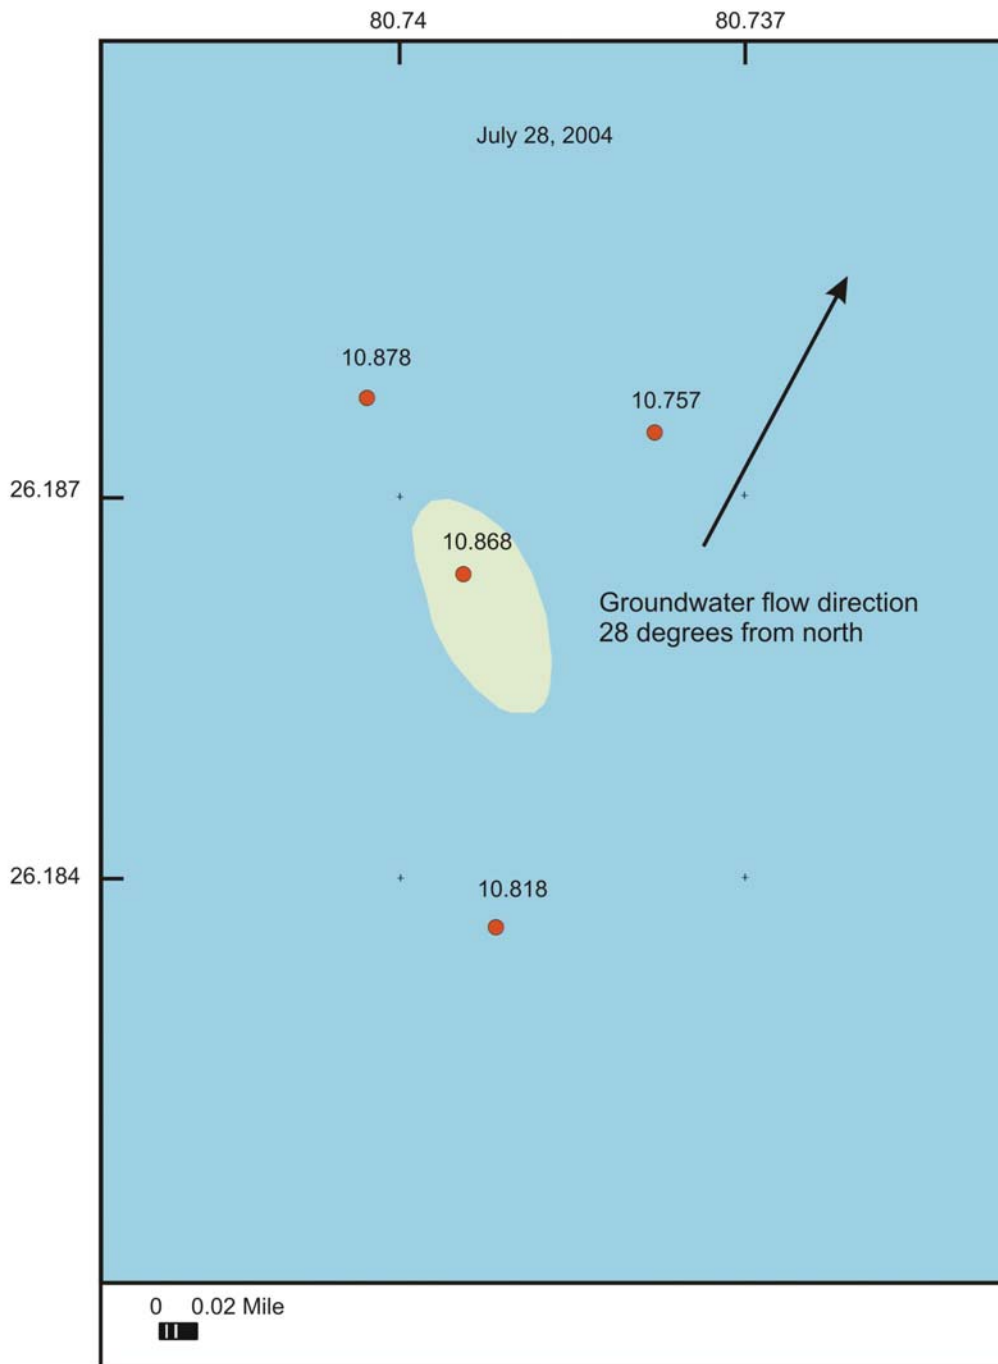
Figure 2 Water levels (ft above NGVD29) in piezometers at 3AN1 on July 28, 2004 (average conditions)

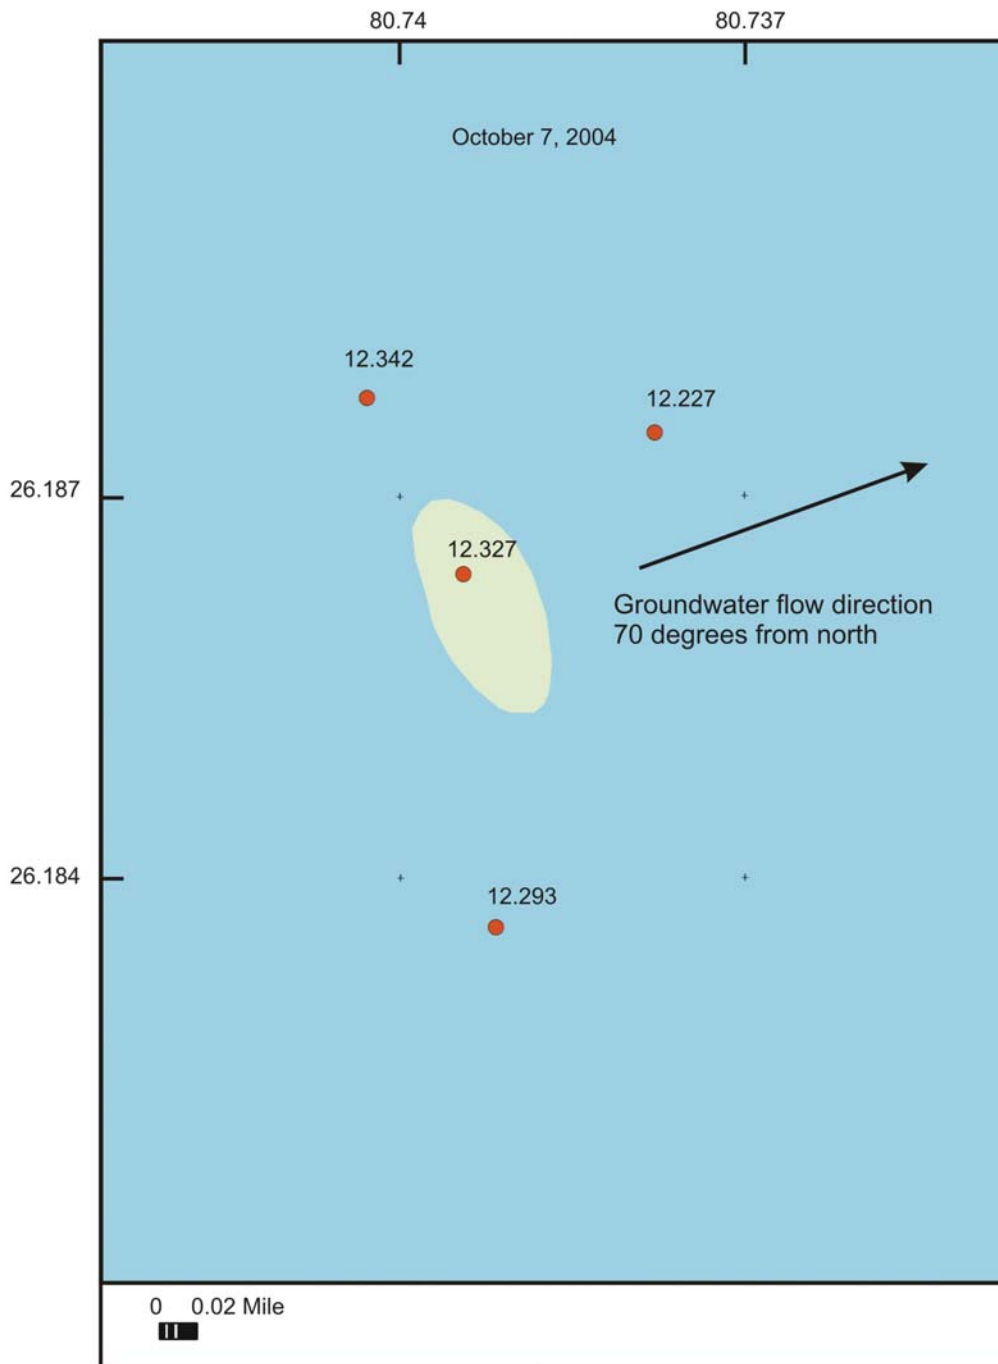
Figure 3 Water levels (ft above NGVD29) in piezometers at 3AN1 on October 7, 2004 (annual maximum).

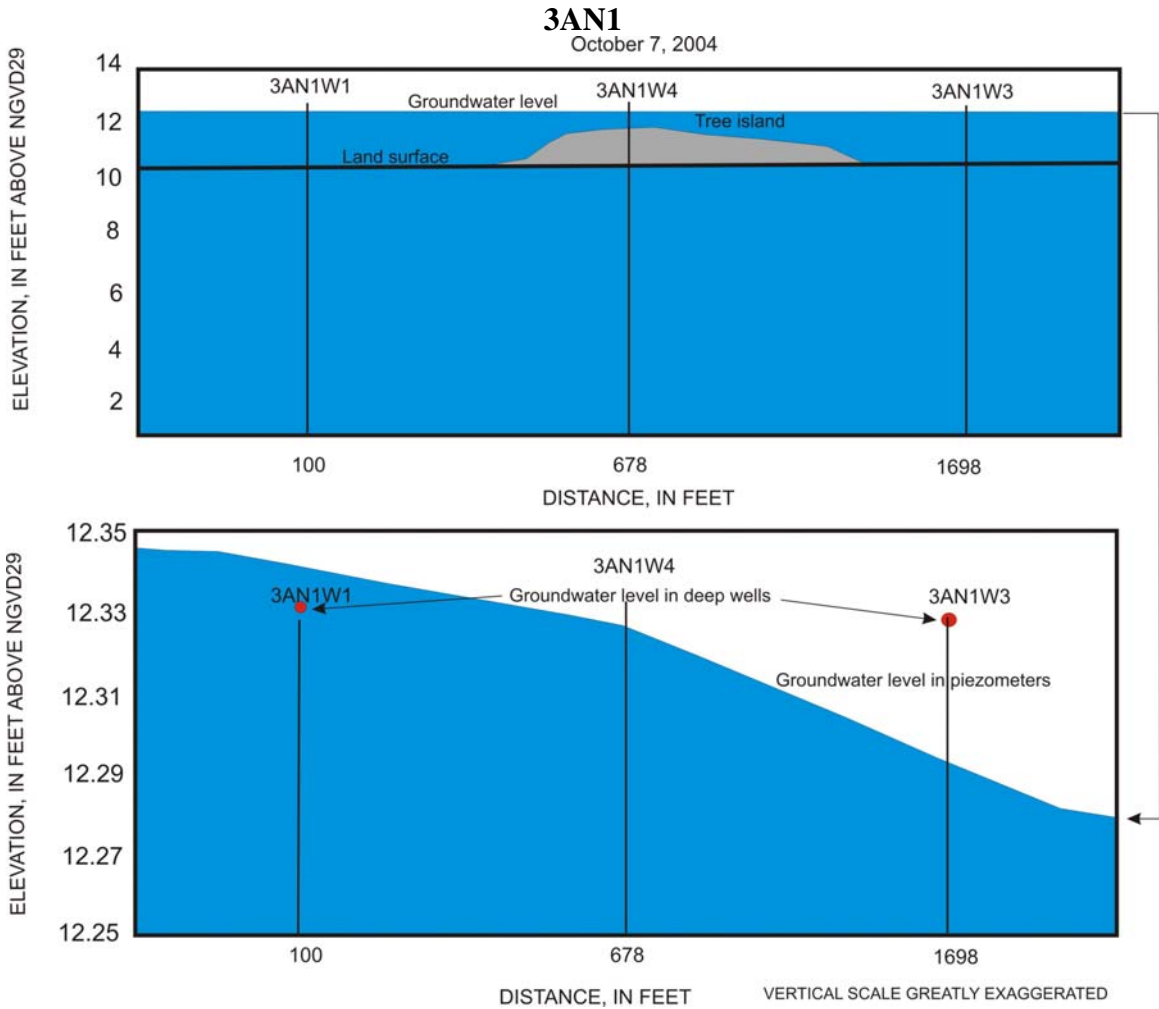
Figure 4 Cross section showing water levels in piezometers and deep wells at 3AN1 on October 7, 2004 (annual maximum).

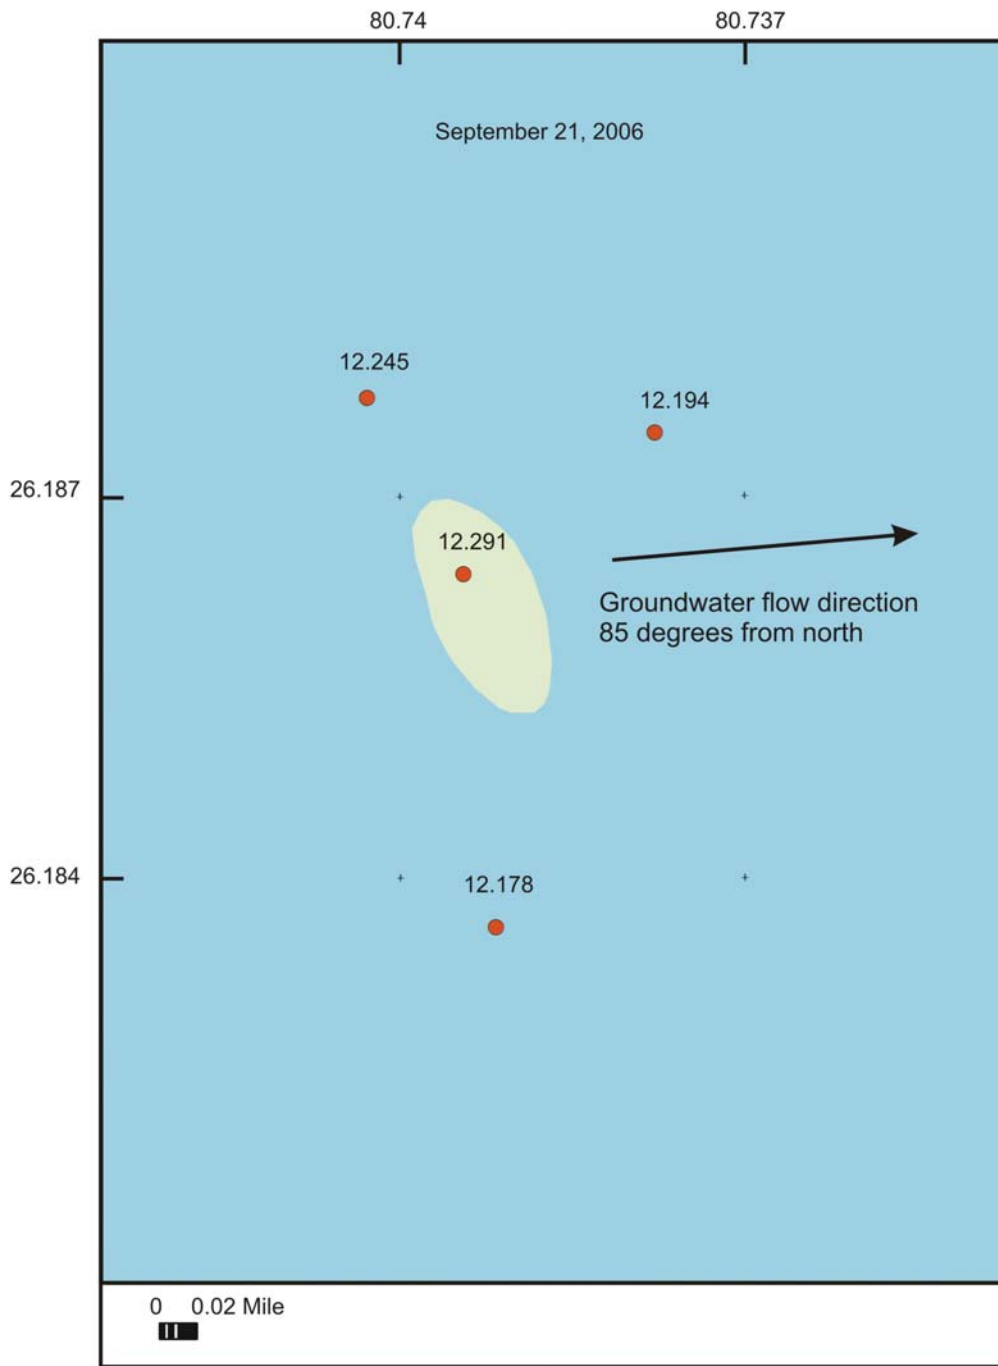
Figure 5 Water levels (ft above NGVD29) in piezometers at 3AN1 on September 21, 2006 (annual maximum).

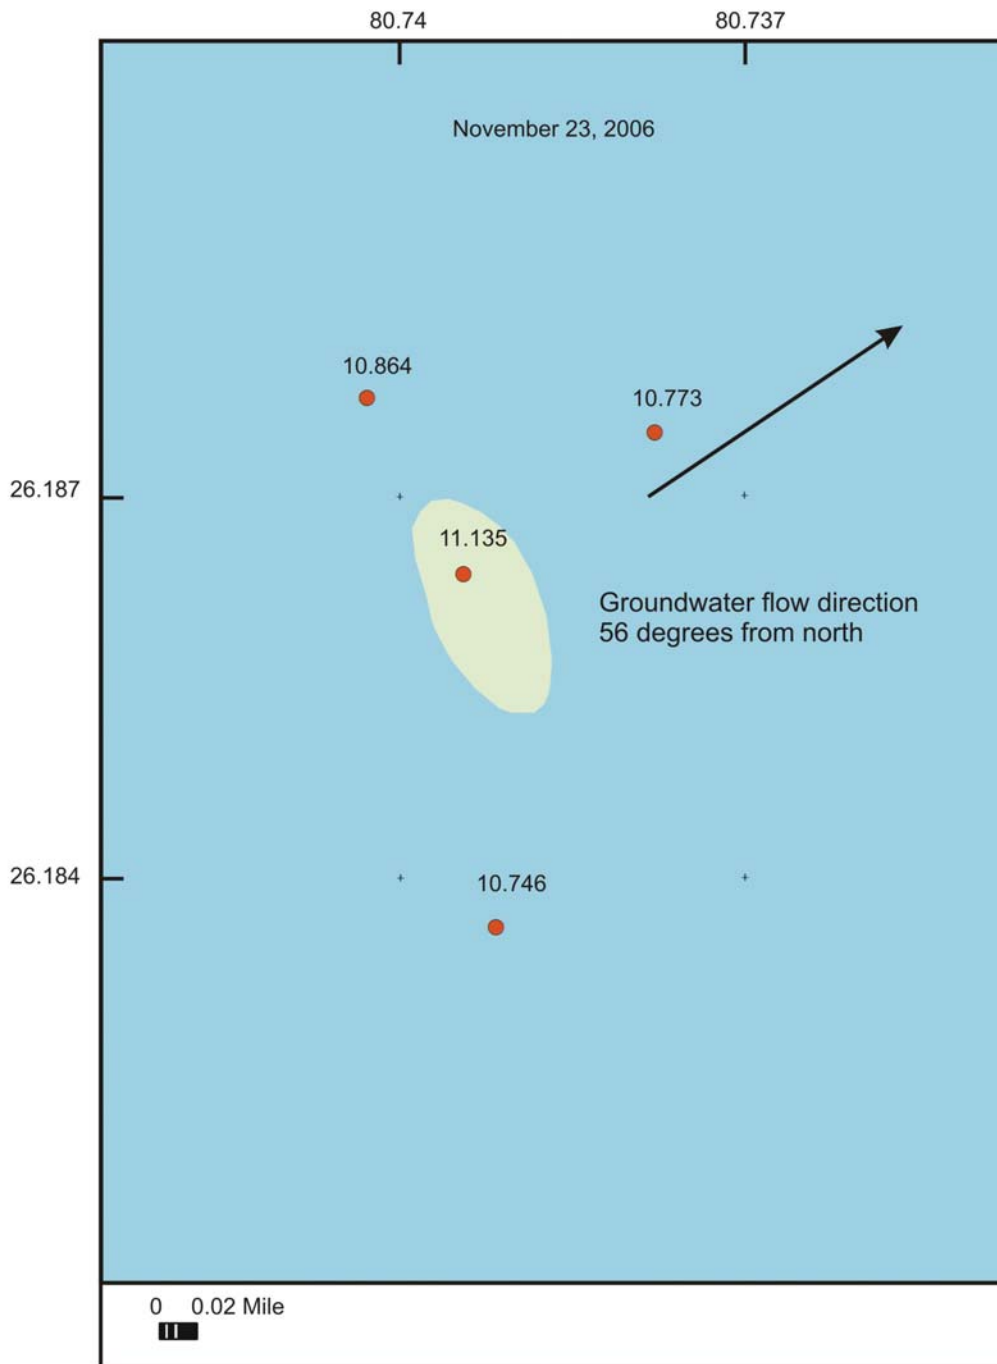
Figure 6 Water levels (ft above NGVD29) in piezometers at 3AN1 on November 23, 2006 (average conditions).

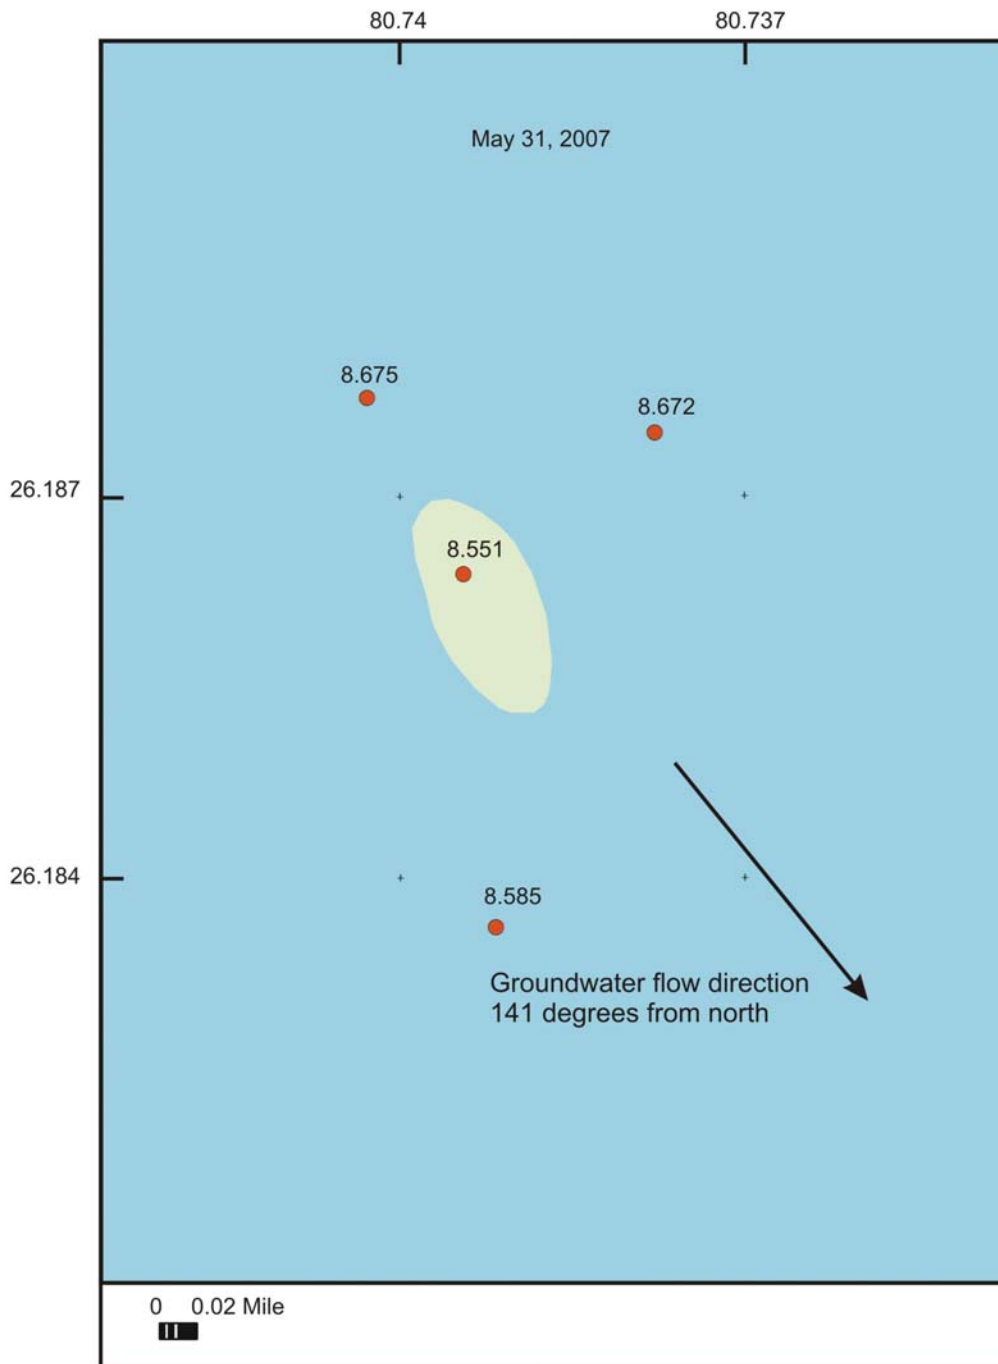
Figure 7 Water levels (ft above NGVD29) in piezometers at 3AN1 on May 31, 2007 (annual minimum).

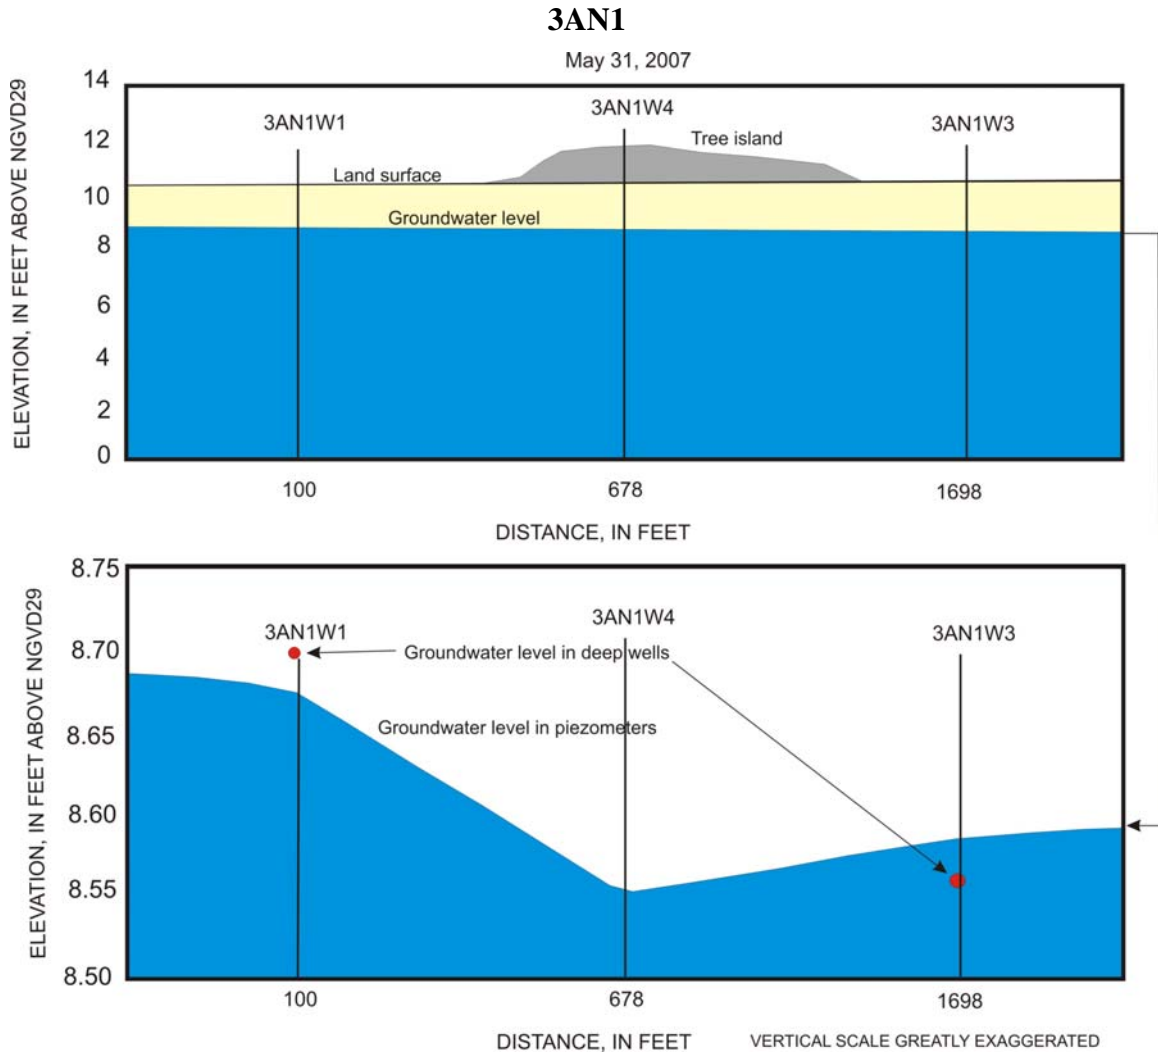
Figure 8 Cross section showing water levels in piezometers and deep wells at 3AN1 on May 31, 2007 (annual minimum).

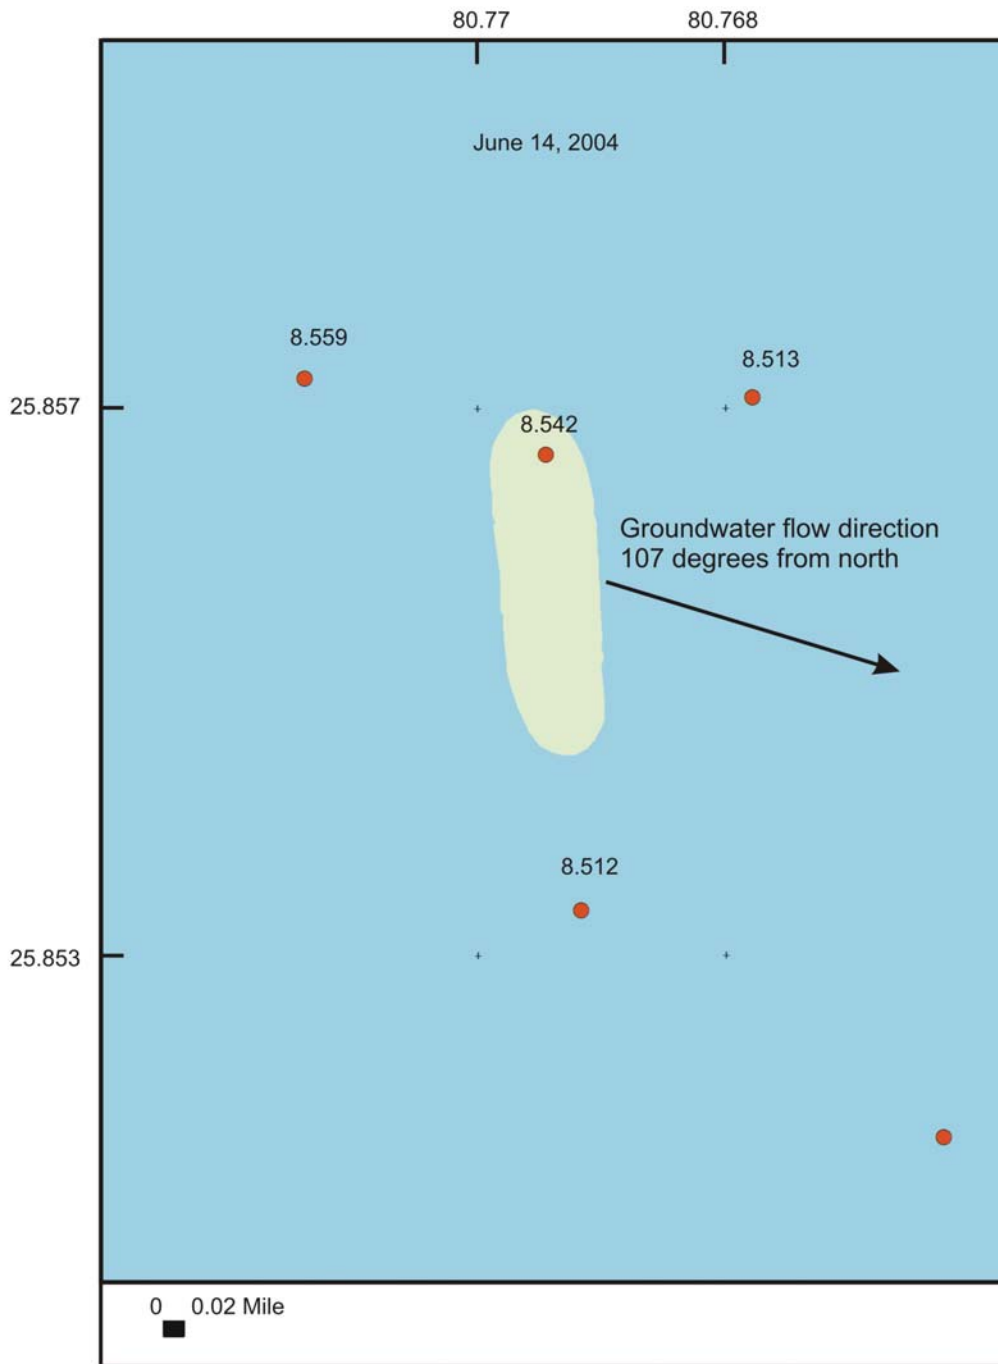
Figure 9 Water levels (ft above NGVD29) in deep wells at 3AS3 on June 14, 2004 (annual minimum).

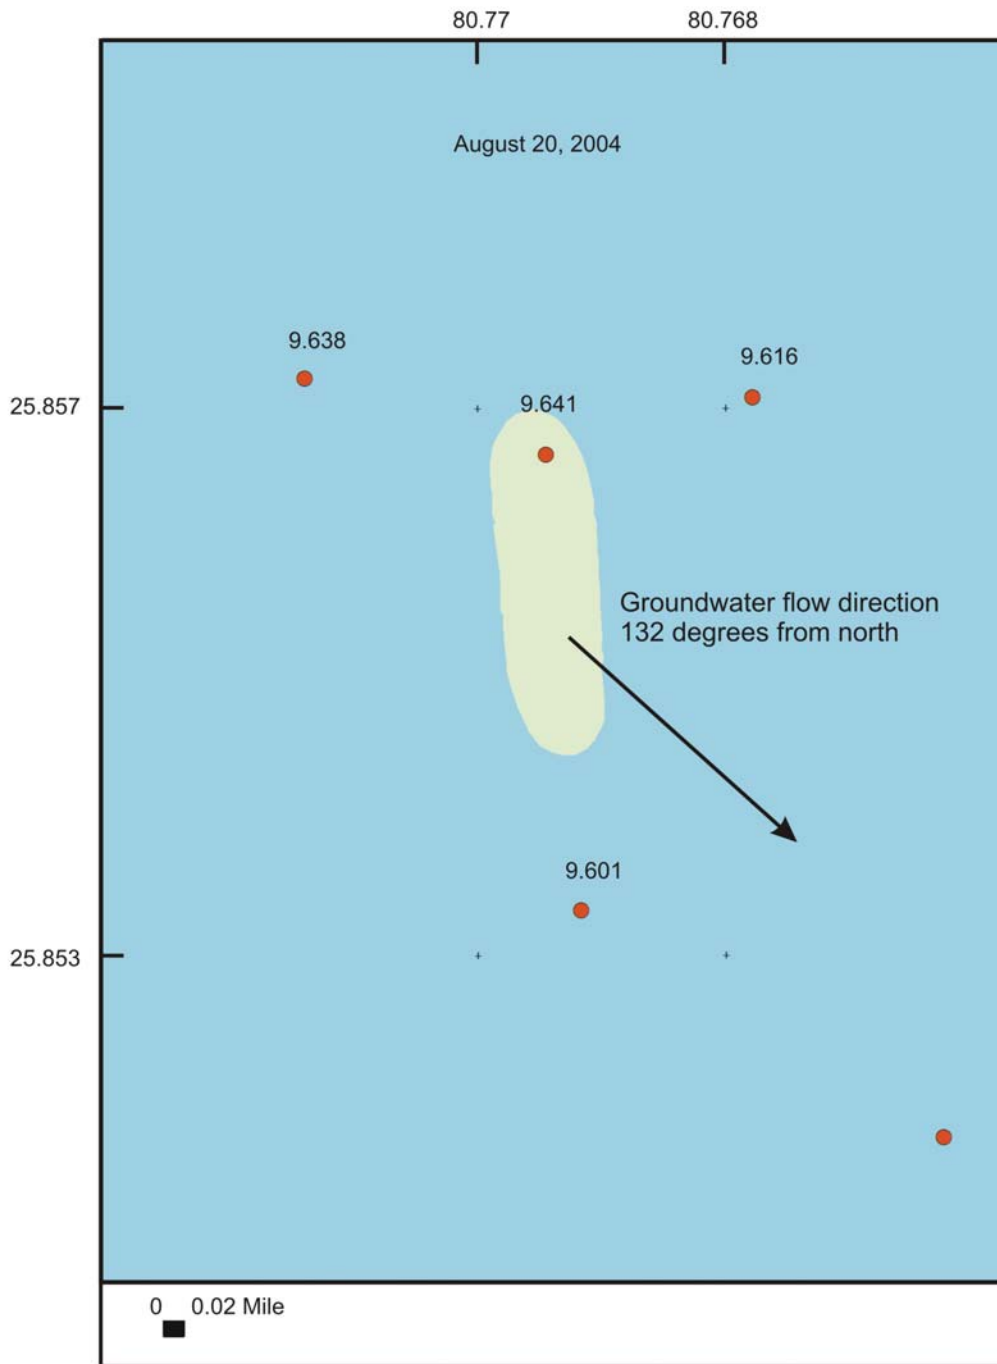
Figure 10 Water levels (ft above NGVD29) in deep wells at 3AS3 on August 20, 2004 (average conditions).

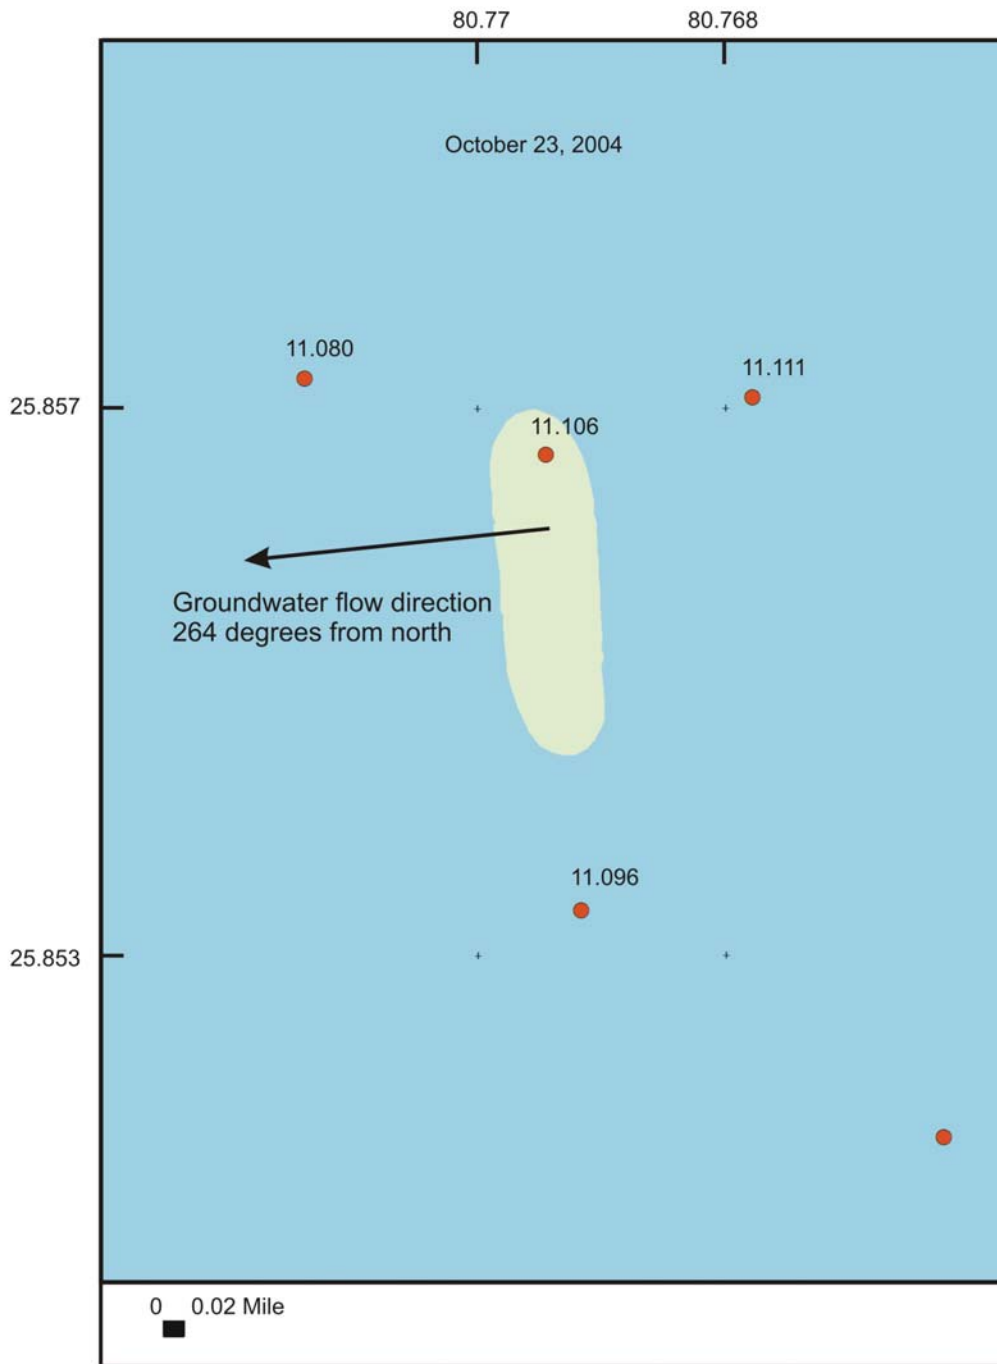
Figure 11 Water levels (ft above NGVD29) in deep wells at 3AS3 on October 23, 2004 (annual maximum).

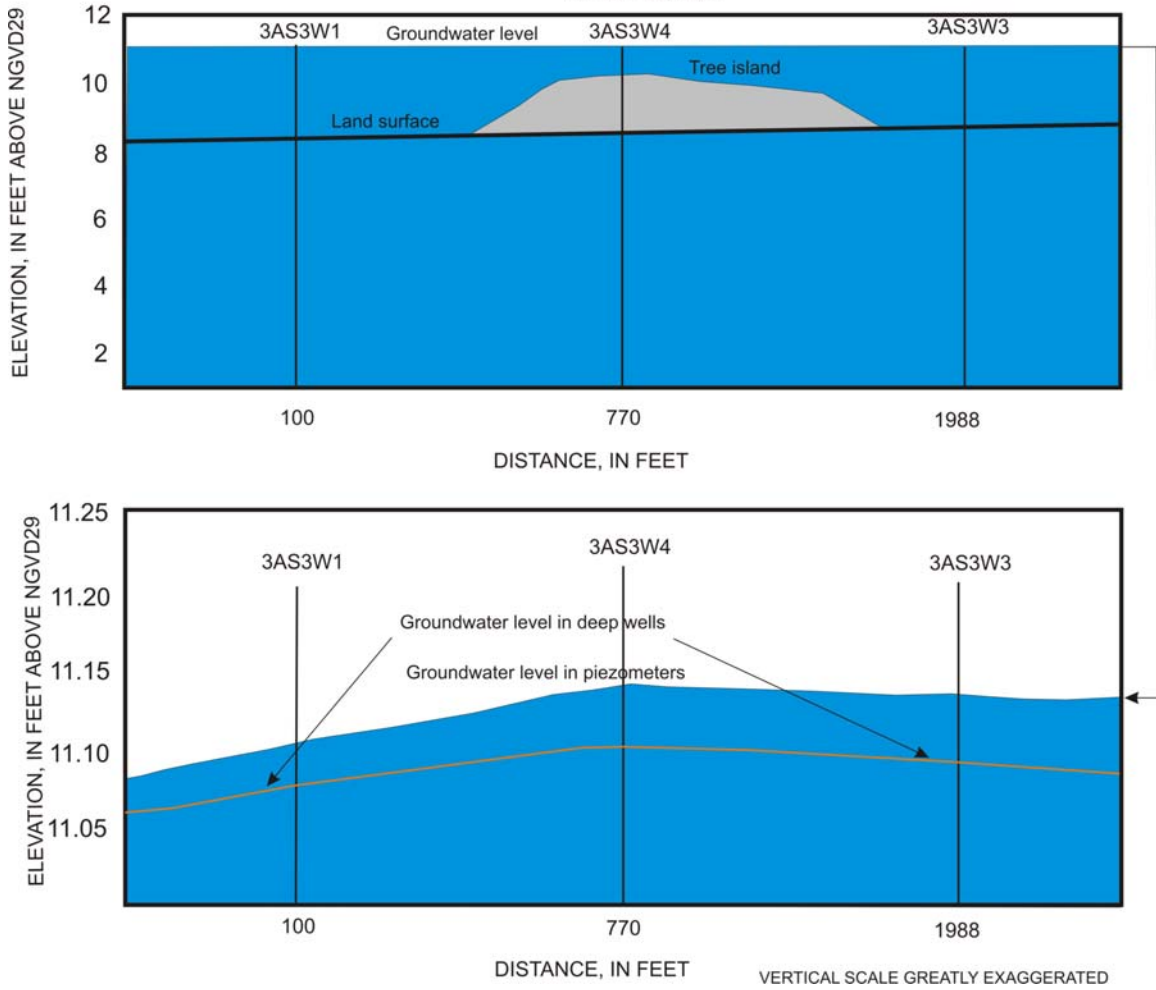
3AS3

Figure 12 Cross section showing water levels in piezometers and deep wells on October 23, 2004 (annual maximum).

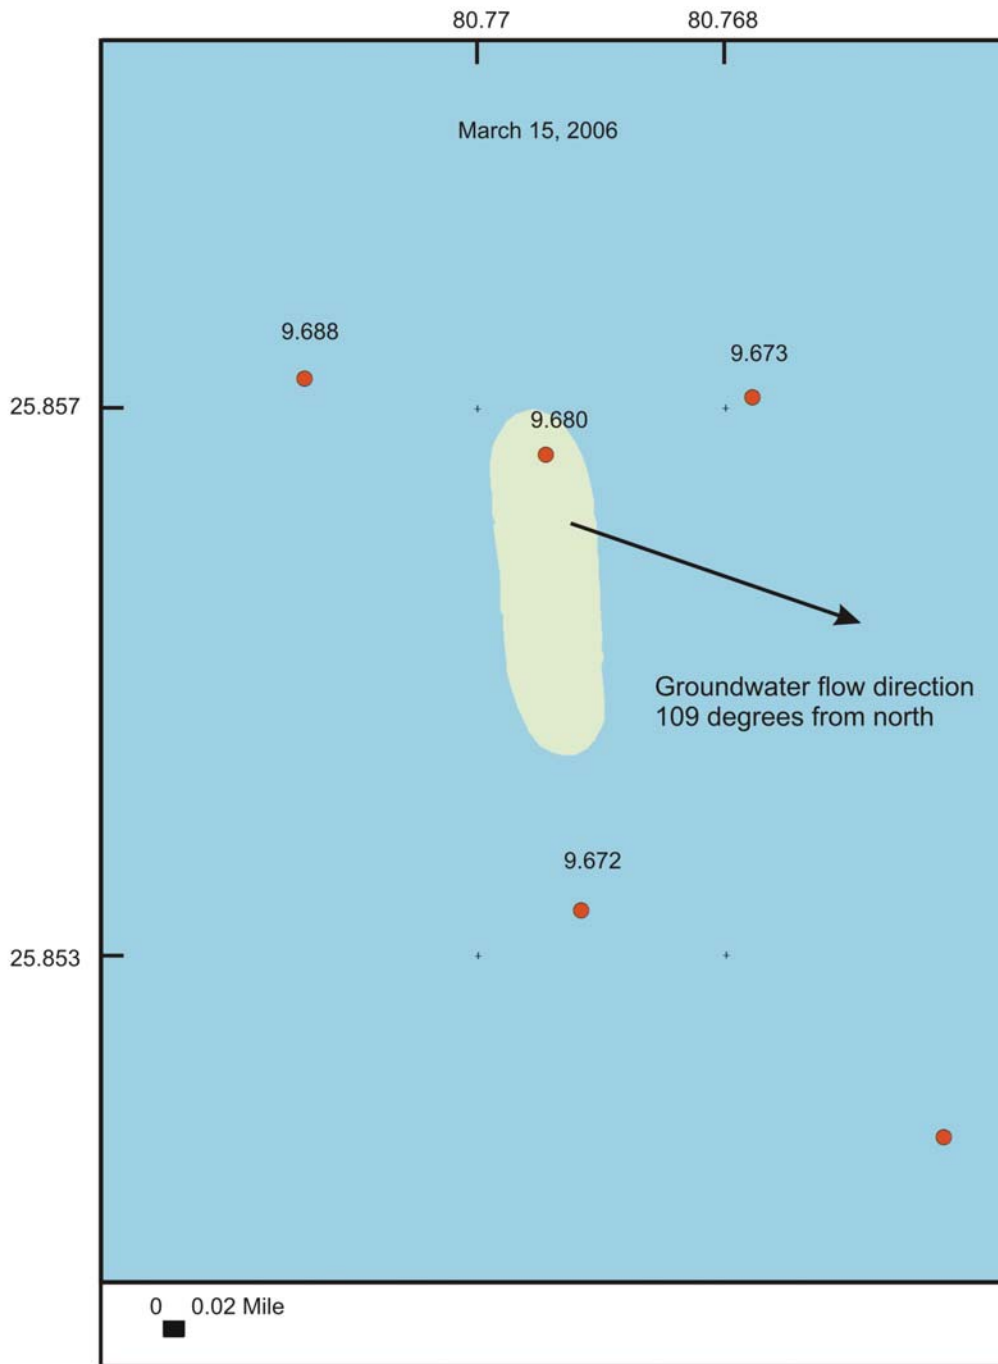
Figure 13 Water levels (ft above NGVD29) in deep wells at 3AS3 on March 15, 2006 (average conditions).

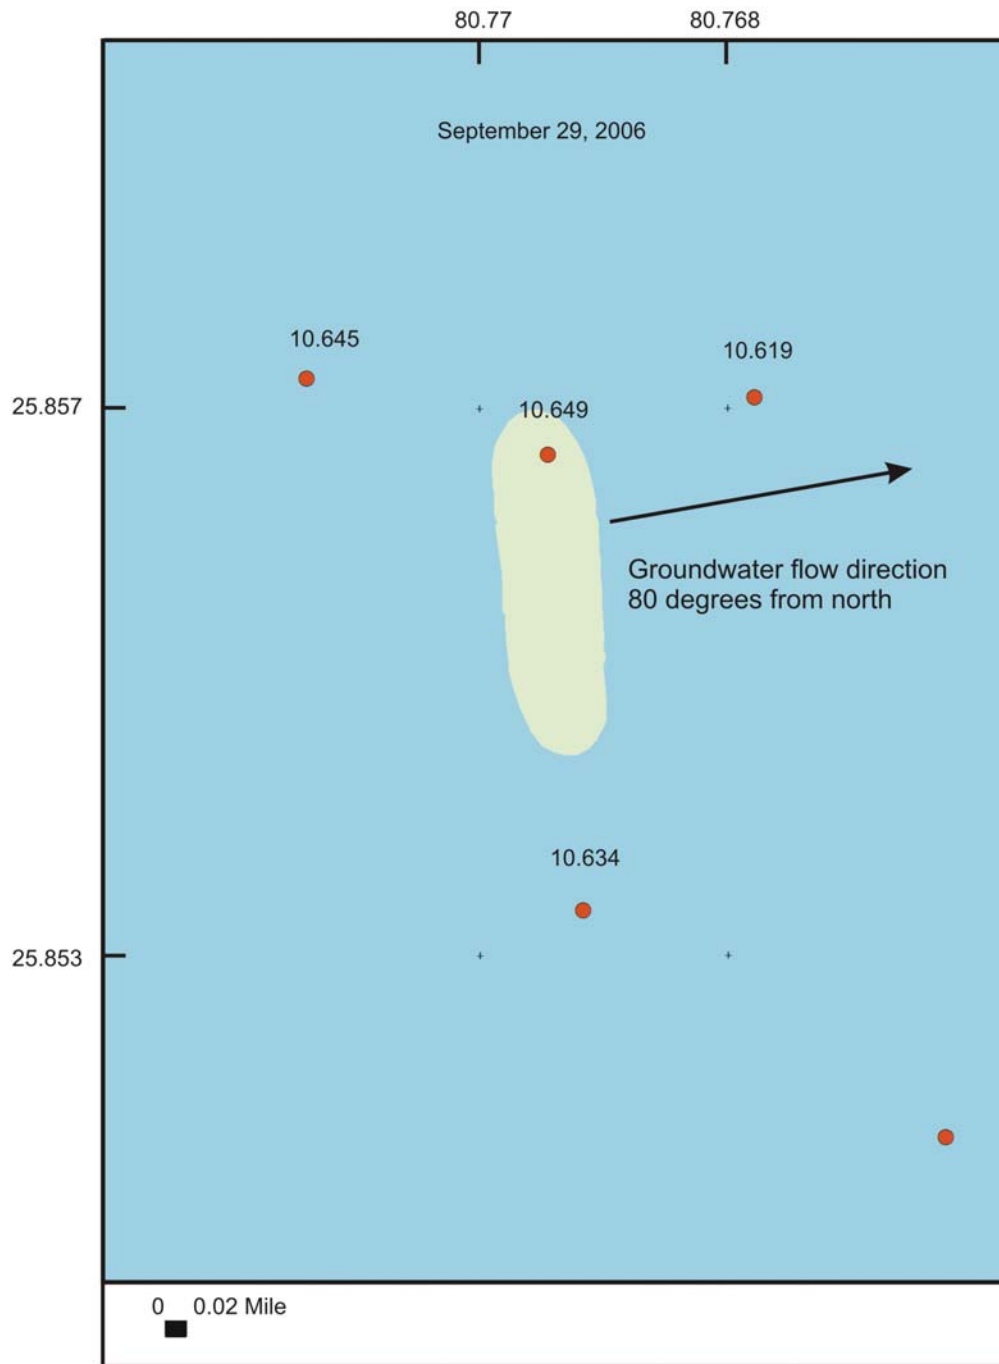
Figure 14 Water levels (ft above NGVD29) in deep wells at 3AS3 on September 29, 2006 (annual maximum).

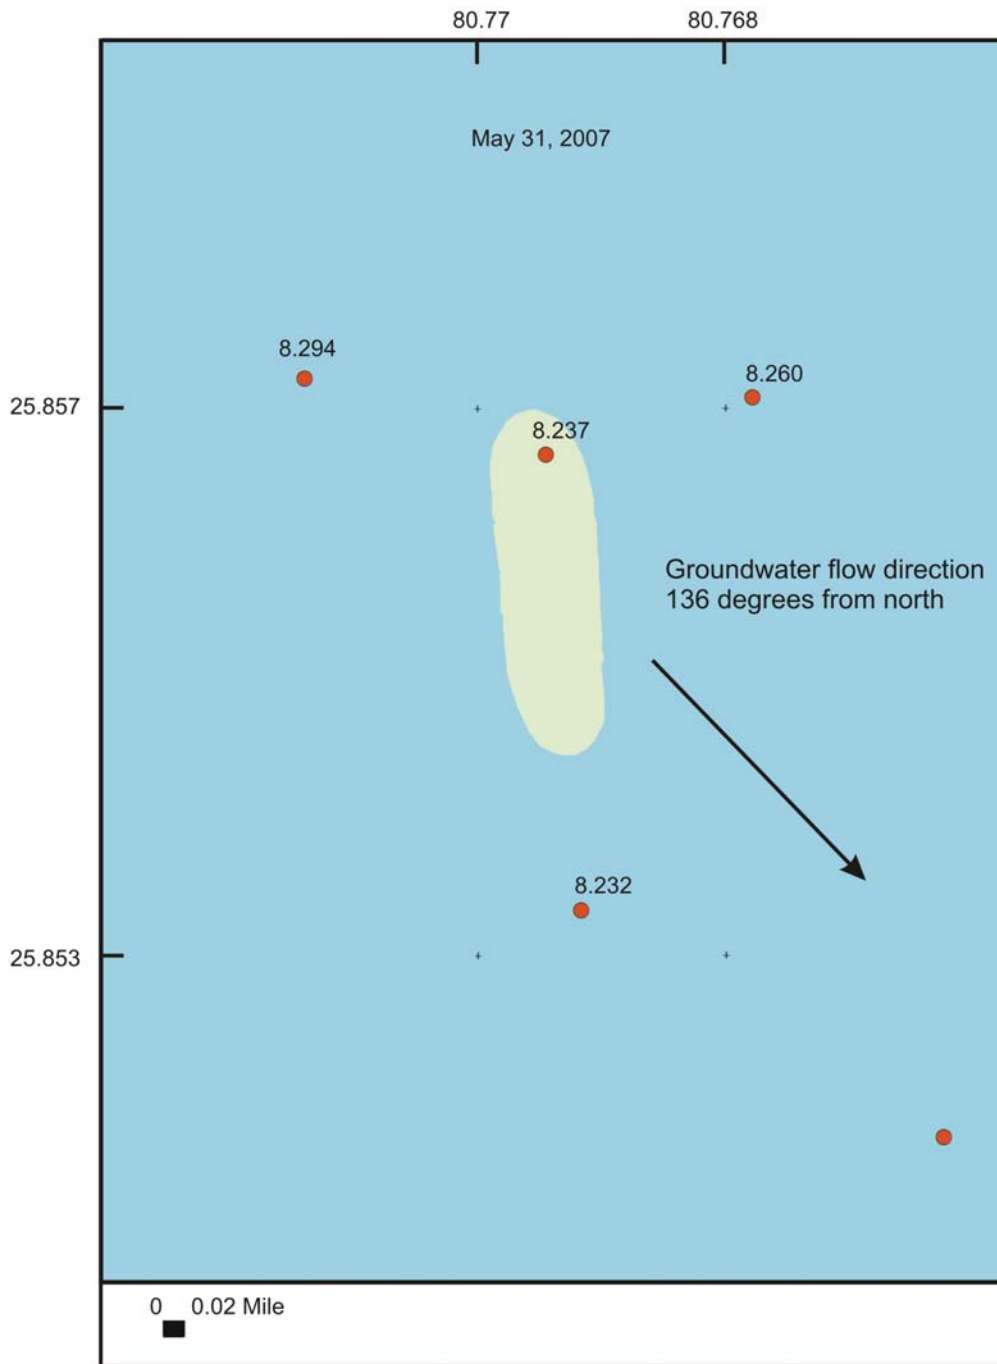
Figure 15 Water levels (ft above NGVD29) in deep wells at 3AS3 on May 31, 2007 (annual minimum).

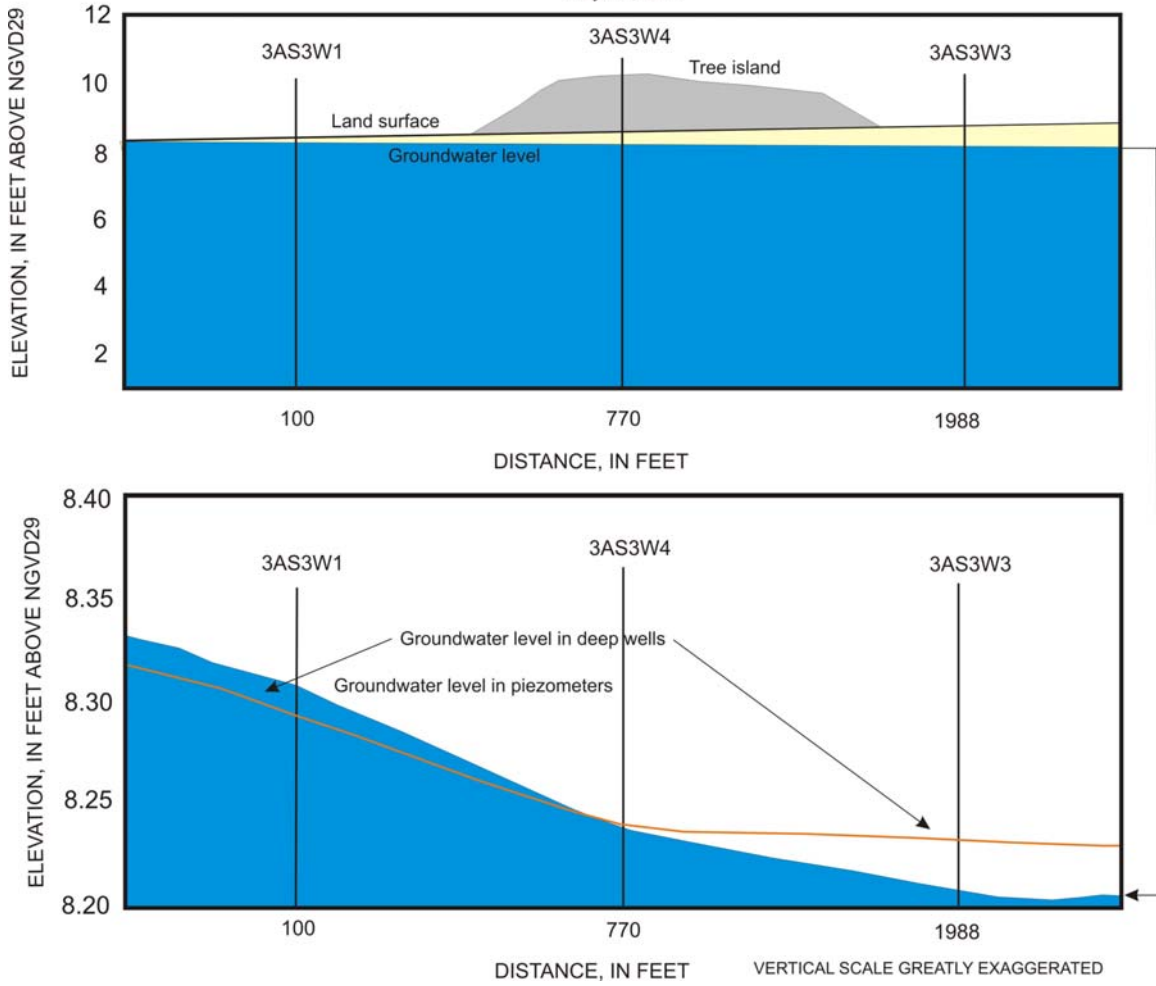
Figure 16 Cross section showing water levels in piezometers and deep wells at 3AS3 on May 31, 2007.

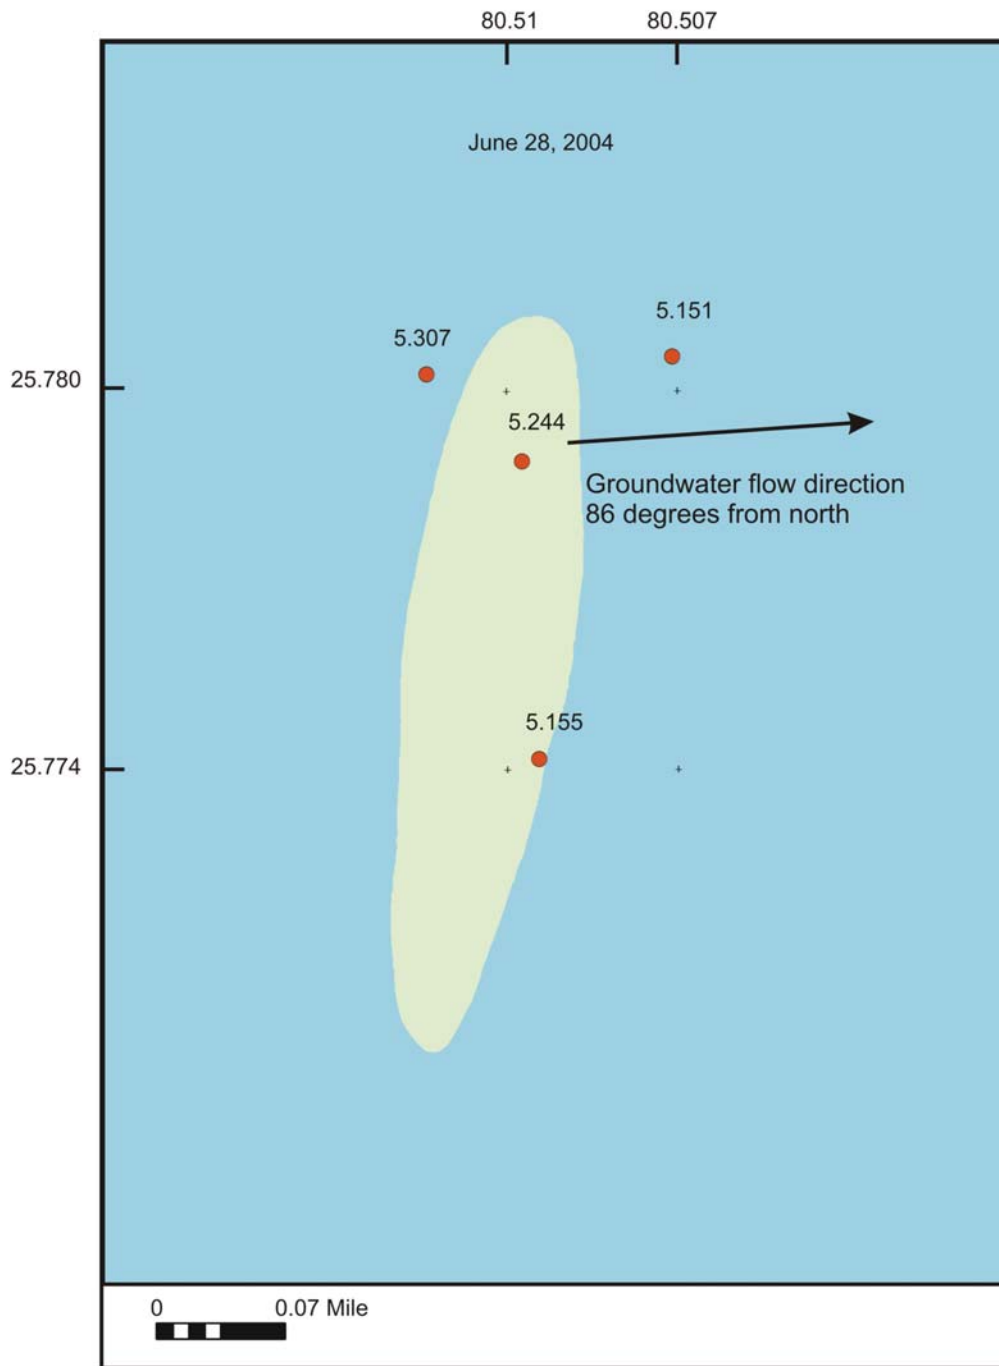
Figure 17 Water levels (ft above NGVD29) in deep wells at 3BS1 on June 28, 2004 (annual minimum).
