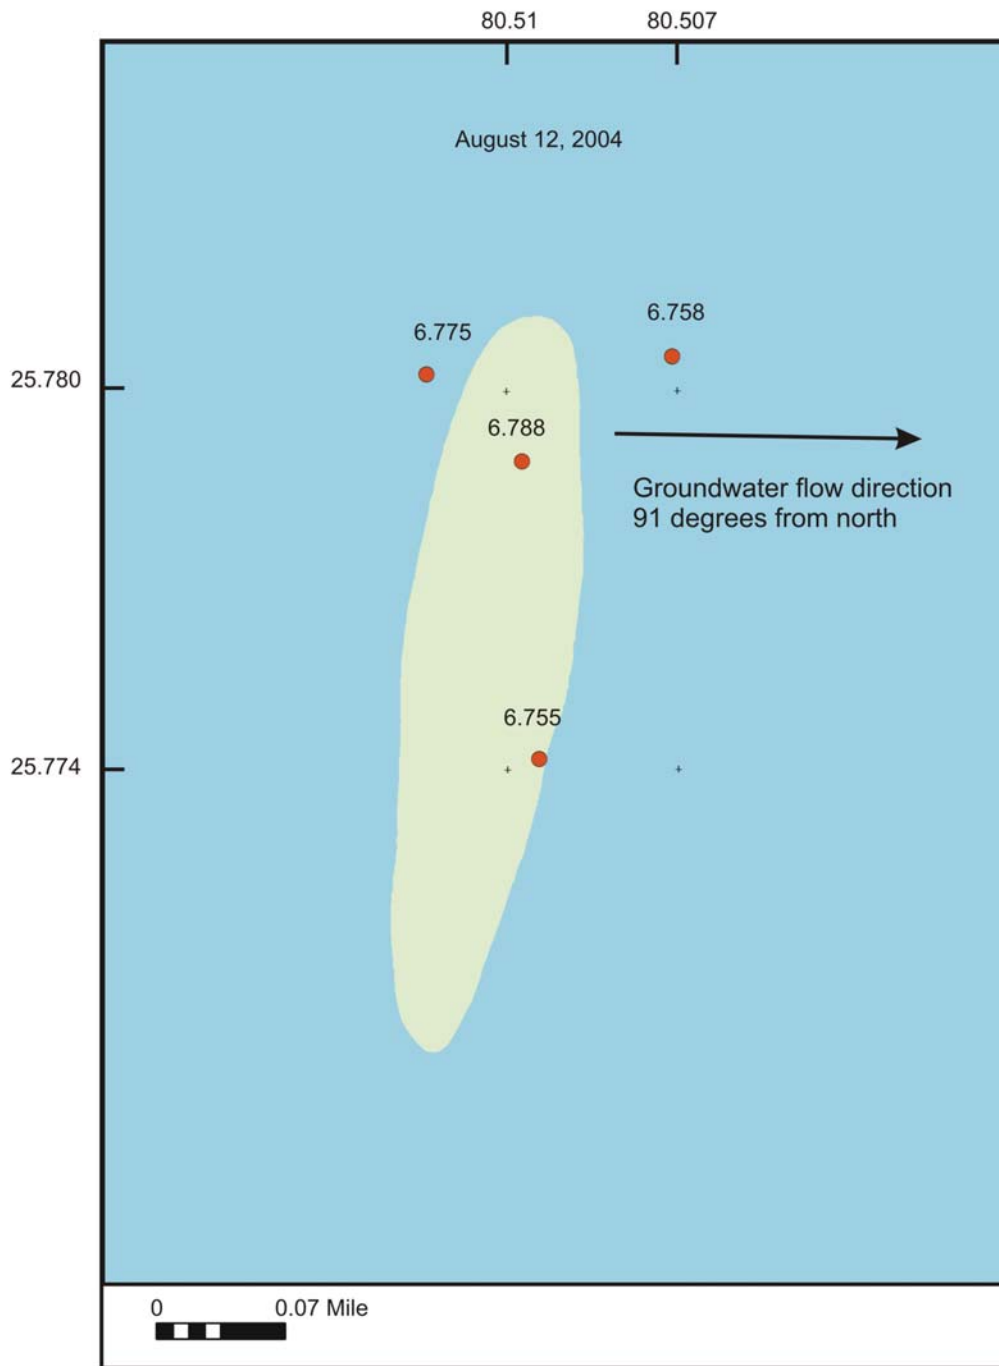
Figure 18 Water levels (ft above NGVD29) in deep wells at 3BS1 on August 12, 2004 (average conditions).

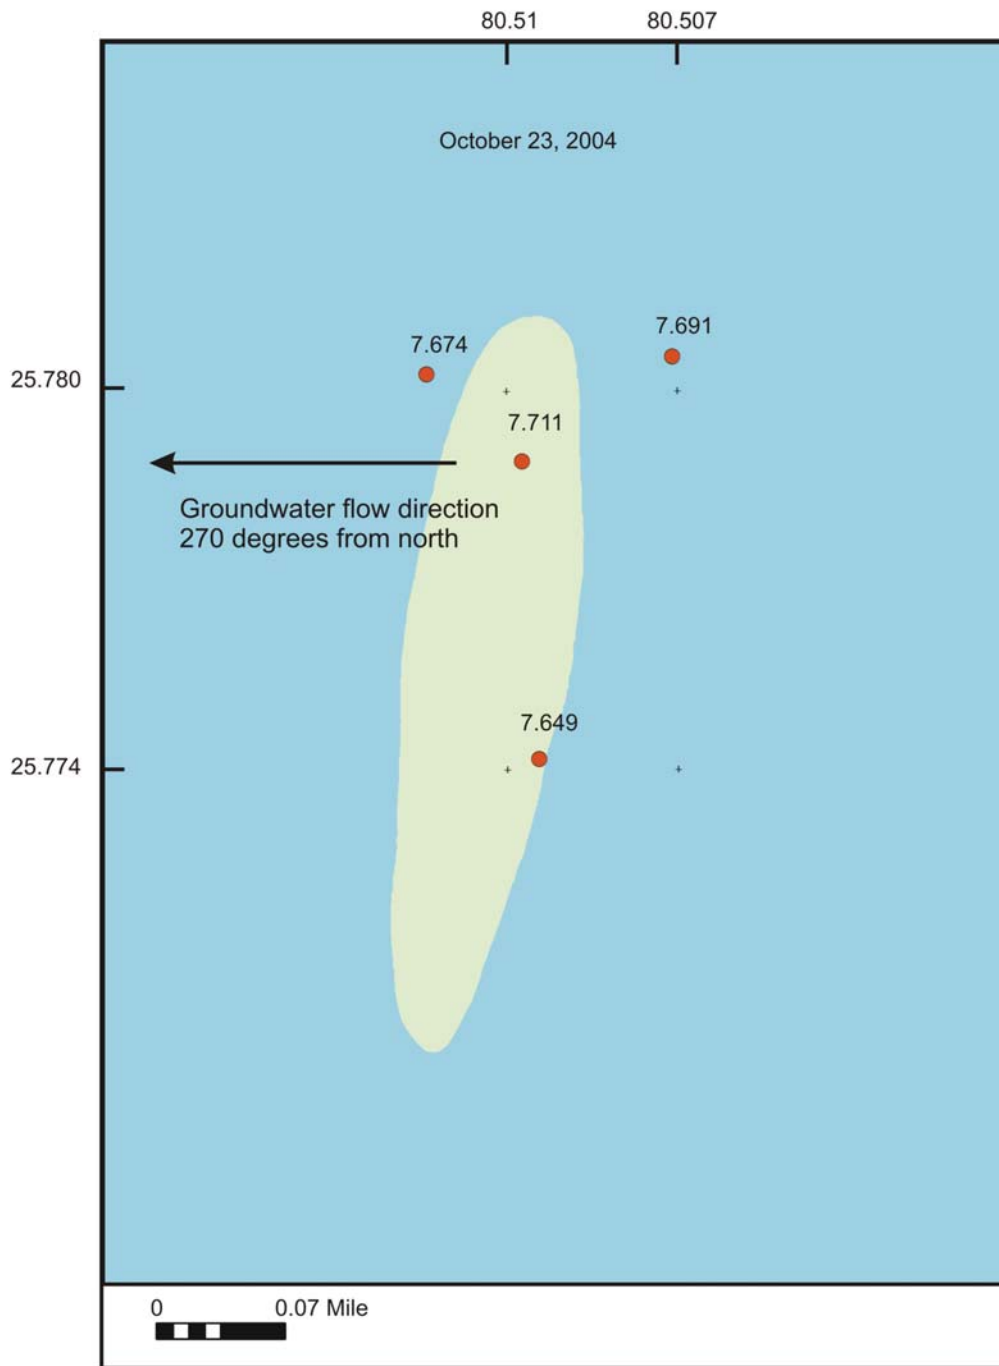
Figure 19 Water levels (ft above NGVD29) in deep wells at 3BS1 on October 23, 2004 (annual maximum).

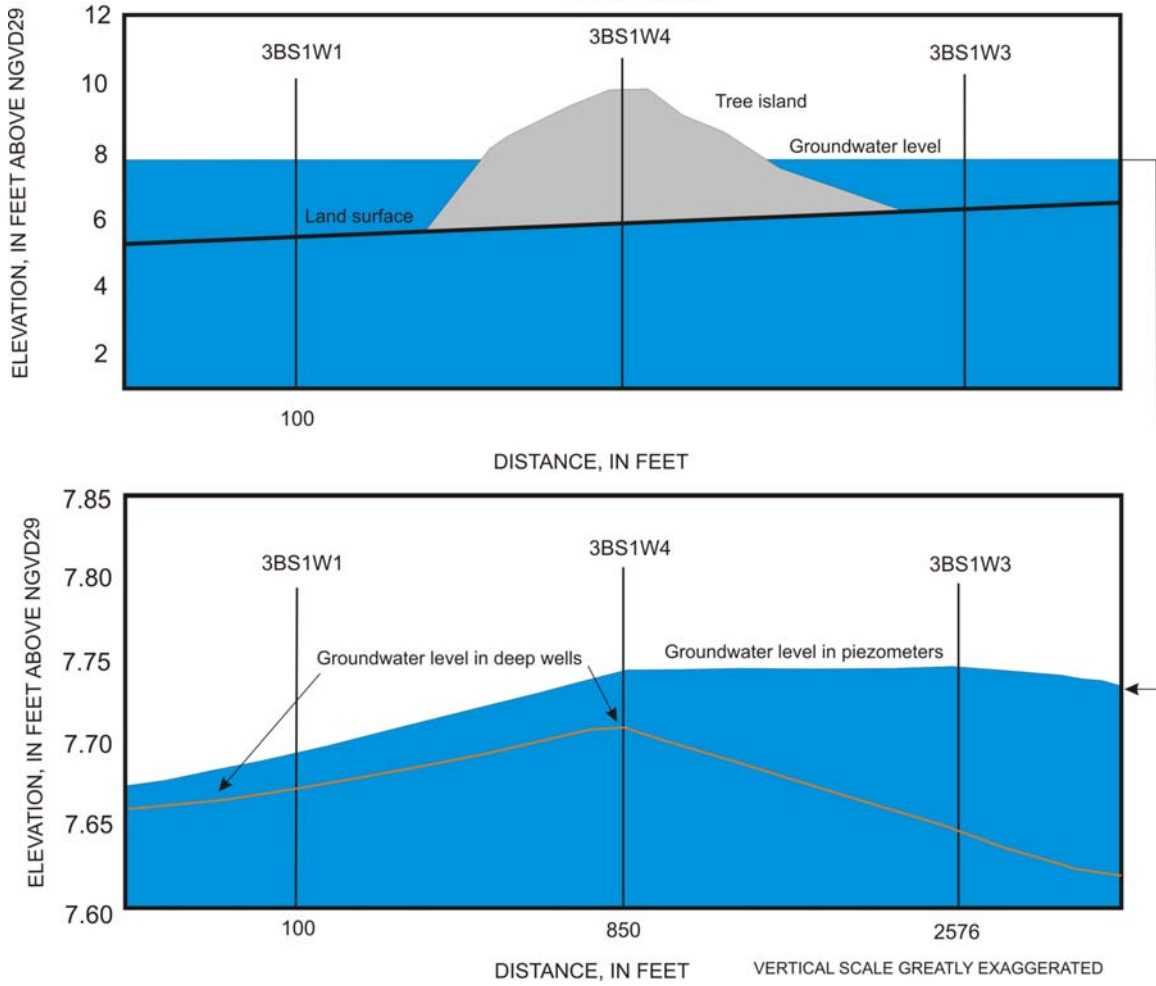
Figure 20 Cross section showing water levels in piezometers and deep wells at 3BS1 on October 7, 2004.

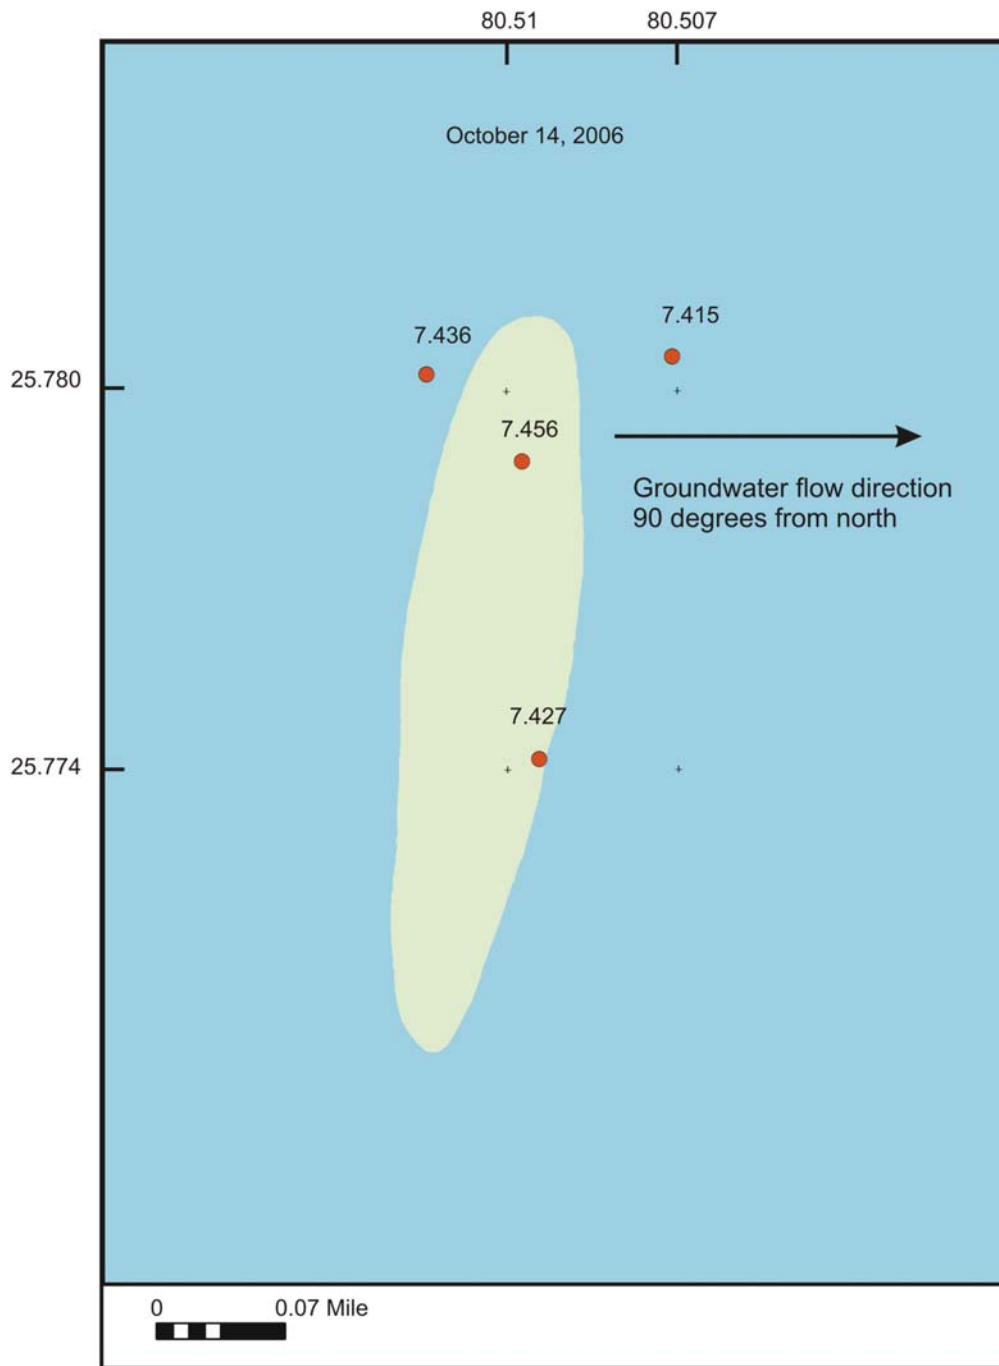
Figure 21 Water levels (ft above NGVD29) in deep wells at 3BS1 on October 14, 2006 (annual maximum).

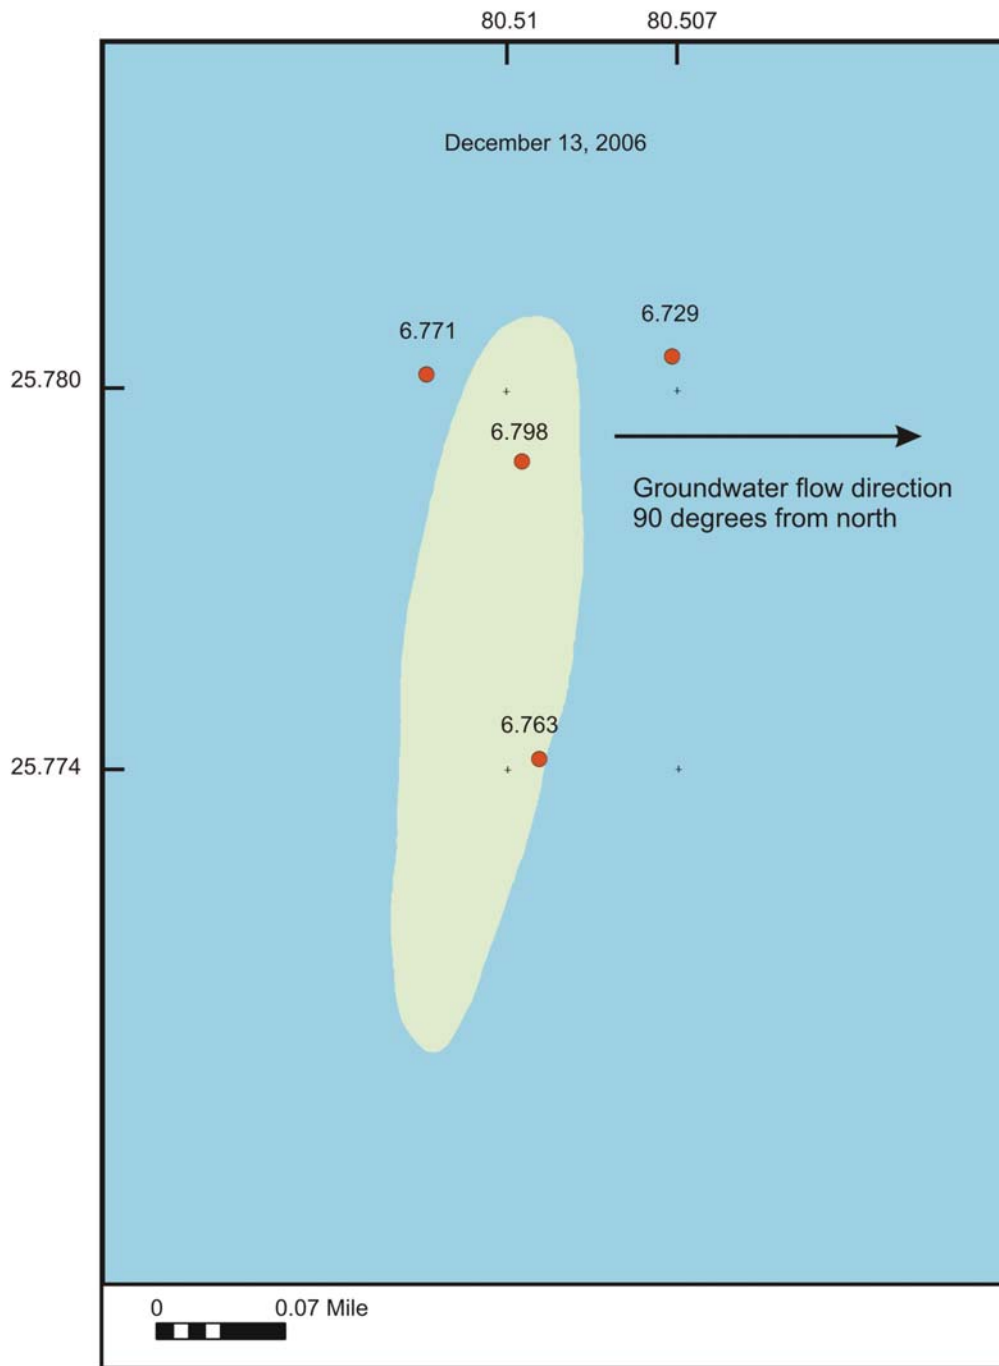
Figure 22 Water levels (ft above NGVD29) in deep wells at 3BS1 on December 13, 2006 (average conditions).

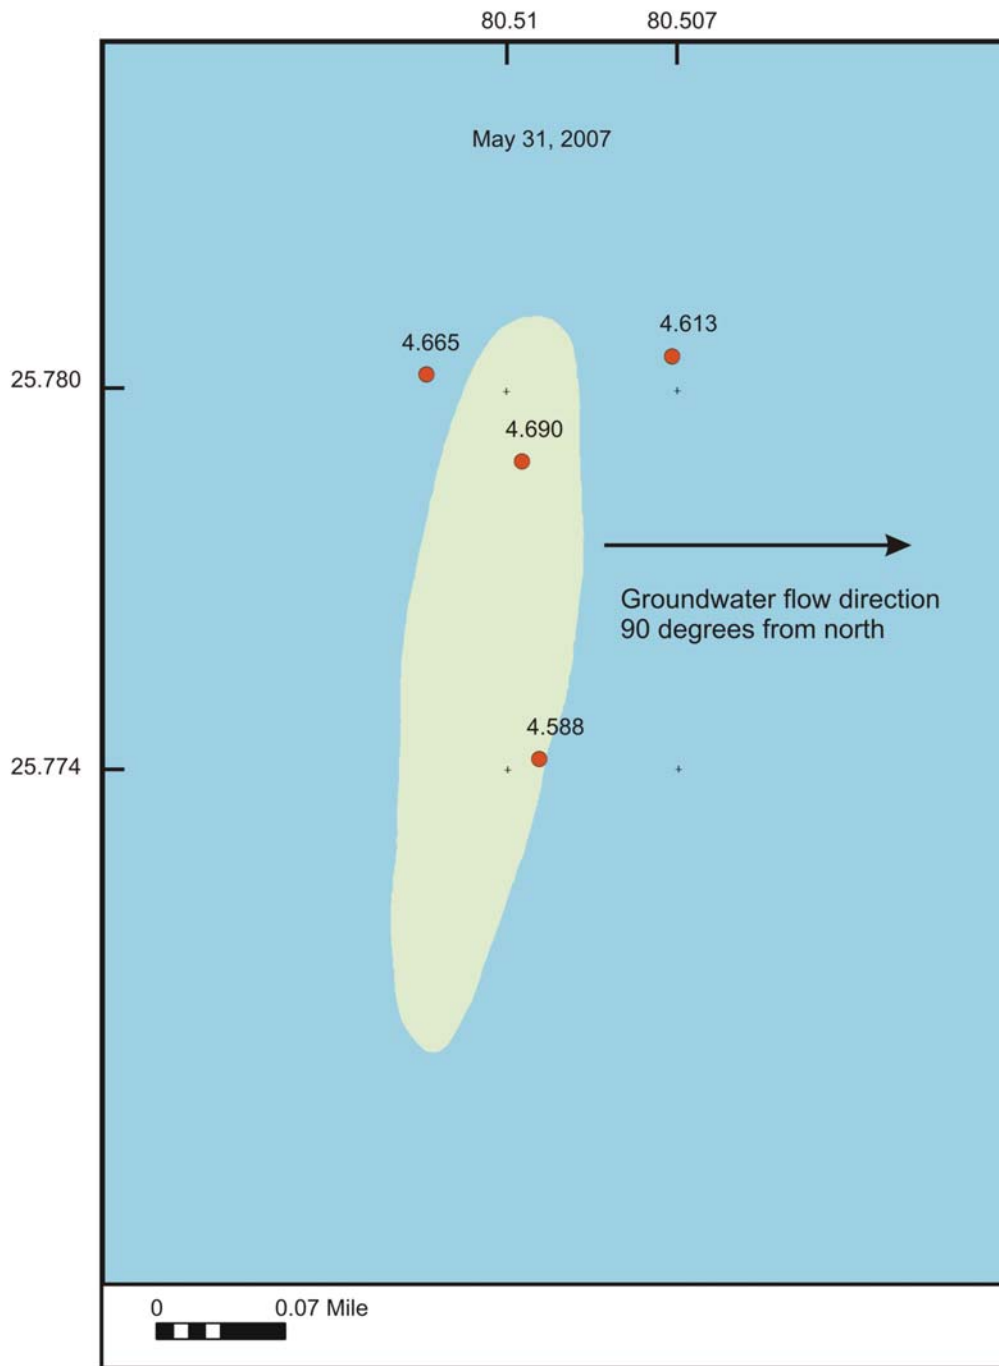
Figure 23 Water levels (ft above NGVD29) in deep wells at 3BS1 on May 31, 2007 (annual minimum).

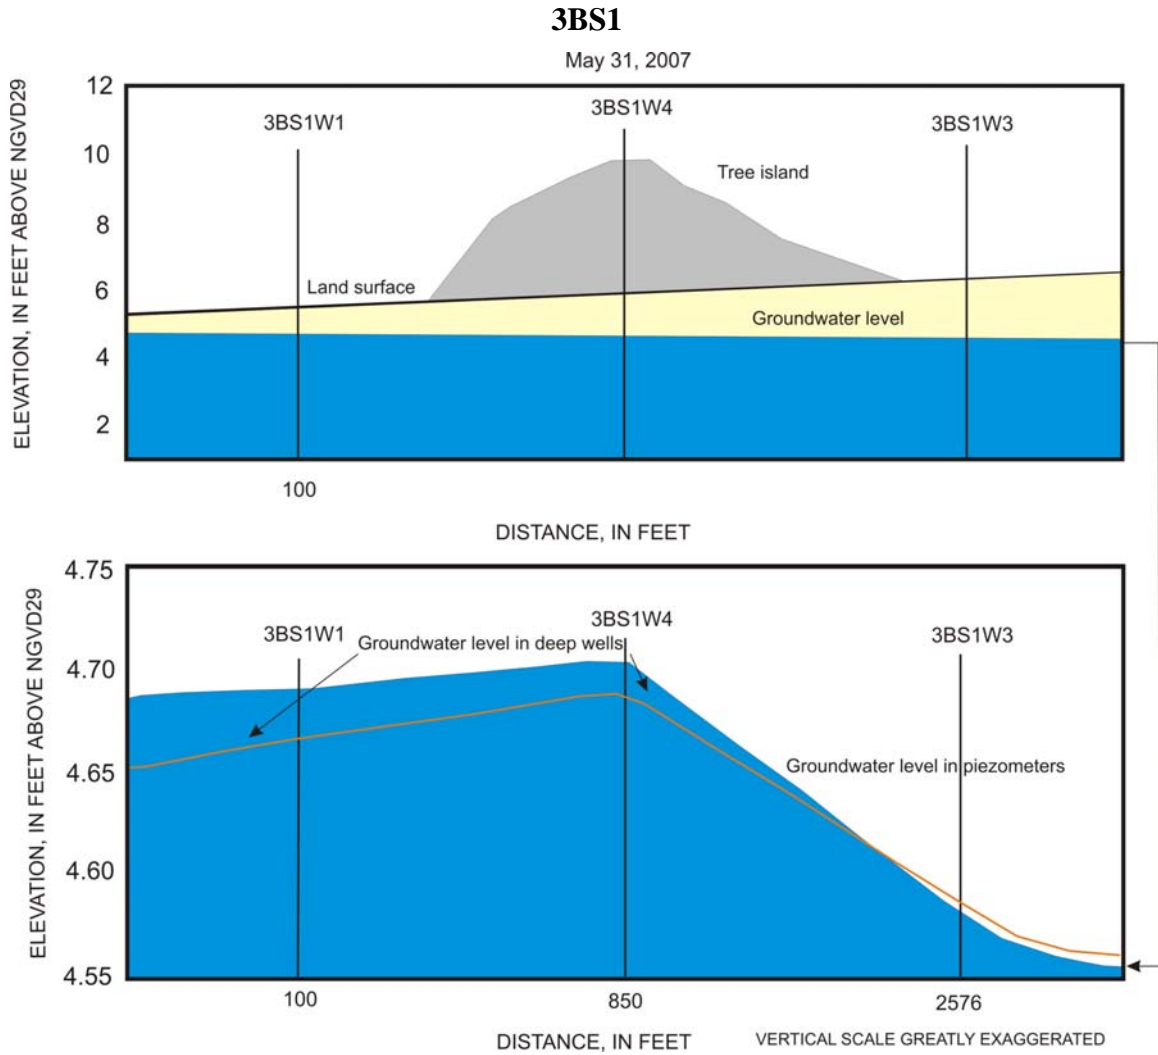
Figure 24 Cross section showing water levels in piezometers and deep wells at 3BS1 on May 31, 2007 (annual minimum).
