Well Condition Report

RMBAKER LLC was retained by the South Florida Water Management District (SFWMD) to perform a well video of PZ5D at the L8 reservoir site.

WELL ID: PZ5D
 LOGGING DATE: Feb 4, 2019

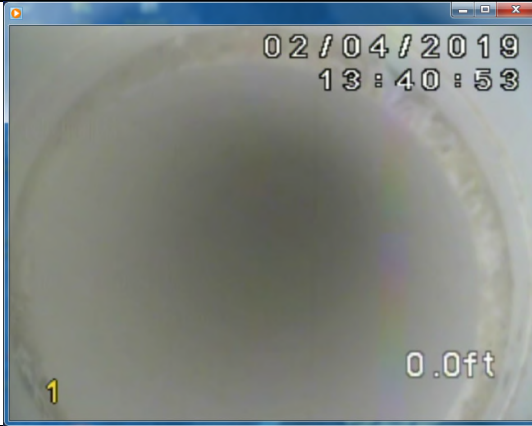
<p>02/04/2019 13:40:53 0.0ft 1</p>

<p>02/04/2019 13:42:17 20.4ft 1</p>
<p>Depth: 0.0 At top of casing reference; elevation 24.21 ft NAV88.</p>	<p>Depth: 20.4 Just above water level at 20.5 ft.</p>

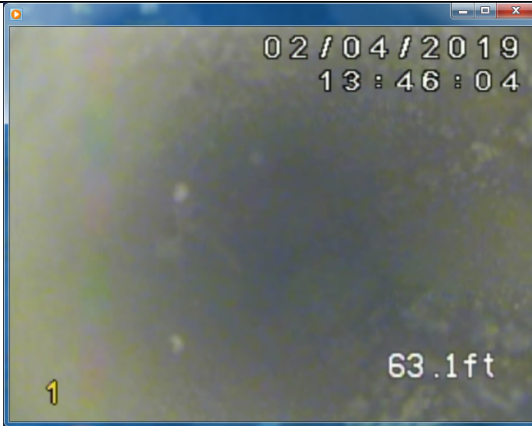
<p>02/04/2019 13:46:04 63.1ft 1</p>

<p>02/04/2019 13:46:10 63.8ft 1</p>
<p>Depth: 63.1 Bio-crust or scale on PVC casing wall.</p>	<p>Depth: 53.5 Bio-crust or scale obstruction.</p>

- The bio-crust or scale in the well obstructed the well and the total depth and screen depth could not be verified.
- The depth reference of the DBHydro datasets appeared to be ground surface at the time of well construction, rather than the top of casing surveyed reference mark.
