Governing Board Workshop
March 10, 2010

Ecological Conditions Update

Division Director, Lake Okeechobee Division
Restoration Sciences Department

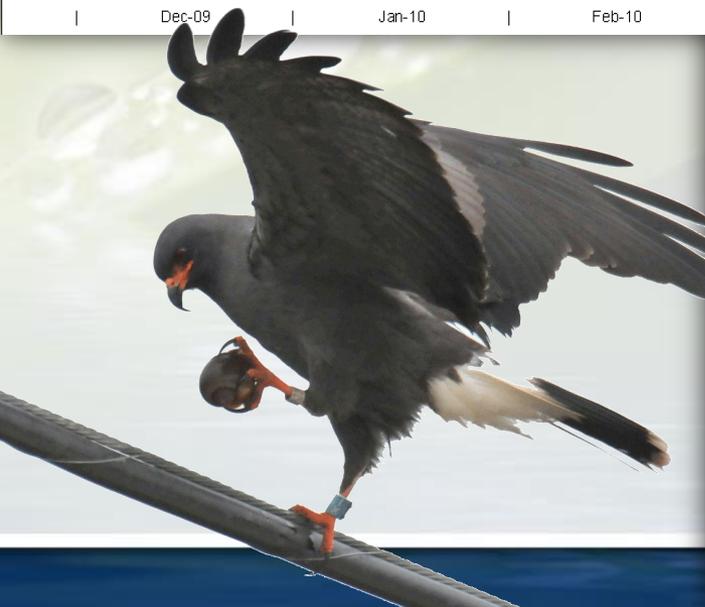
Kissimmee Basin

- **Rainfall and increased discharge from S65 in February to keep lakes below regulation schedule caused a stage reversal in the Phase I area floodplain**
- **Between Feb. 2 and Feb. 23, mean water depths on the Phase I floodplain increased 0.8 foot**
- **Dissolved Oxygen (DO) in the Phase I river channel has remained high**

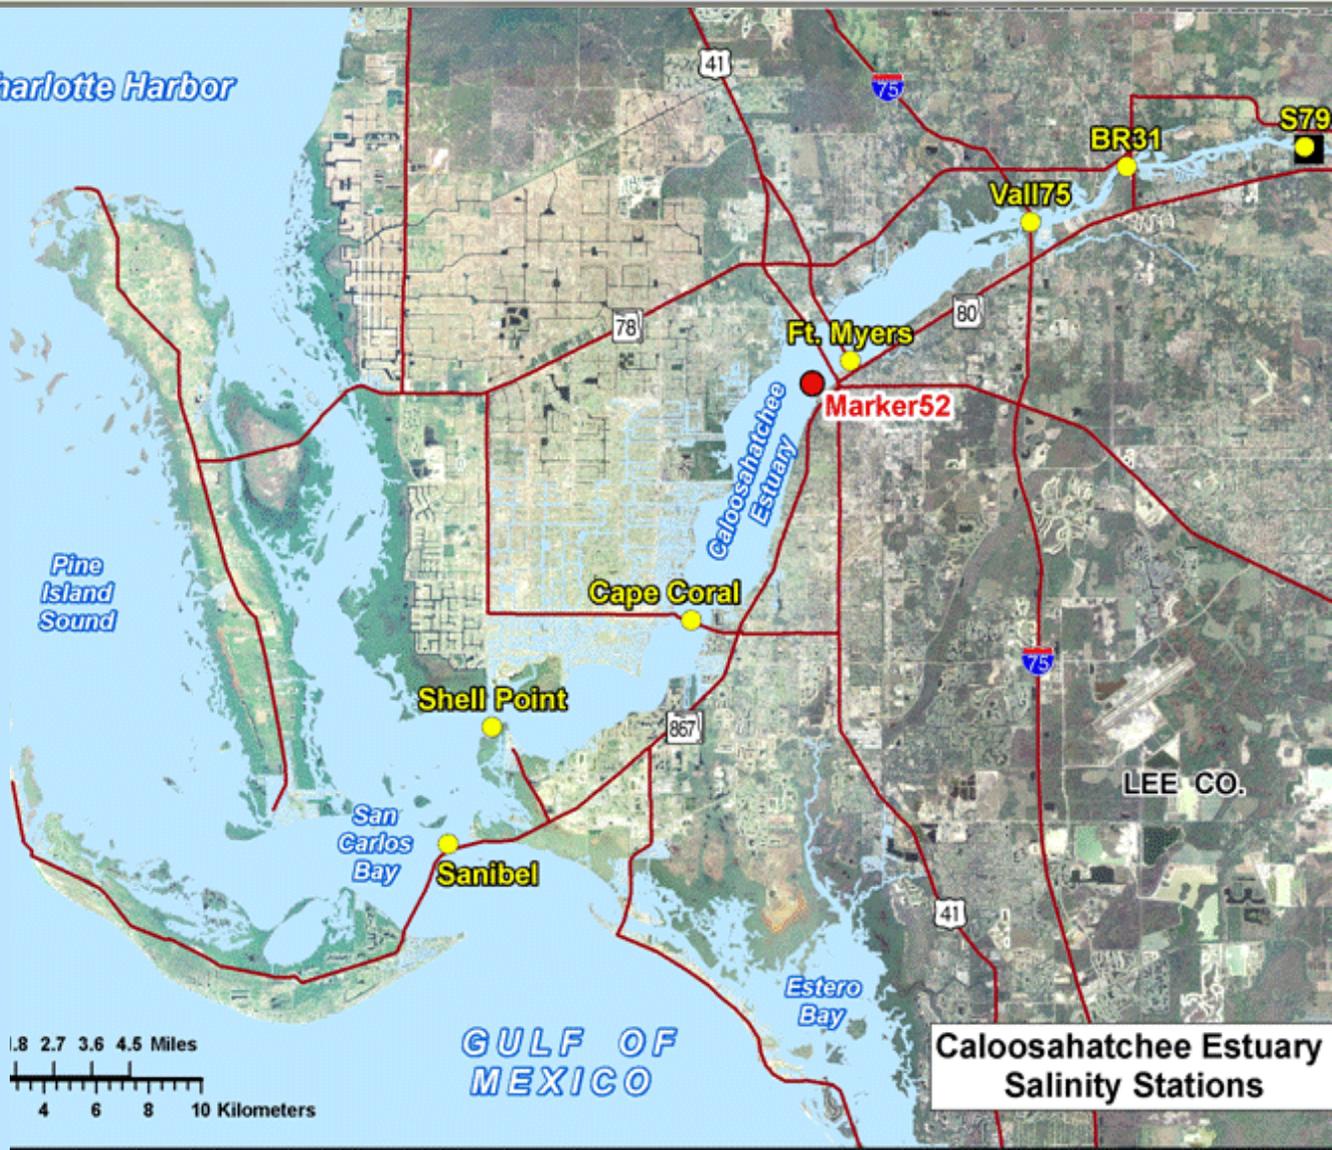
Caloosahatchee Salinity: Fort Myers

Pulse releases to the Caloosahatchee estuary have reduced the 30-day moving average salinity at Ft. Myers

Salinity conditions in the upper and lower Estuary are within the environmentally favorable range

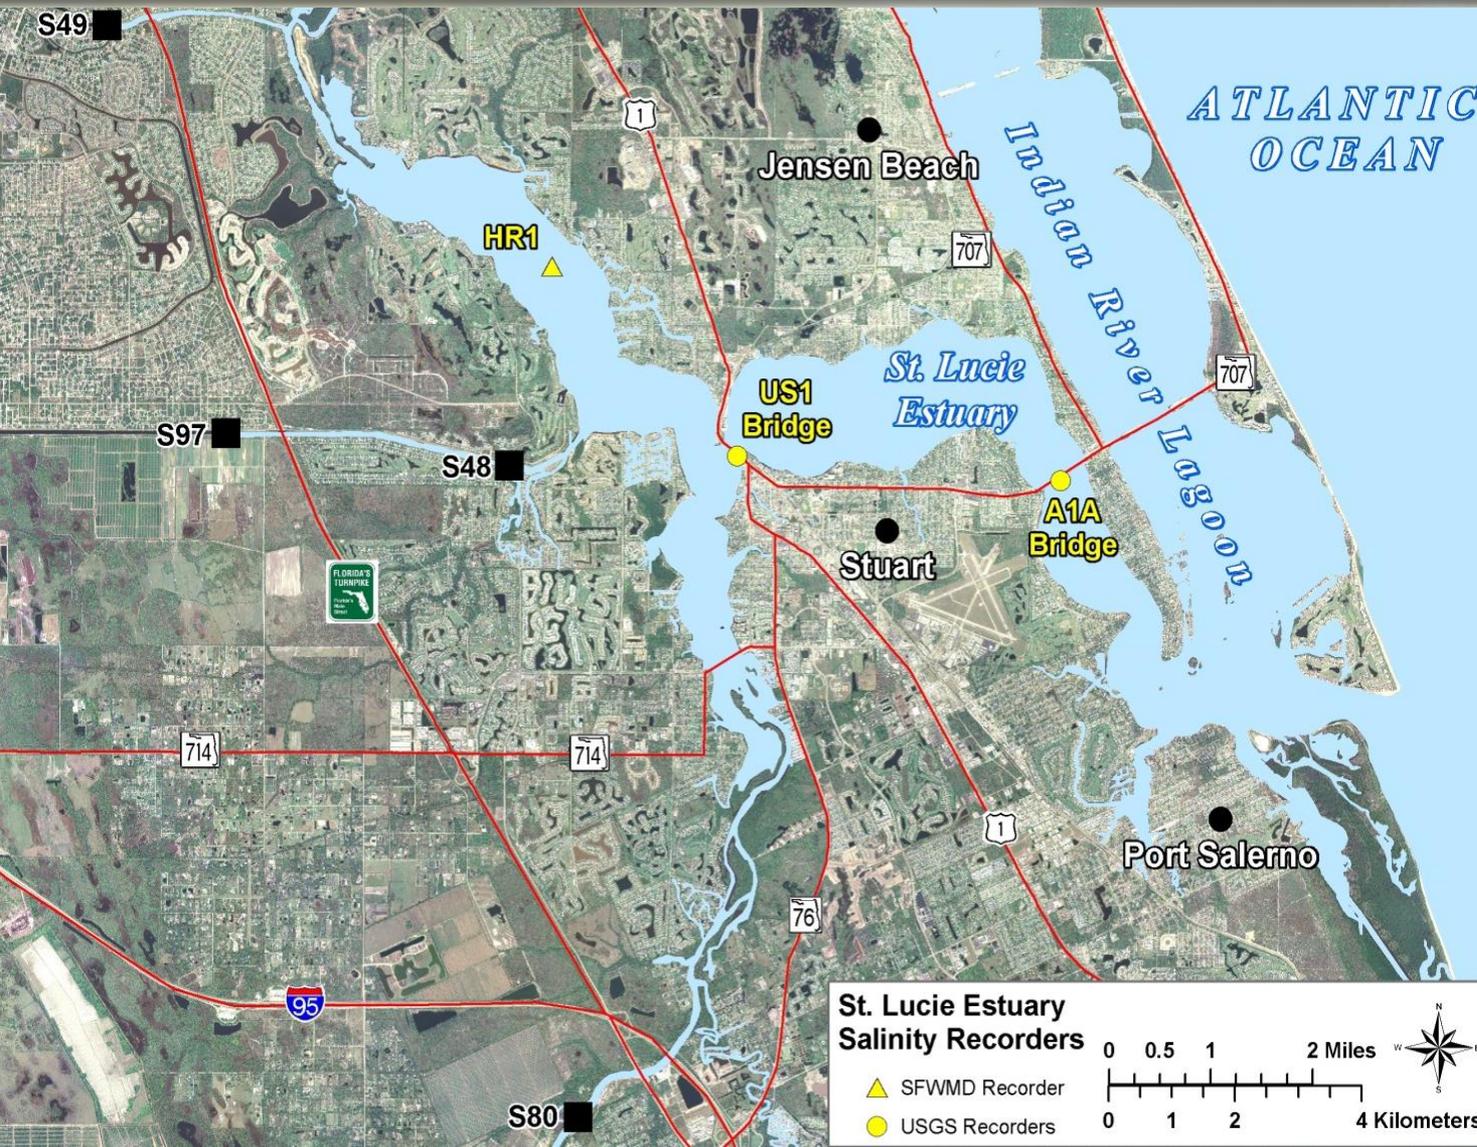
St. Lucie Salinity: US 1 Bridge

In the St. Lucie, the daily salinity at the US1 Bridge was within the salinity envelope

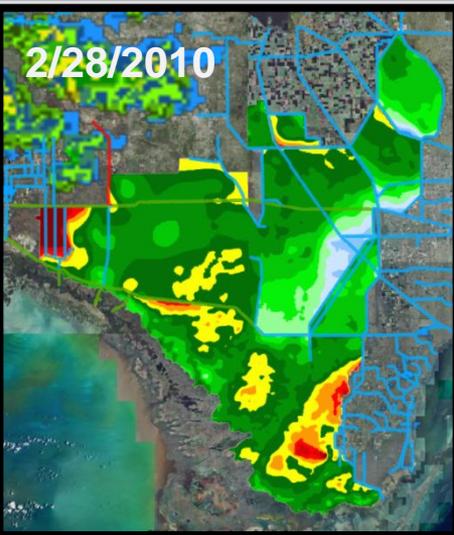
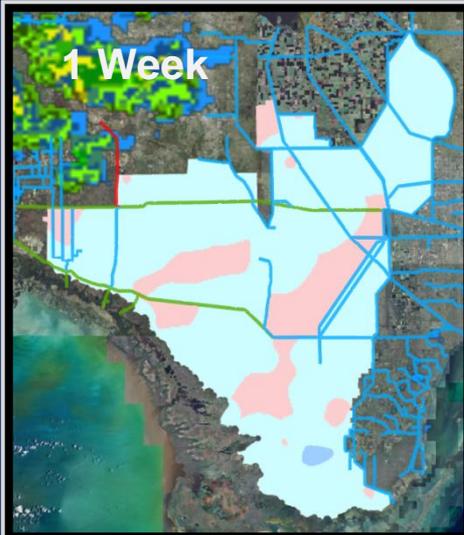
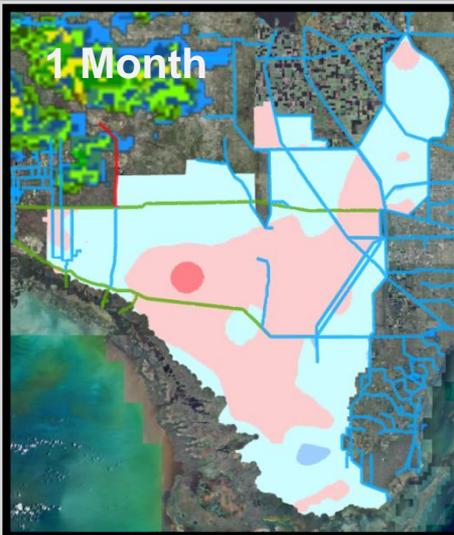
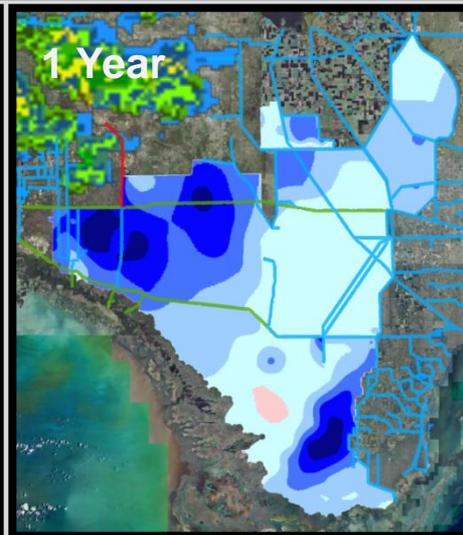
Everglades Water Depths and Difference Maps (Present minus Past)

Water Depth (feet)

Water Depth Difference (feet)

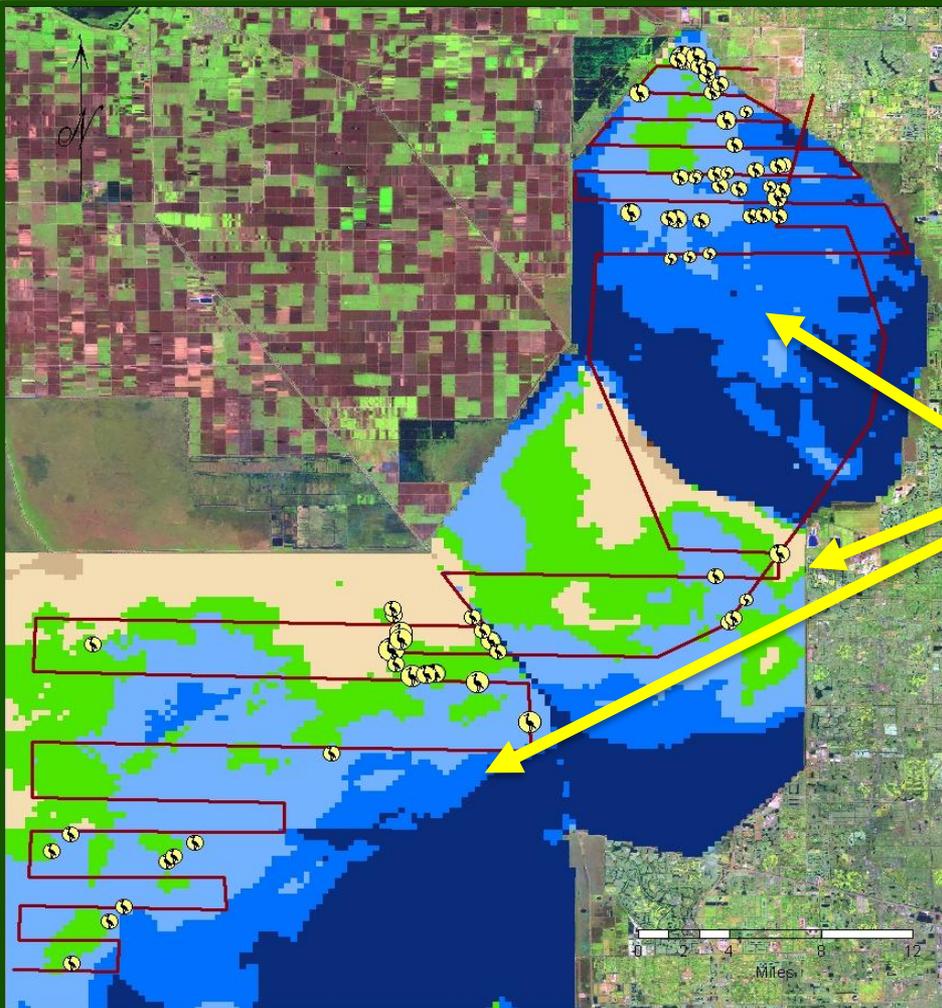
Wading Bird Foraging Areas

This map shows where wading birds were feeding in relation to water depth on Feb 26th 2010

Wading birds are currently feeding in WCA-2A, WCA-3A and the Lox National Wildlife Refuge

Green areas represent water depths that are optimal for wading bird feeding (~0.25 – ~0.5 ft)

Dark red lines are the flight lines used to survey for wading birds

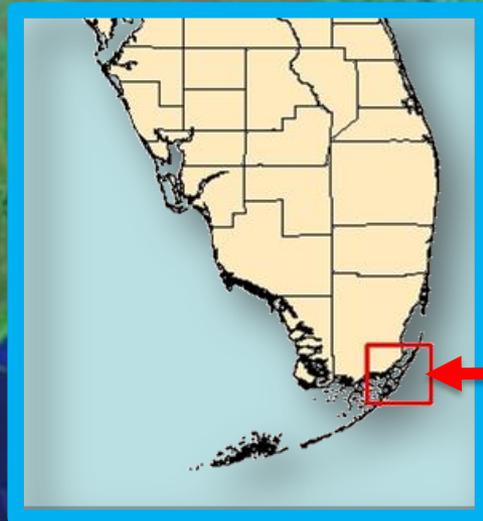
Blackwater Sound Benthic Vegetation

Seagrasses are showing signs of successional recovery in the northern section of the Blackwater Sound

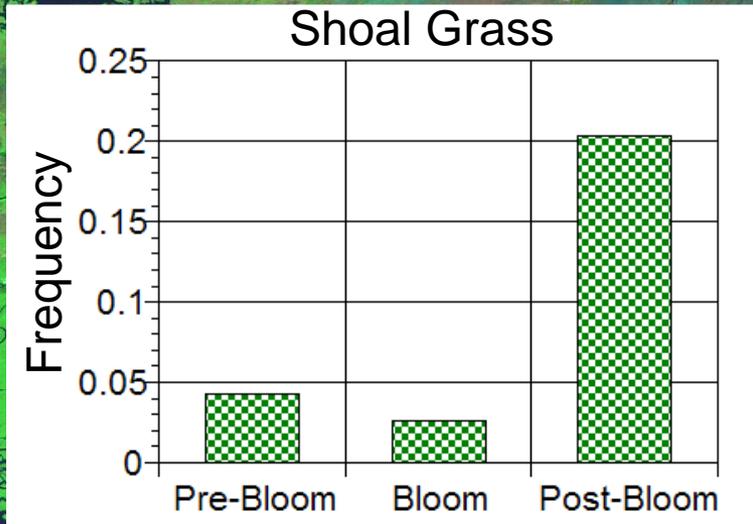
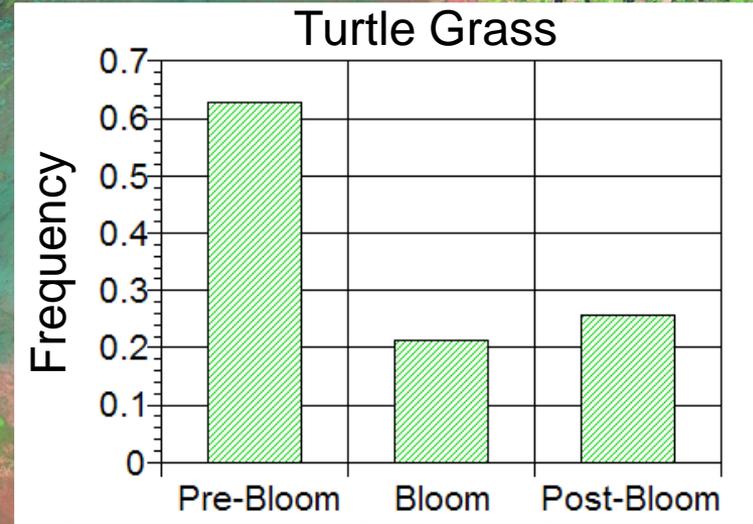
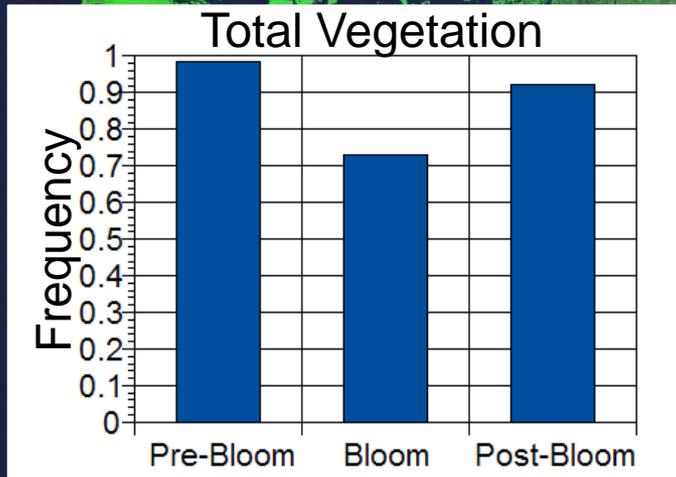
Pre-Bloom: WY2003 & 2004
 Bloom: WY2007 & 2008
 Post-Bloom: WY2009 & 2010

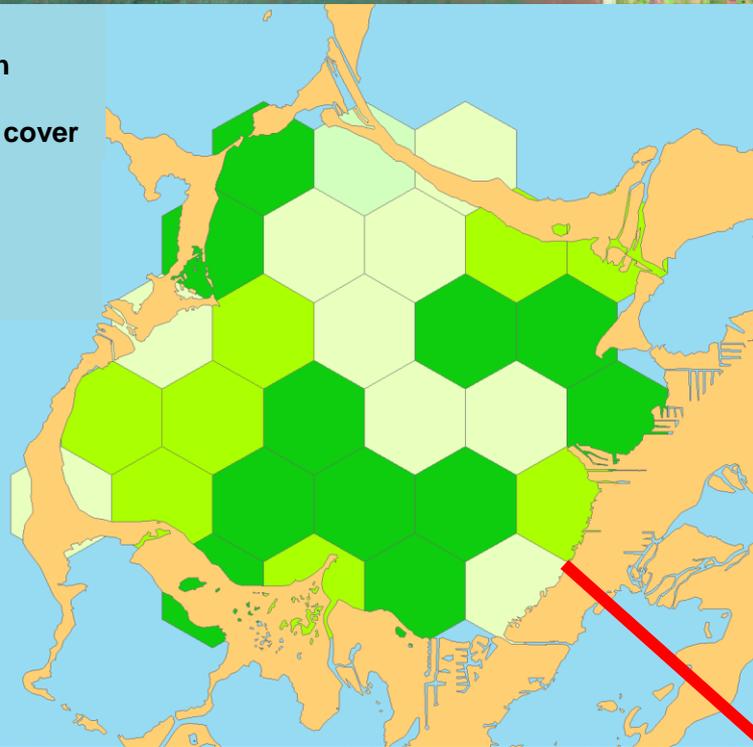
Blackwater Sound Seagrasses

Total seagrass cover in Blackwater Sound remains patchy and sparse

Percentage of observations with greater than 5% seagrass bottom cover

* Data shown were collected in May 2009 through a cooperative agreement with the South Florida Fish Habitat Assessment Program (FWCC)

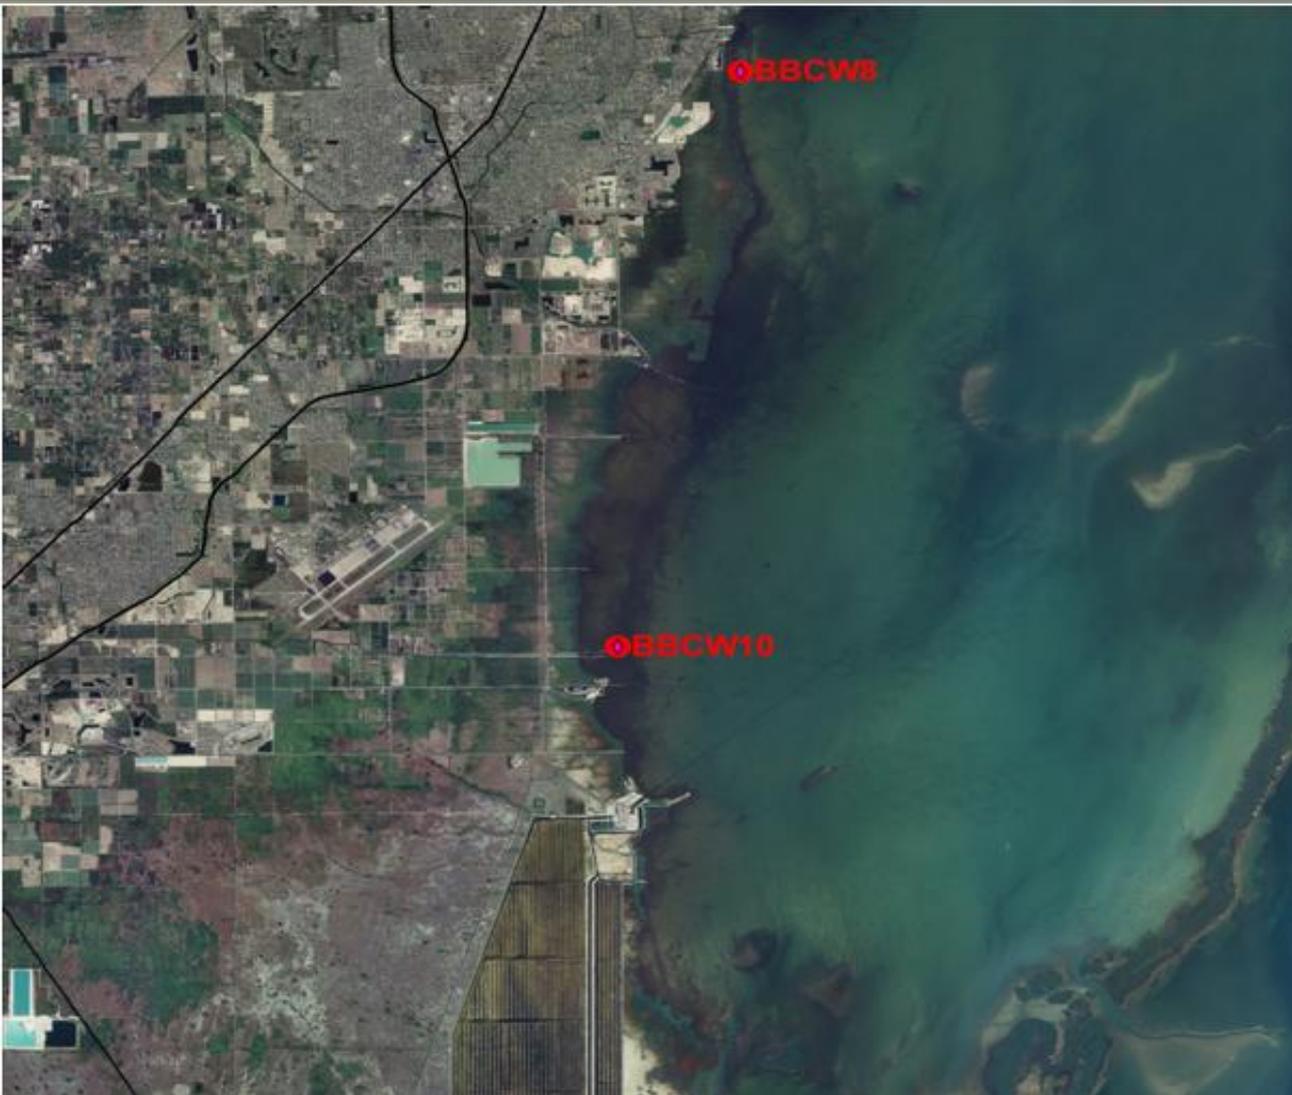
Biscayne Bay Salinity

**In Biscayne Bay,
the salinity is
within the
preferred range
for seagrasses**

**No hypersalinity
was reported in
the near shore
area last month**
