# Ecological Conditions Update

## Governing Board Workshop December 9, 2009

# Kissimmee Basin

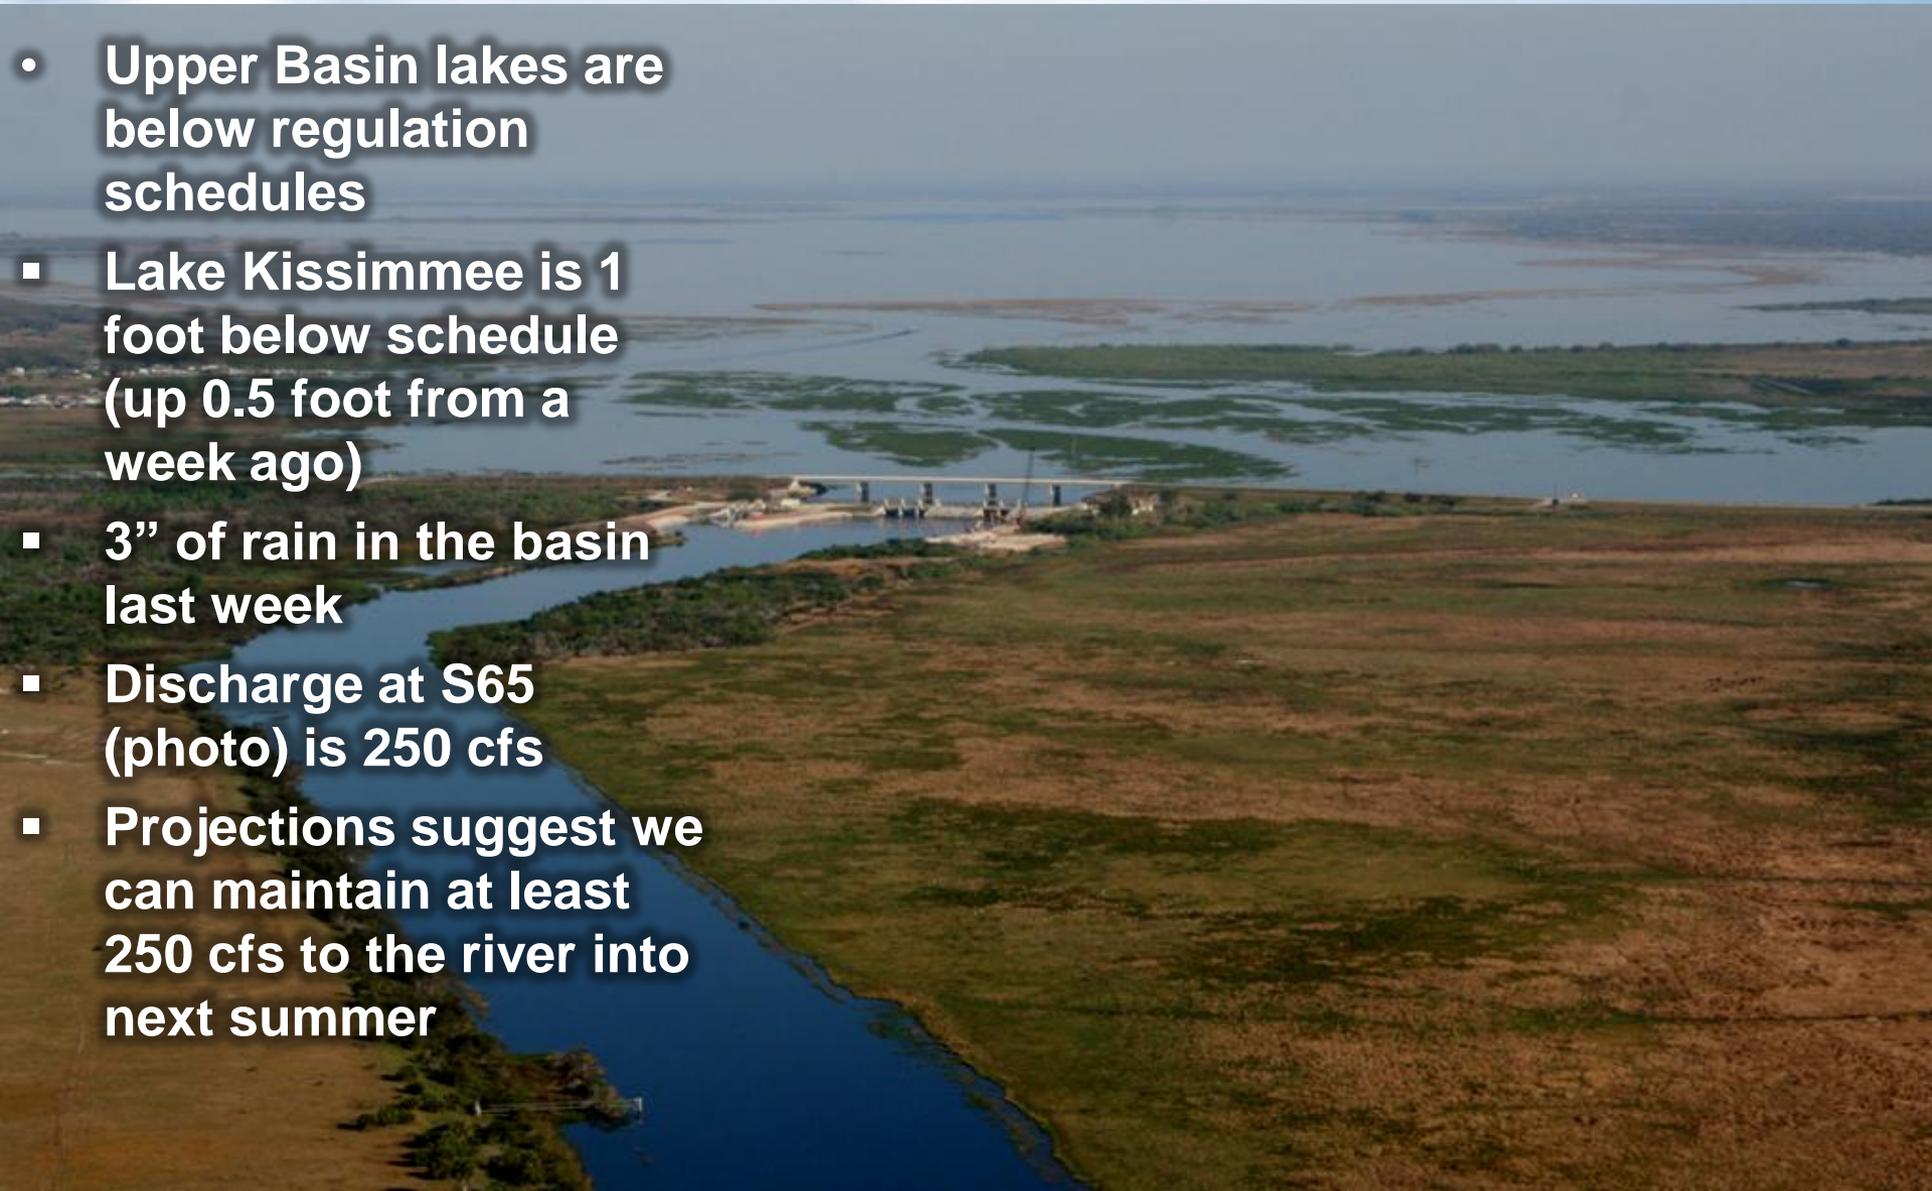
- Upper Basin lakes are below regulation schedules
- Lake Kissimmee is 1 foot below schedule (up 0.5 foot from a week ago)
- 3" of rain in the basin last week
- Discharge at S65 (photo) is 250 cfs
- Projections suggest we can maintain at least 250 cfs to the river into next summer

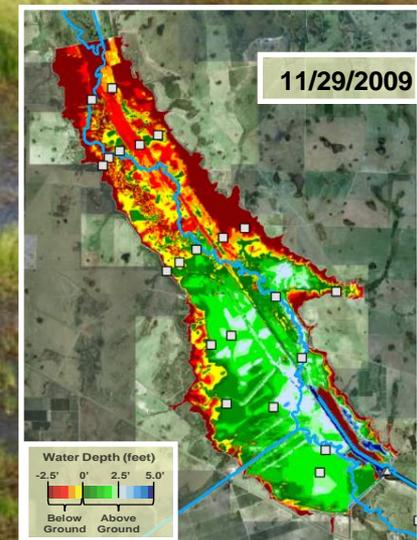
- With reduced rainfall and inflow, water levels on the Kissimmee River floodplain continue to recede
- Water depths average less than 0.7 foot (map)
- Wading bird foraging is focused on drying pools, which concentrate prey (photo)
- Dissolved oxygen levels in the river have remained well above levels of concern

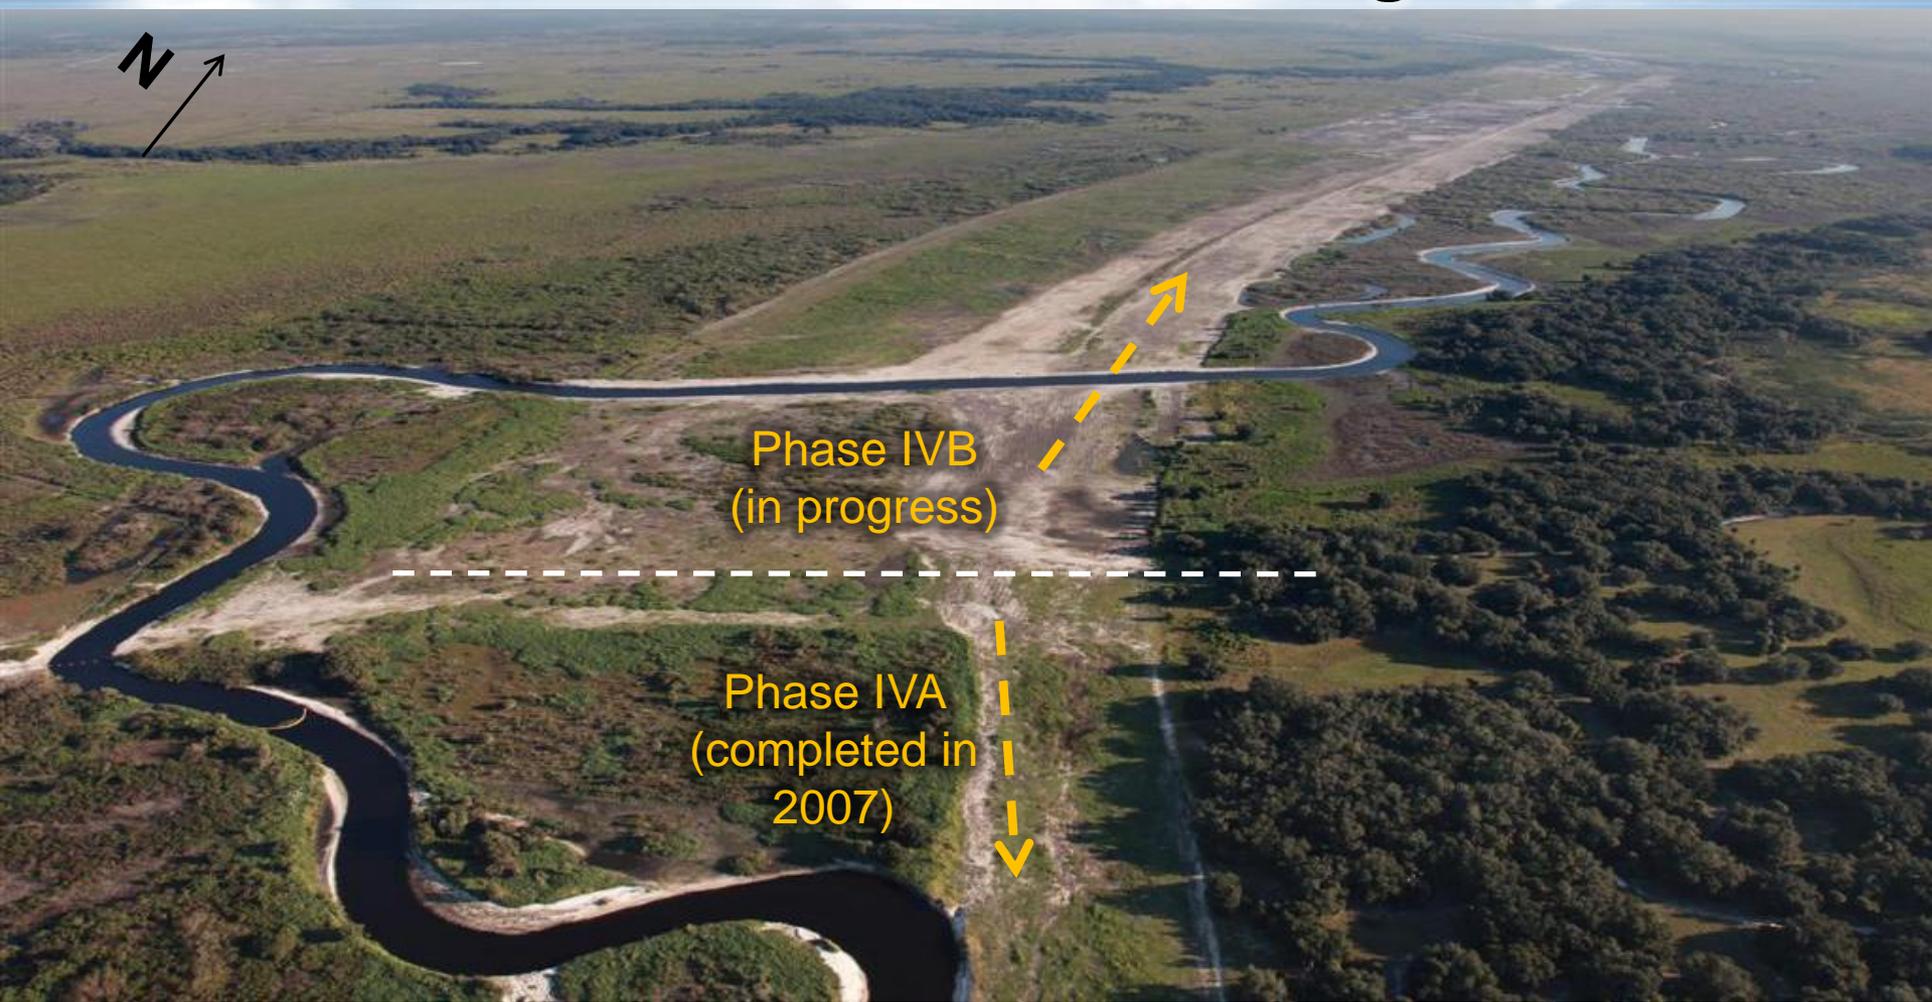
Receding water levels in October-November revealed Phase IVB construction progress that was made over the summer

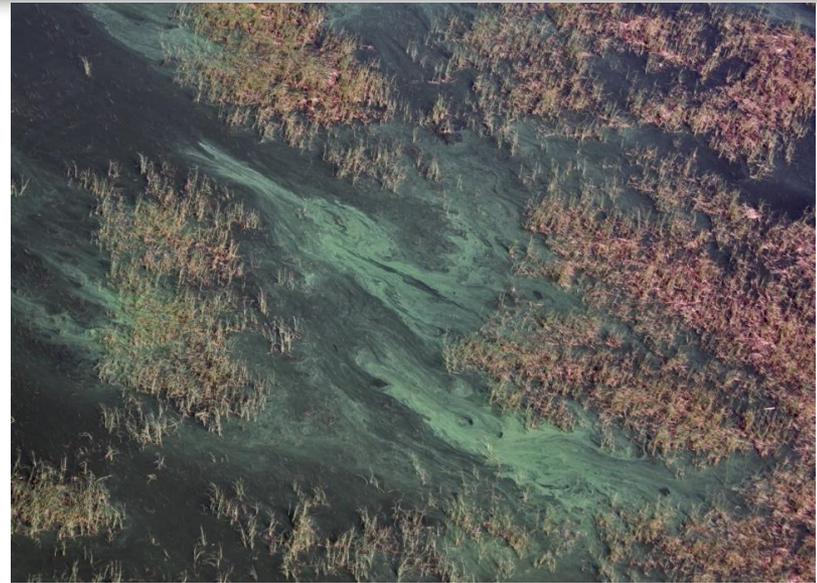
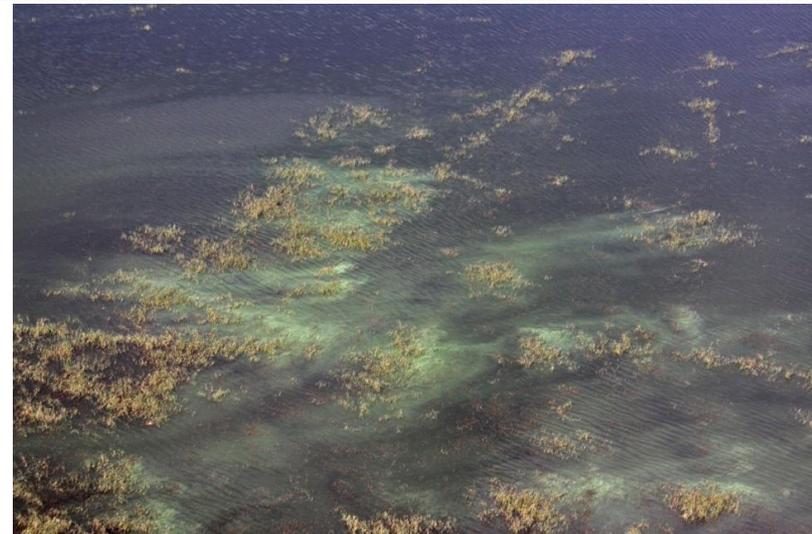
- **Lake stage is 13.65 feet, 0.42 feet lower than a month ago and 0.61 feet lower than a year ago**
- **Moderate bloom conditions on southwestern shore and light bloom conditions on western shore**
- **Total Suspended Solids and Total Phosphorus decreased slightly in last 4 months**

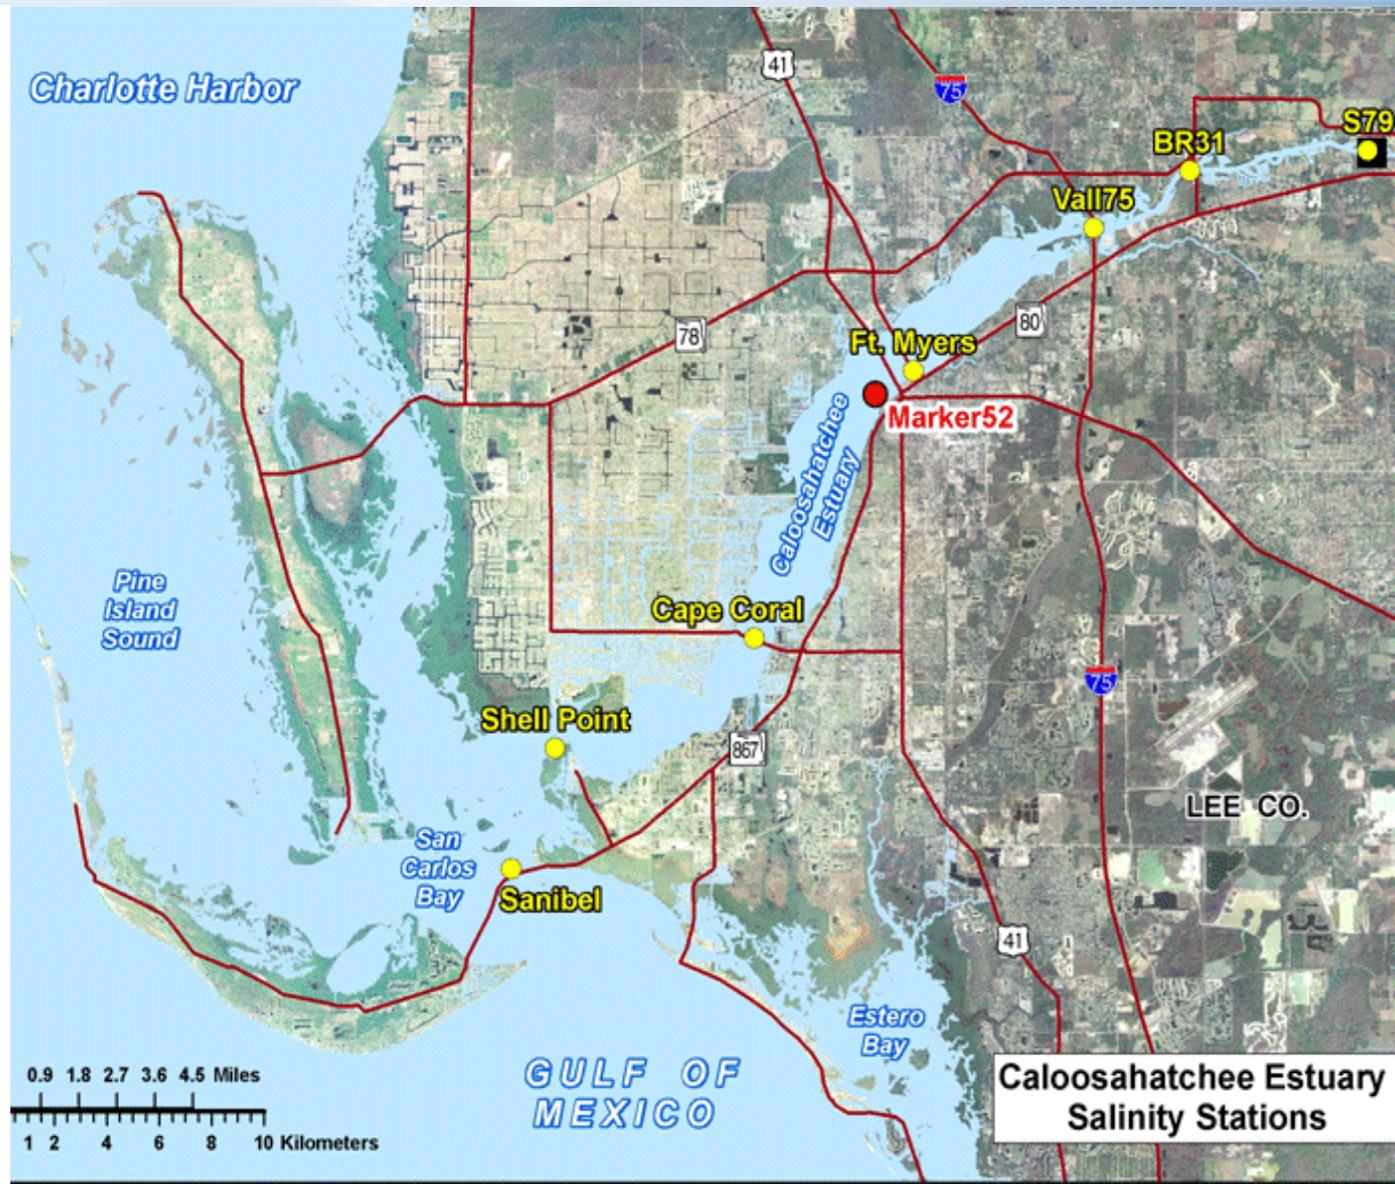
Salinity conditions in the Upper Estuary are poor.

Salinity conditions in the Lower Estuary and San Carlos Bay continue to be good.

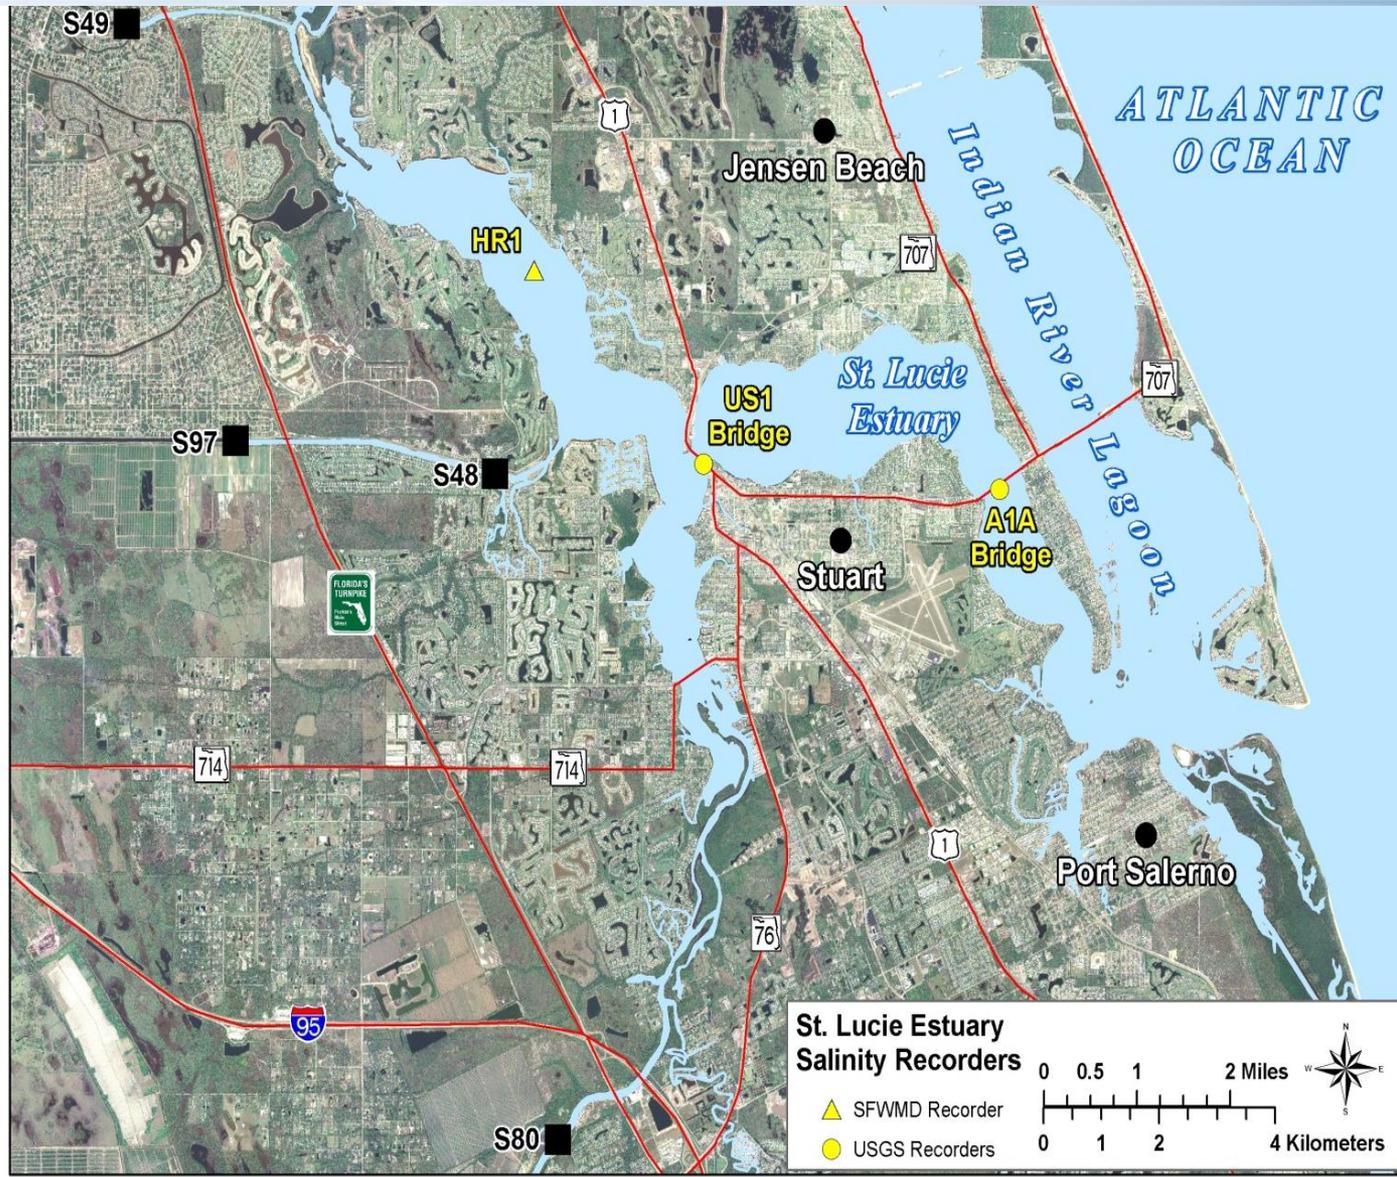
The 30-day average surface salinity at the US-1 Bridge was within the salinity envelope for the entire month of November.

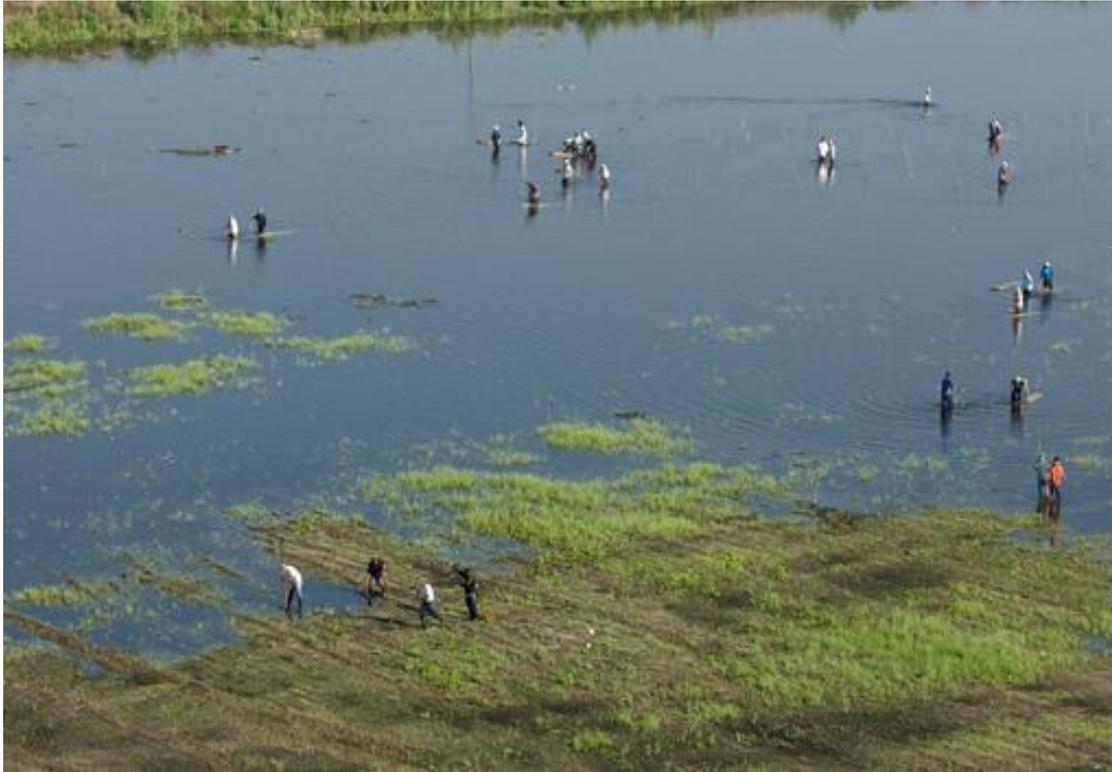
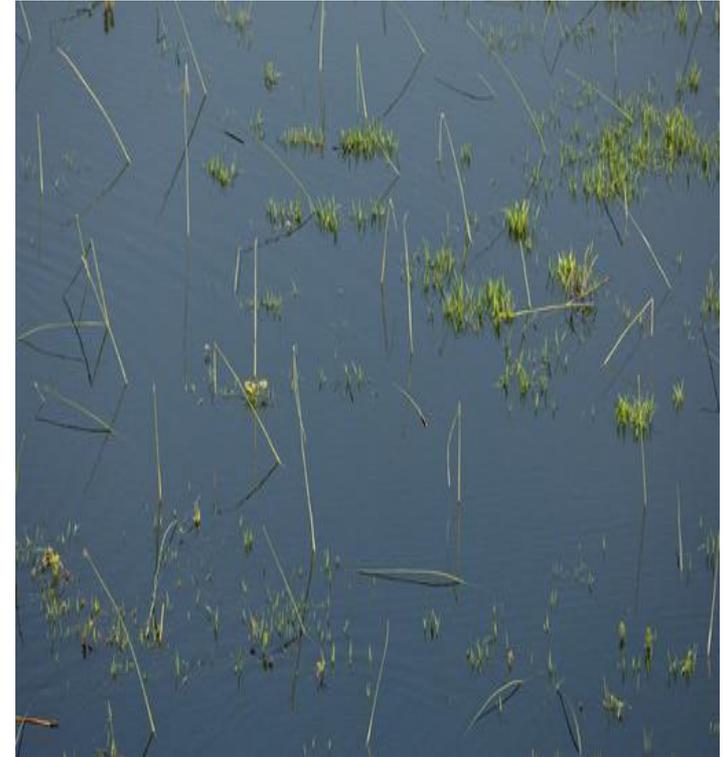
Giant bulrush plants are being tried as alternative vegetation in the STAs particularly for areas with persistent deep water condition.

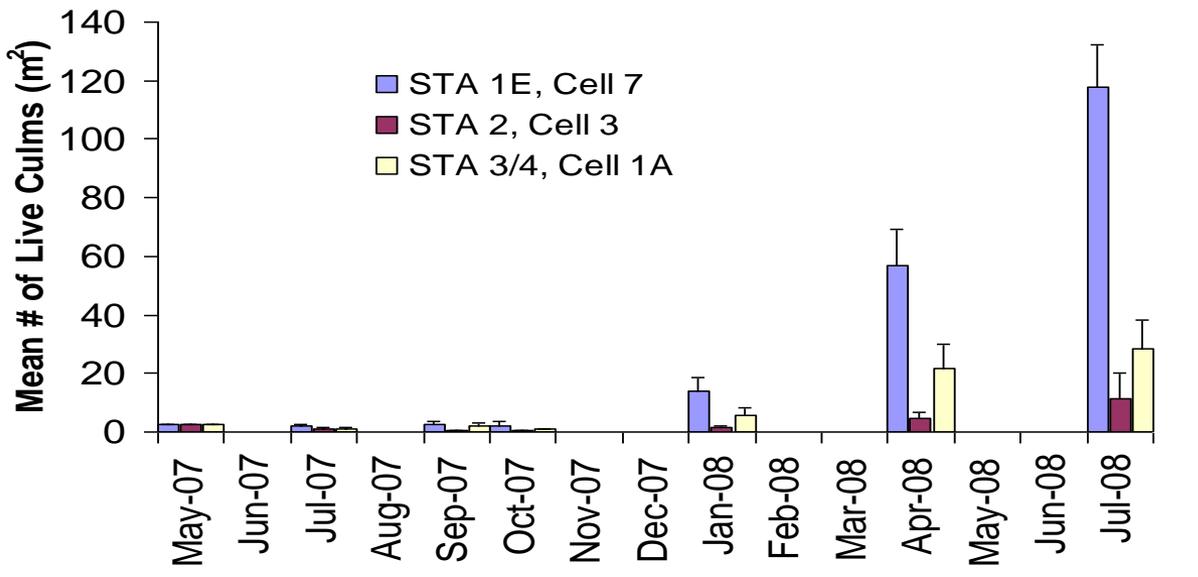
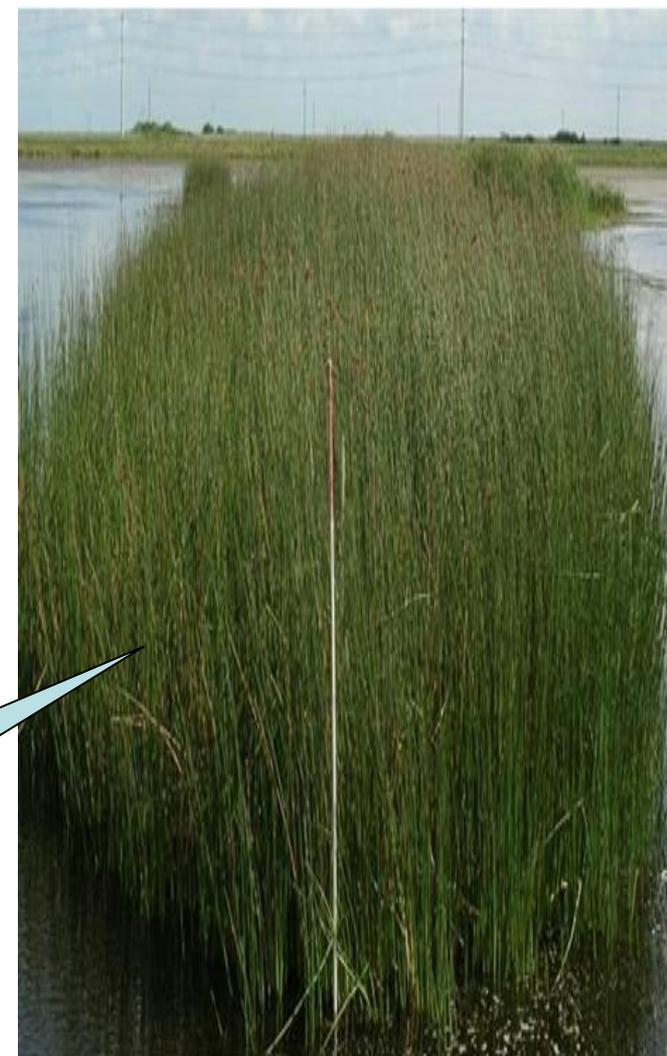
**Bullrush Planted in May 2007 (2.8 culms/m<sup>2</sup>)**

Successful giant bulrush established in STA-1W

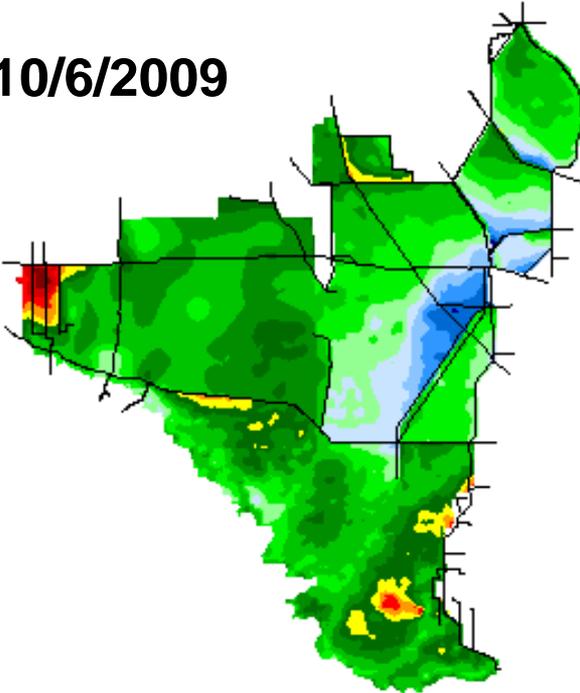
10/6/2009

Water Depth (feet)

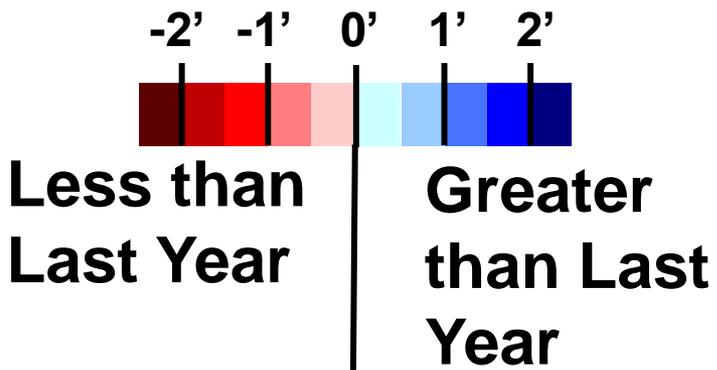
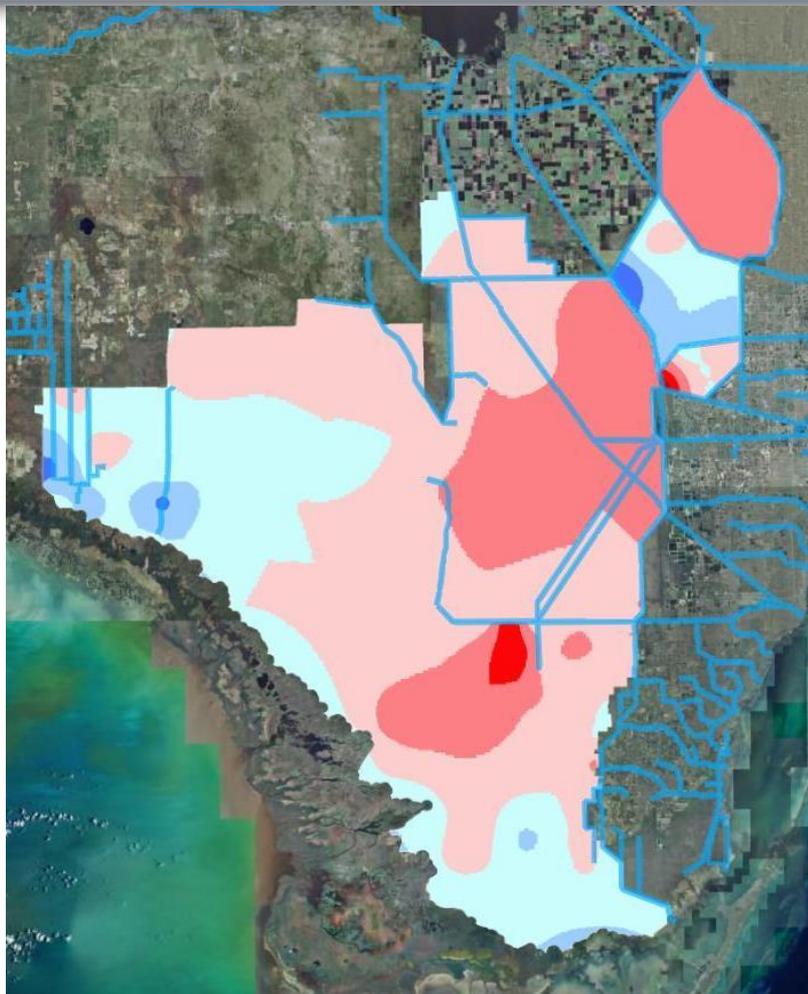
# One Year Water Depth Difference: Dec. 2009 - Dec 2008 (Feet)

South Florida Water Depth  
Assessment Tool (SFWDAT)
