CITY OF STUART DEEP MONITOR WELL REHABILITATION PLAN

Deep Monitor Well Plan August 2, 2012

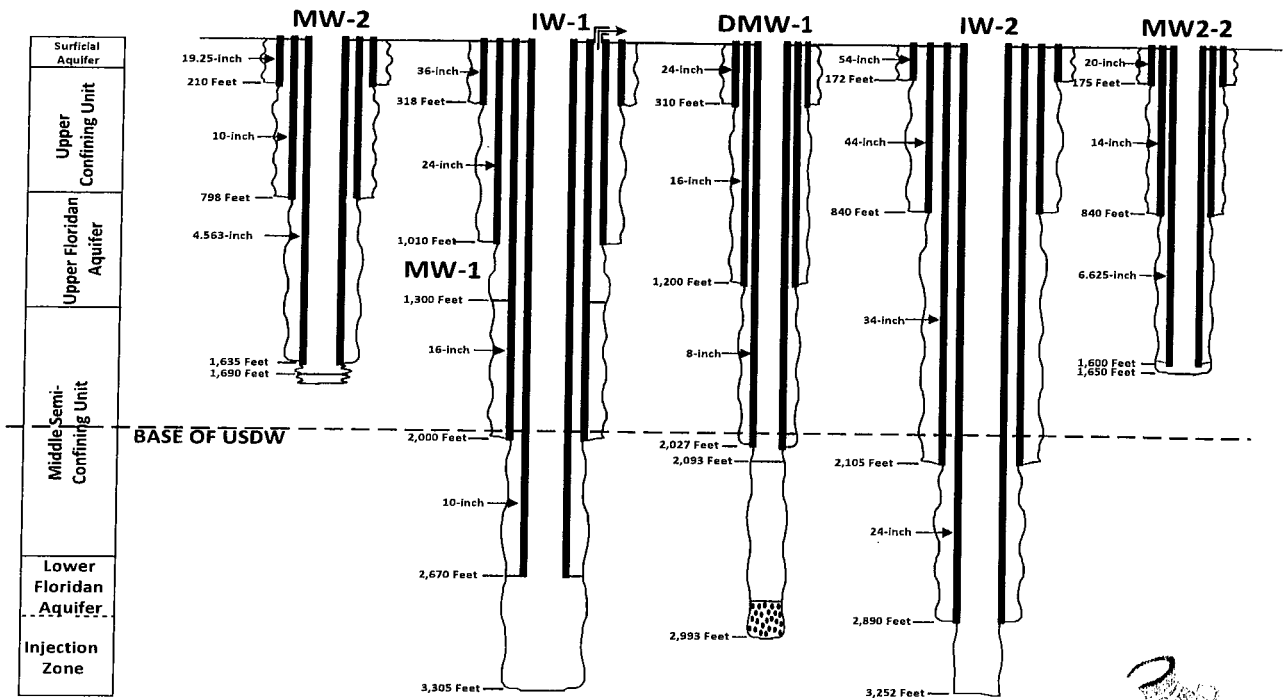
FIGURE 1
CITY OF STUART INJECTION WELL SYSTEM DIAGRAM

Figure 1 represents the reported construction details for the various wells associated with the City's Injection Well System.
