**Project & Lands – Item 4**

**C-43 West Reservoir  
Entrapment Issues  
and Next Steps**

**Project and Lands Committee  
April 14, 2010**

*Jeffrey R. Kivett, P.E., Director  
Engineering Department  
Everglades Restoration and Capital Projects*

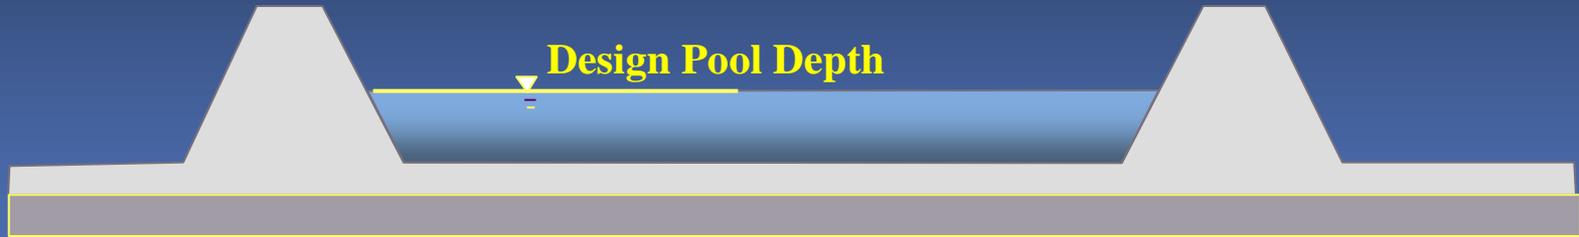
# Design challenges - hurricanes

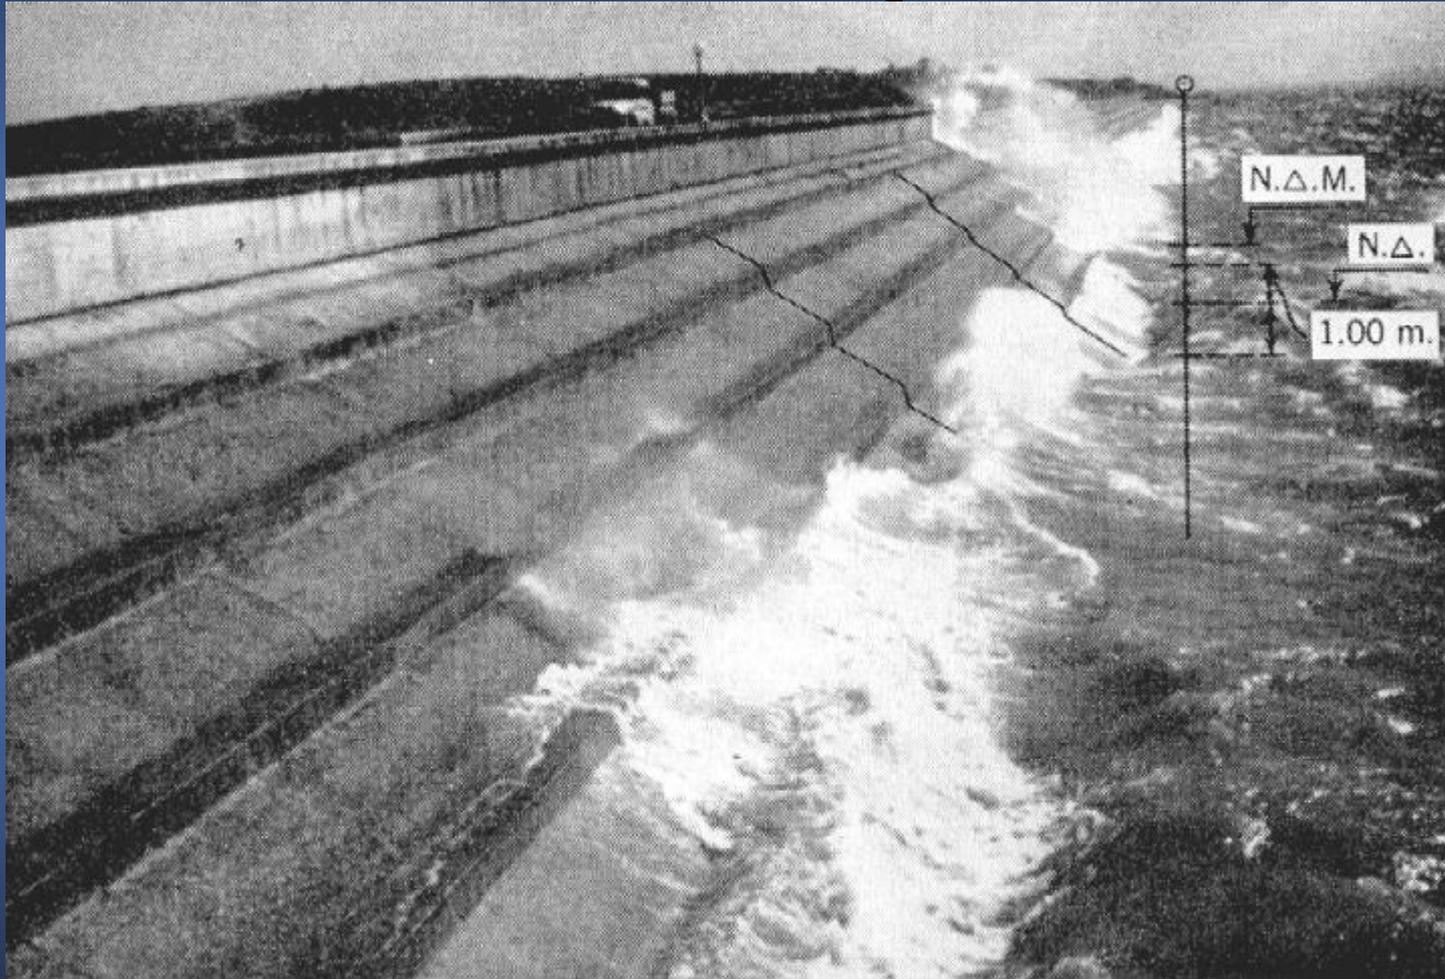
# Wave run-up

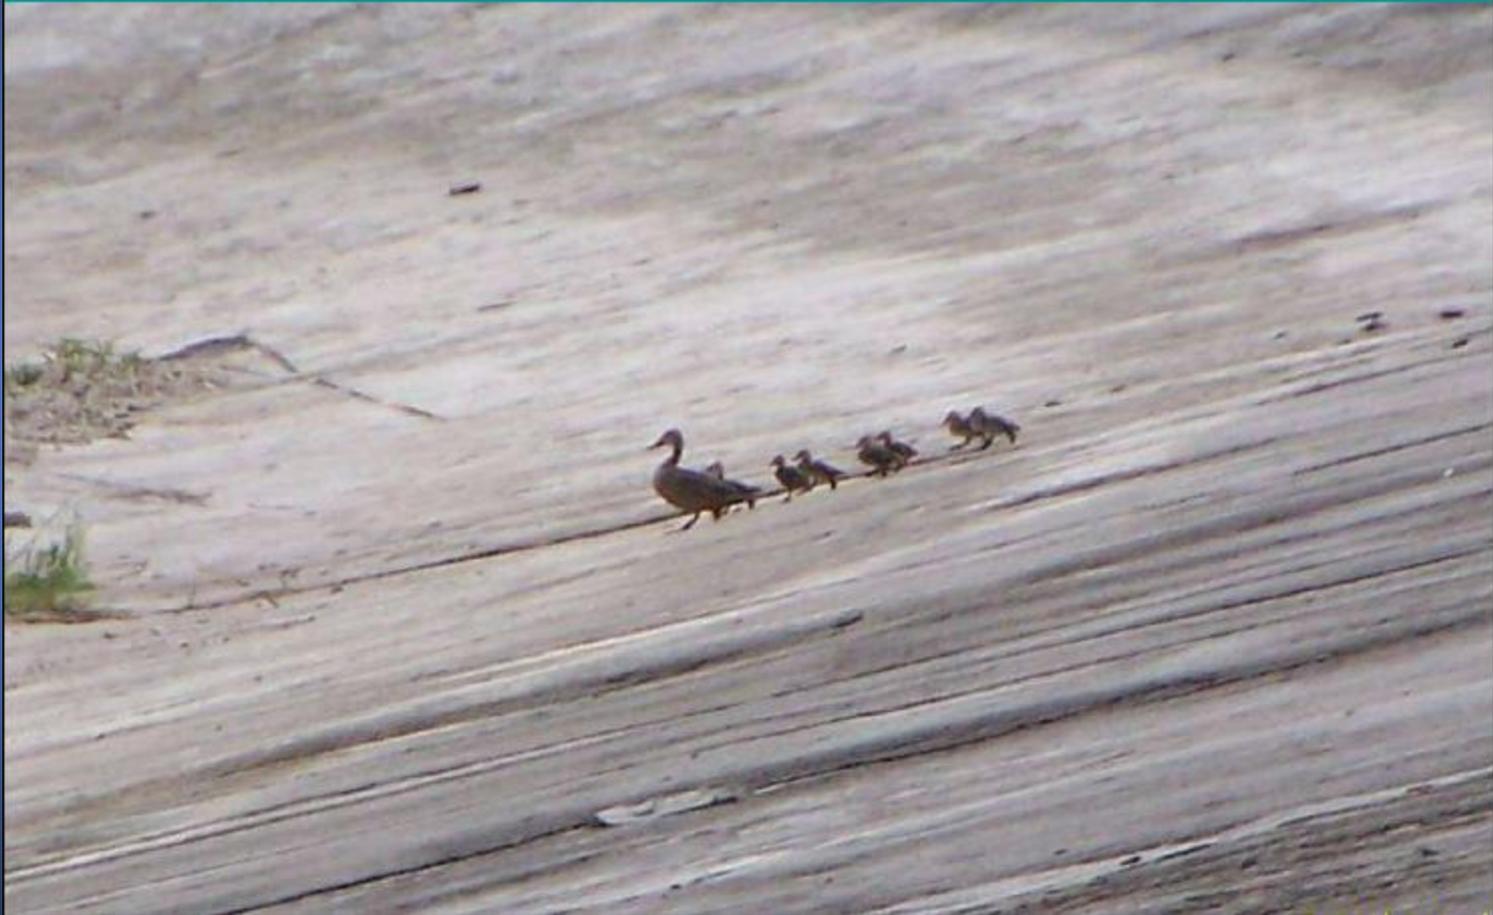
06/24/2008

**Mottle duck brood returns to water  
after failed attempt to leave reservoir**

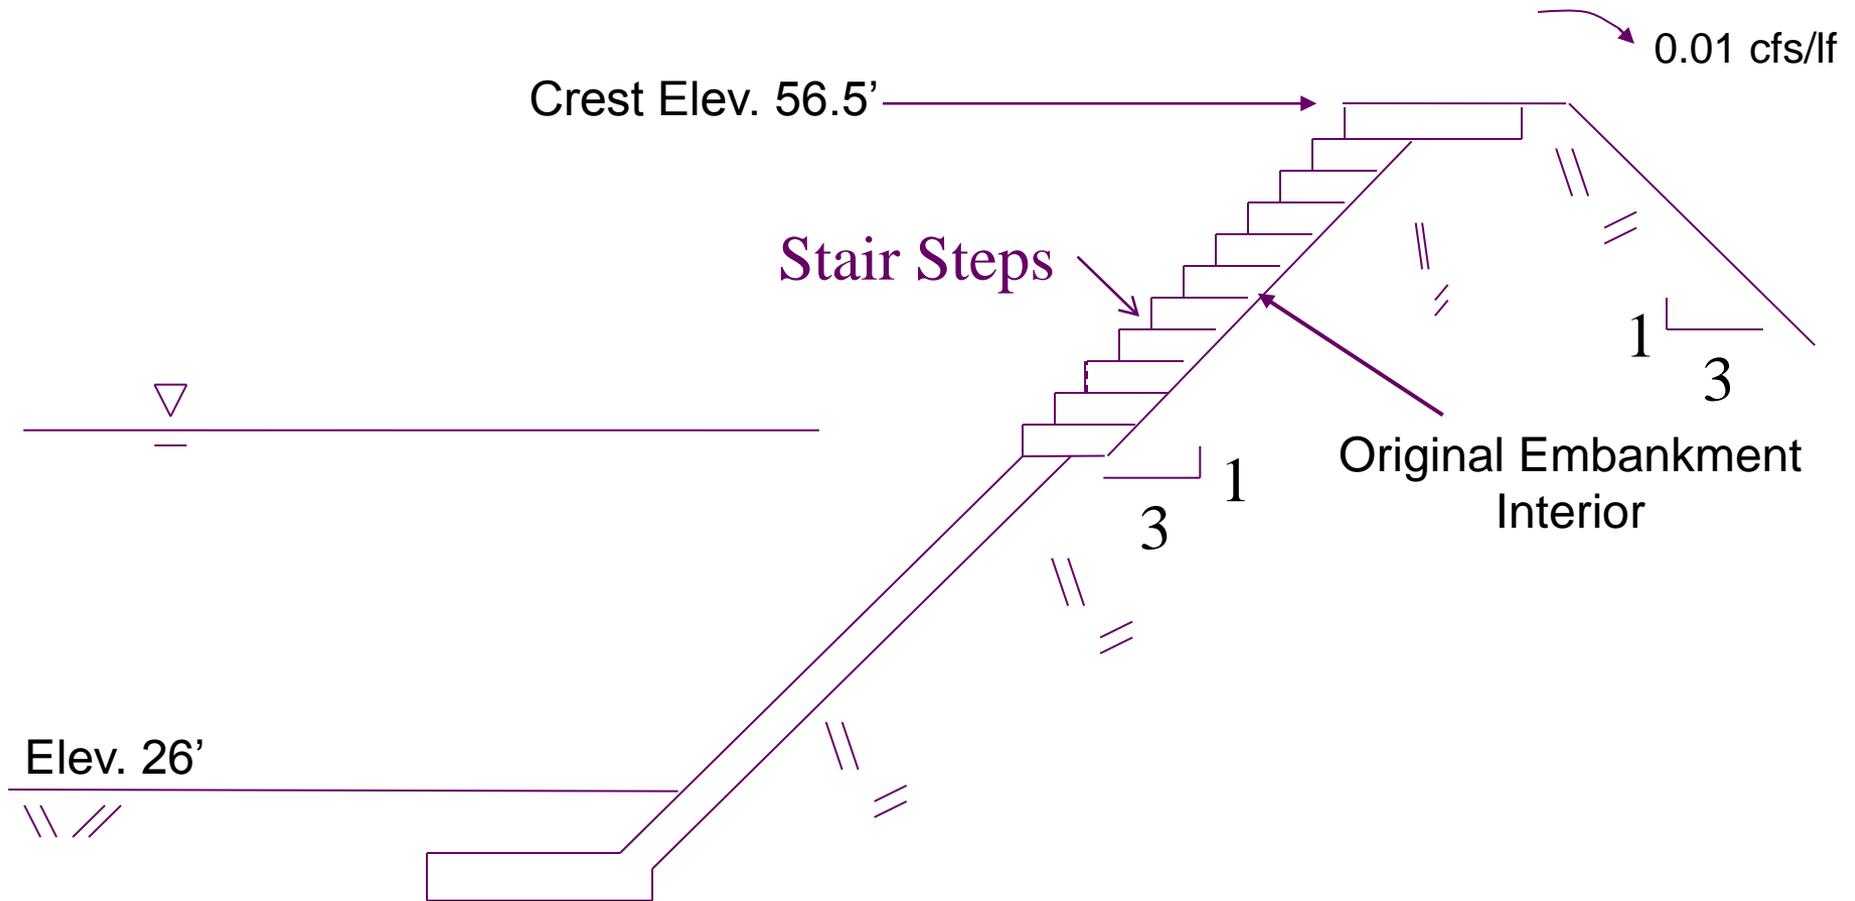
## Current Design – Entrapment

- **Current Status**
  - **South Florida Water Management District completed 100% Design of reservoir in 2007**
  - **Includes stair-step soil cement in the interior for protection**
- **Items for Discussion**
  - **Wildlife entrapment issue**
  - **USACE repackaging of plans and specifications**

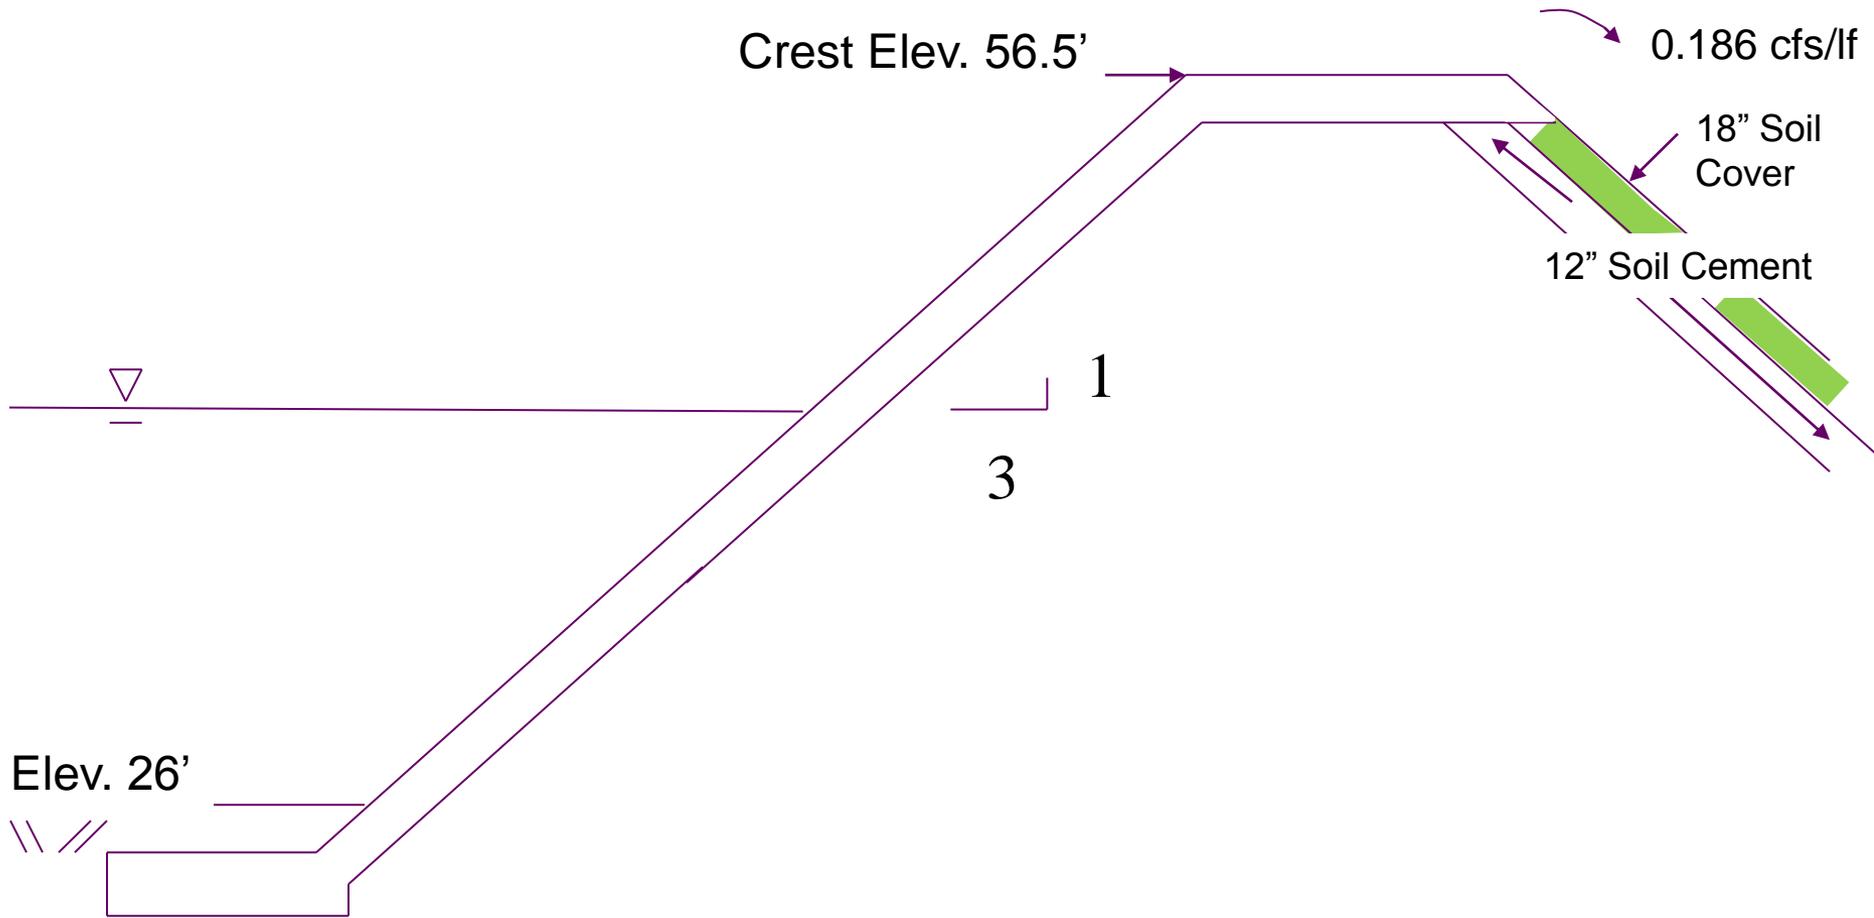
# Full Flat Plate with Increased Overwash – No Entrapment

- USACE is designer of impoundment
- Flat plate with higher over-wash used along embankment between impoundment and refuge (low hazard section)
- Alternative design of wave bench or higher over-wash with downstream protection for embankment along populated area
- Cost projected to be within the project's budget

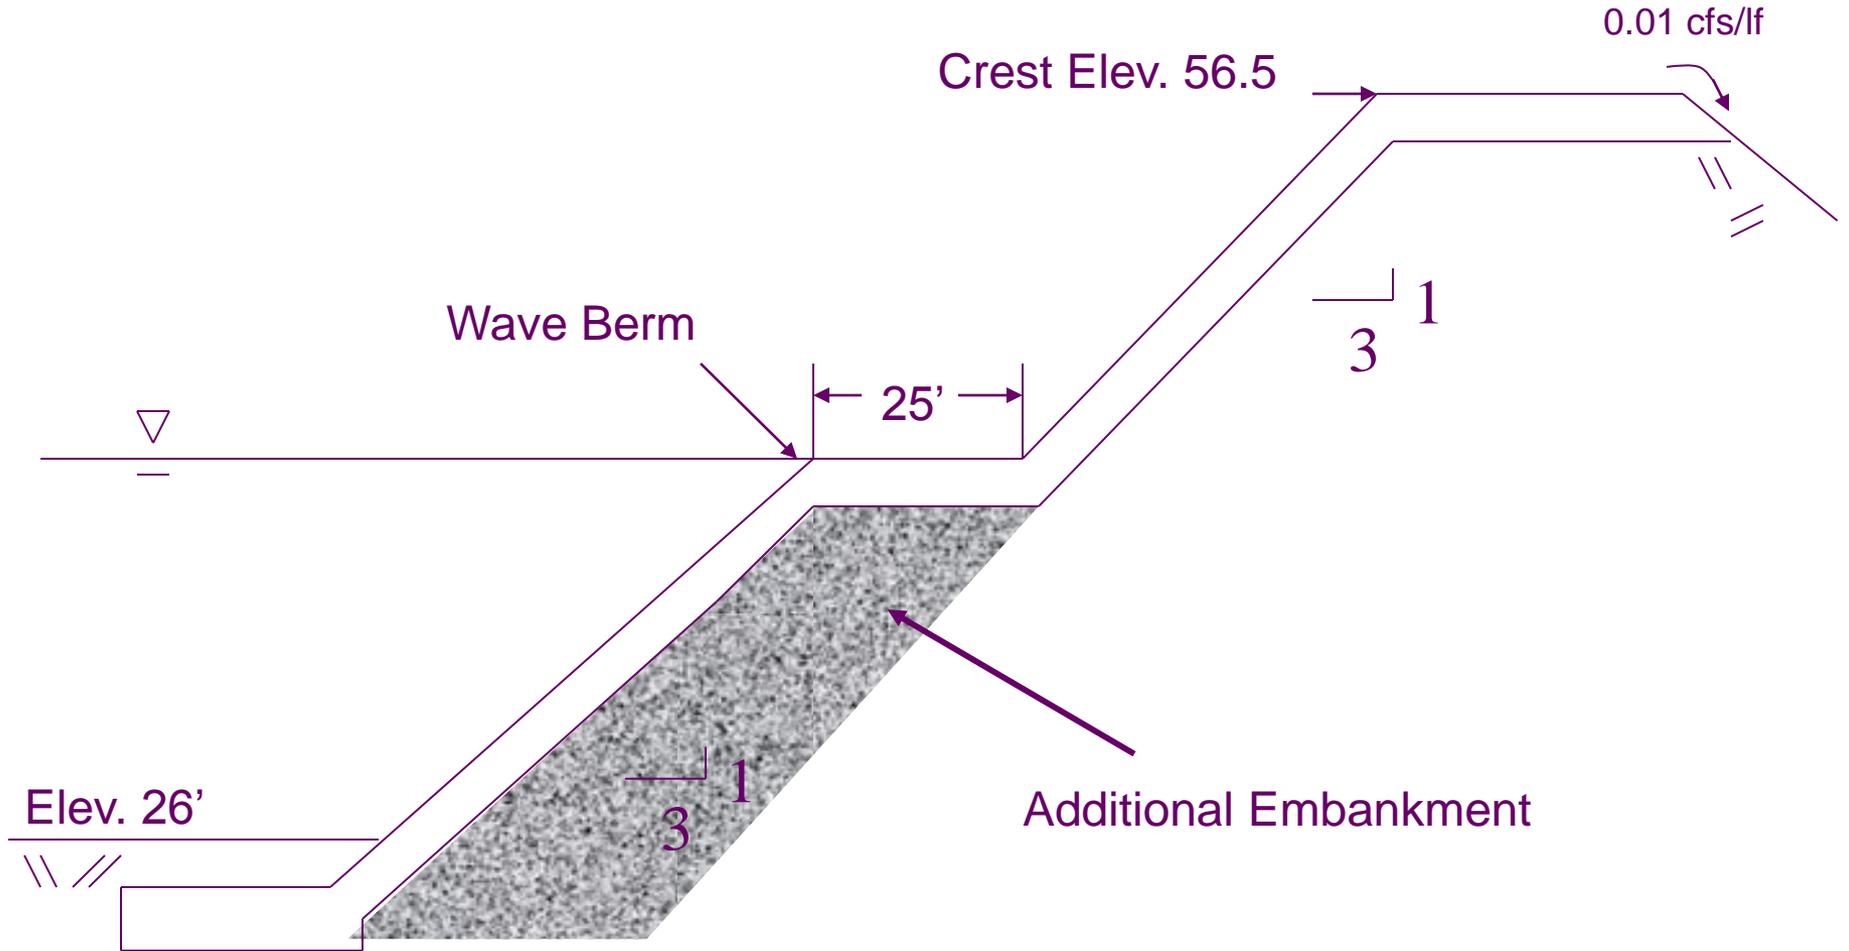
# Flat Plate with 25' Wave Bench – No Entrapment

- USACE is redesigning with wave bench to replace steps
- No entrapment monitoring required by U.S. Fish and Wildlife
- Operation Enhancements
  - Inspection platform inside reservoir
  - Work platform for repairs, if required
    - With steps to access from top (14 at one foot wide )
    - Wave bench provides 25-foot work platform

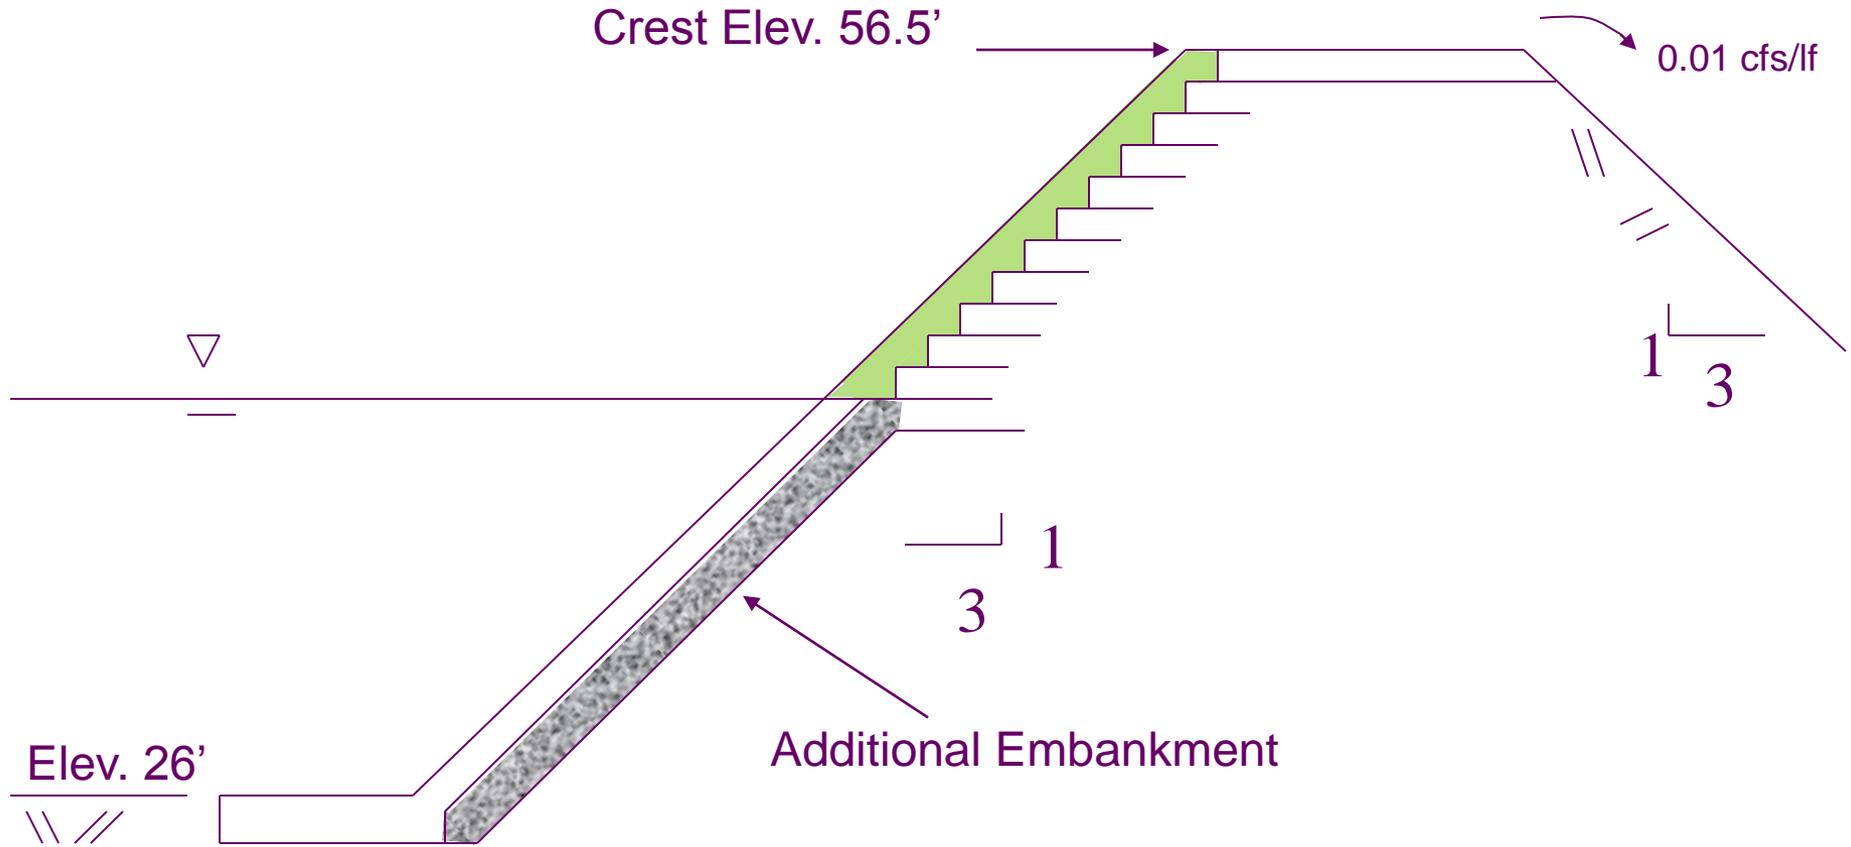
# Stair Step with Vegetation – No Entrapment
