Exhibit B

Cypress Woods Lower Tamiami Aquifer Construction/Testing Summary

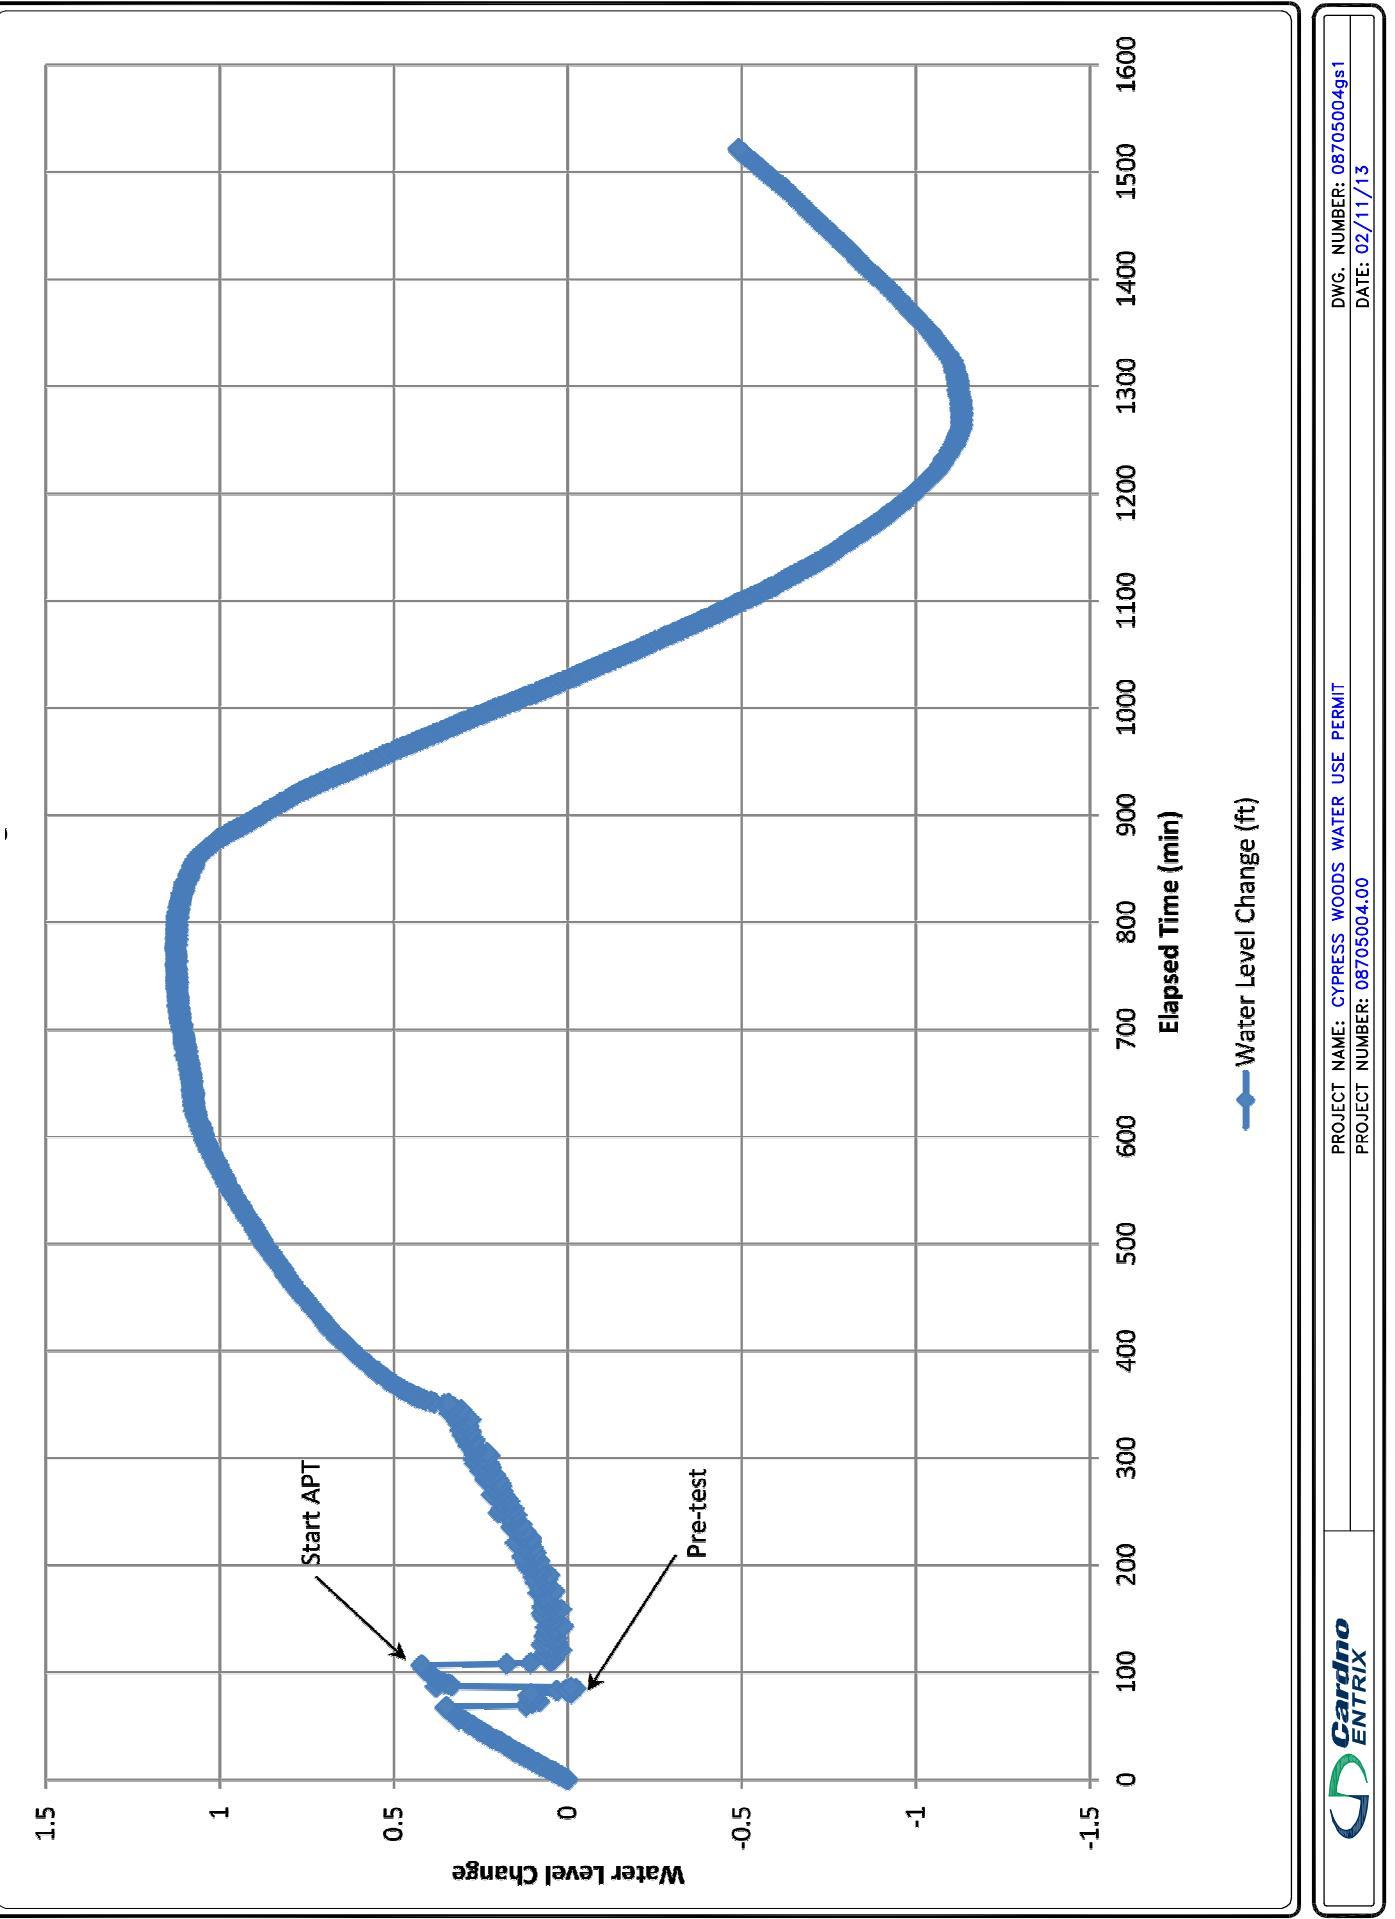
FIGURE 1. CYPRESS WOODS LOWER TAMIAMI AQUIFER APT WATER LEVEL CHANGE.

As was noted during the specific capacity testing, water levels began to rise during the pumpage. Water levels fluctuated throughout the duration of the test. The fluctuating water levels are indicative of off-site usage in the aquifer. These off site influences were greater than the drawdown generated by the pumpage in the Cypress Wood test/production well. A plot the water levels measured during the testing is provided as Figure 1.

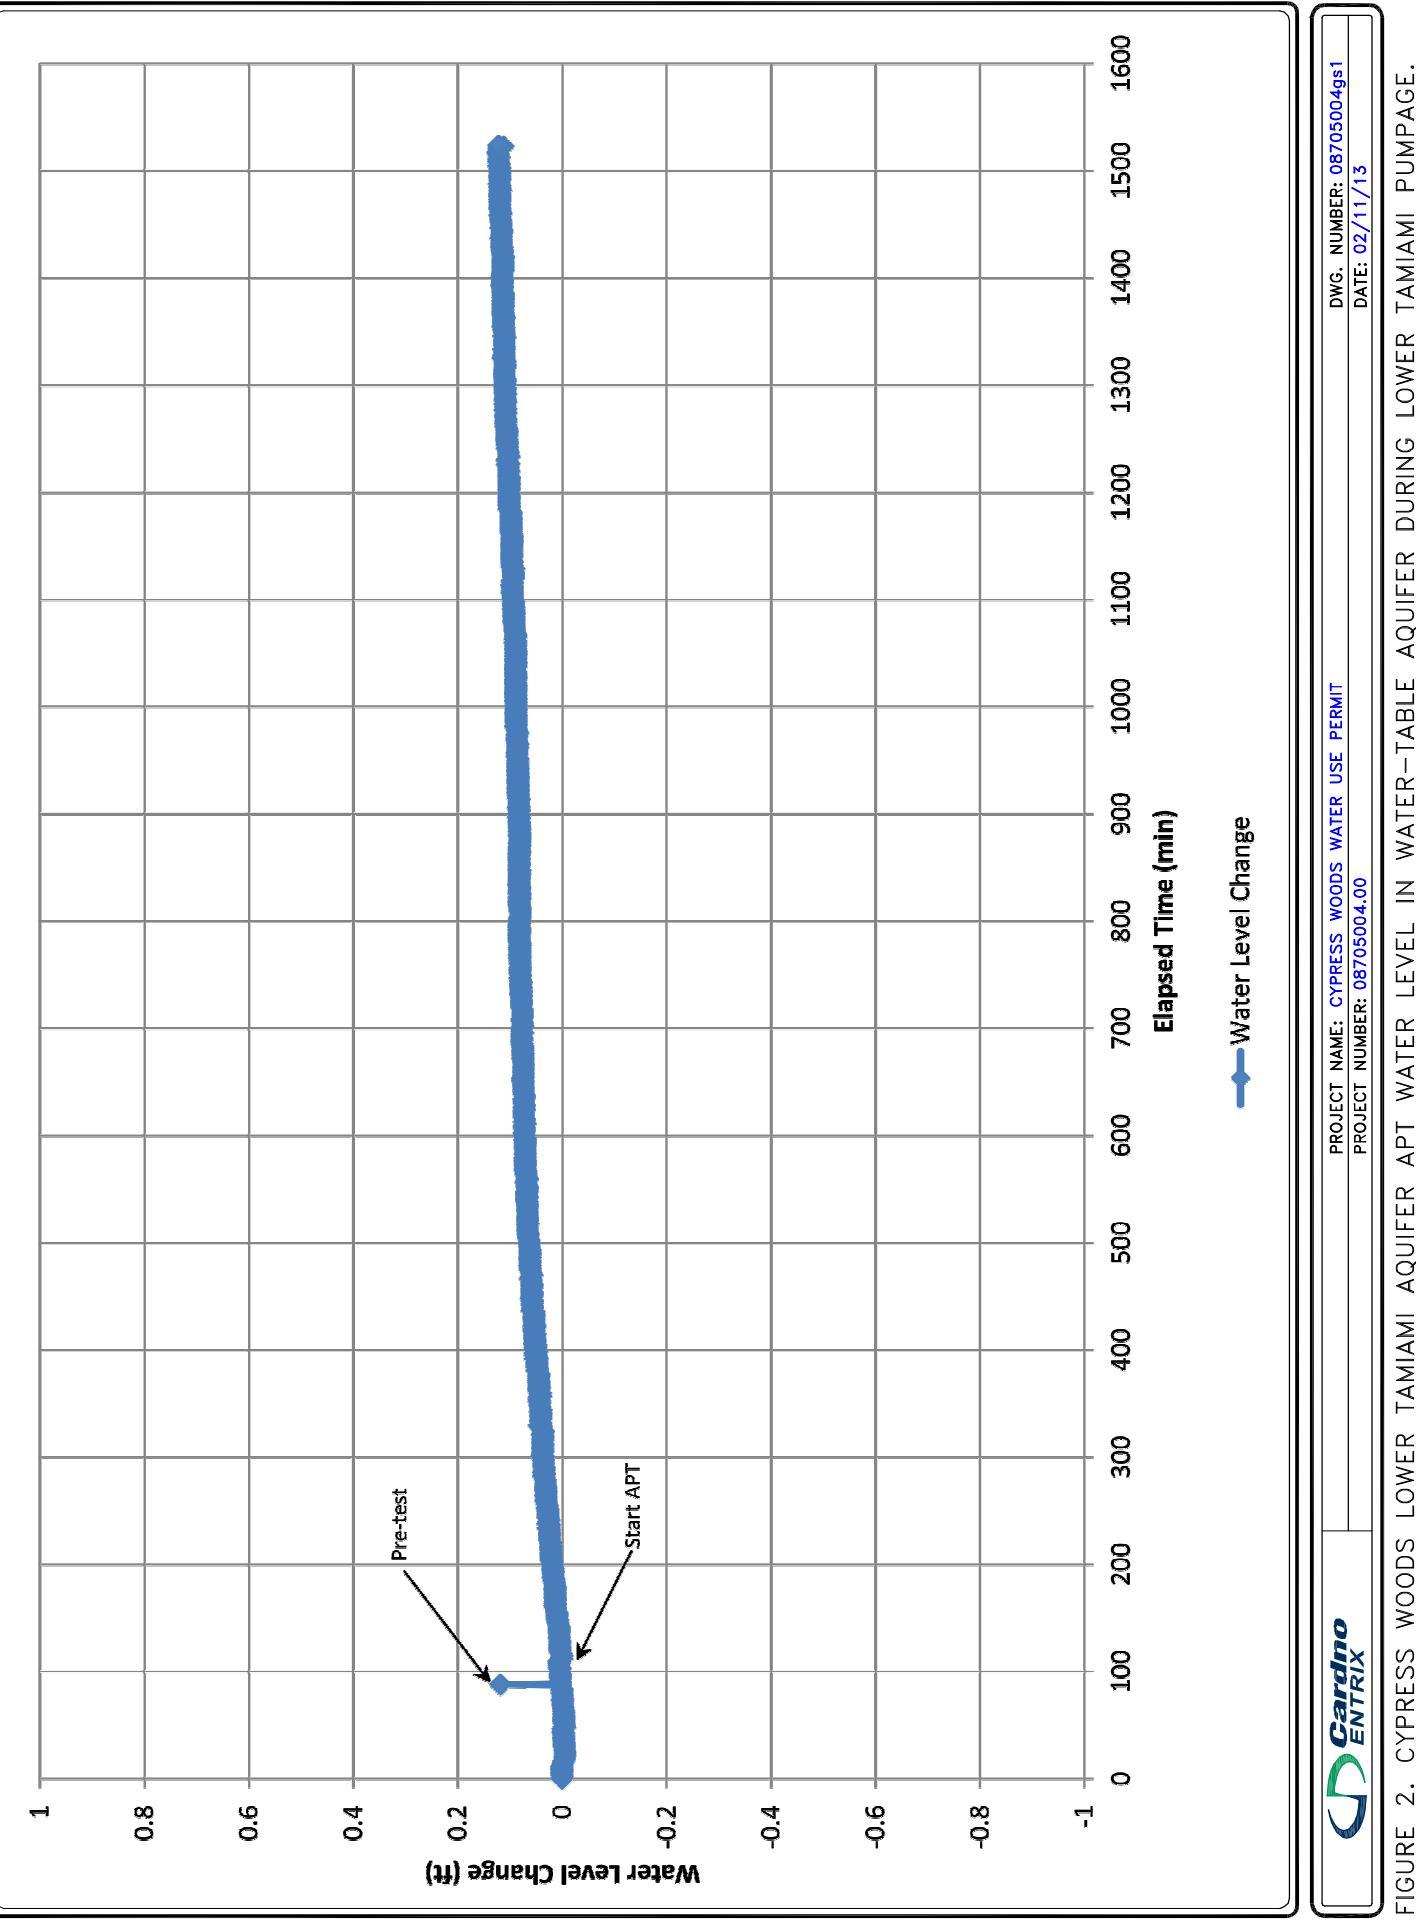
FIGURE 2. CYPRESS WOODS LOWER TAMIAMI AQUIFER APT WATER LEVEL IN WATER-TABLE AQUIFER DURING LOWER TAMIAMI PUMPAGE.

Water levels were also measured during the APT in the previously completed water-table aquifer well located adjacent to the Lower Tamiami production well. No drawdown was noted in the water-table aquifer well during the testing. Water levels in the water-table actually increased gradually throughout the testing. A plot of the water levels measured in the water-table during the testing is provided as Figure 2.

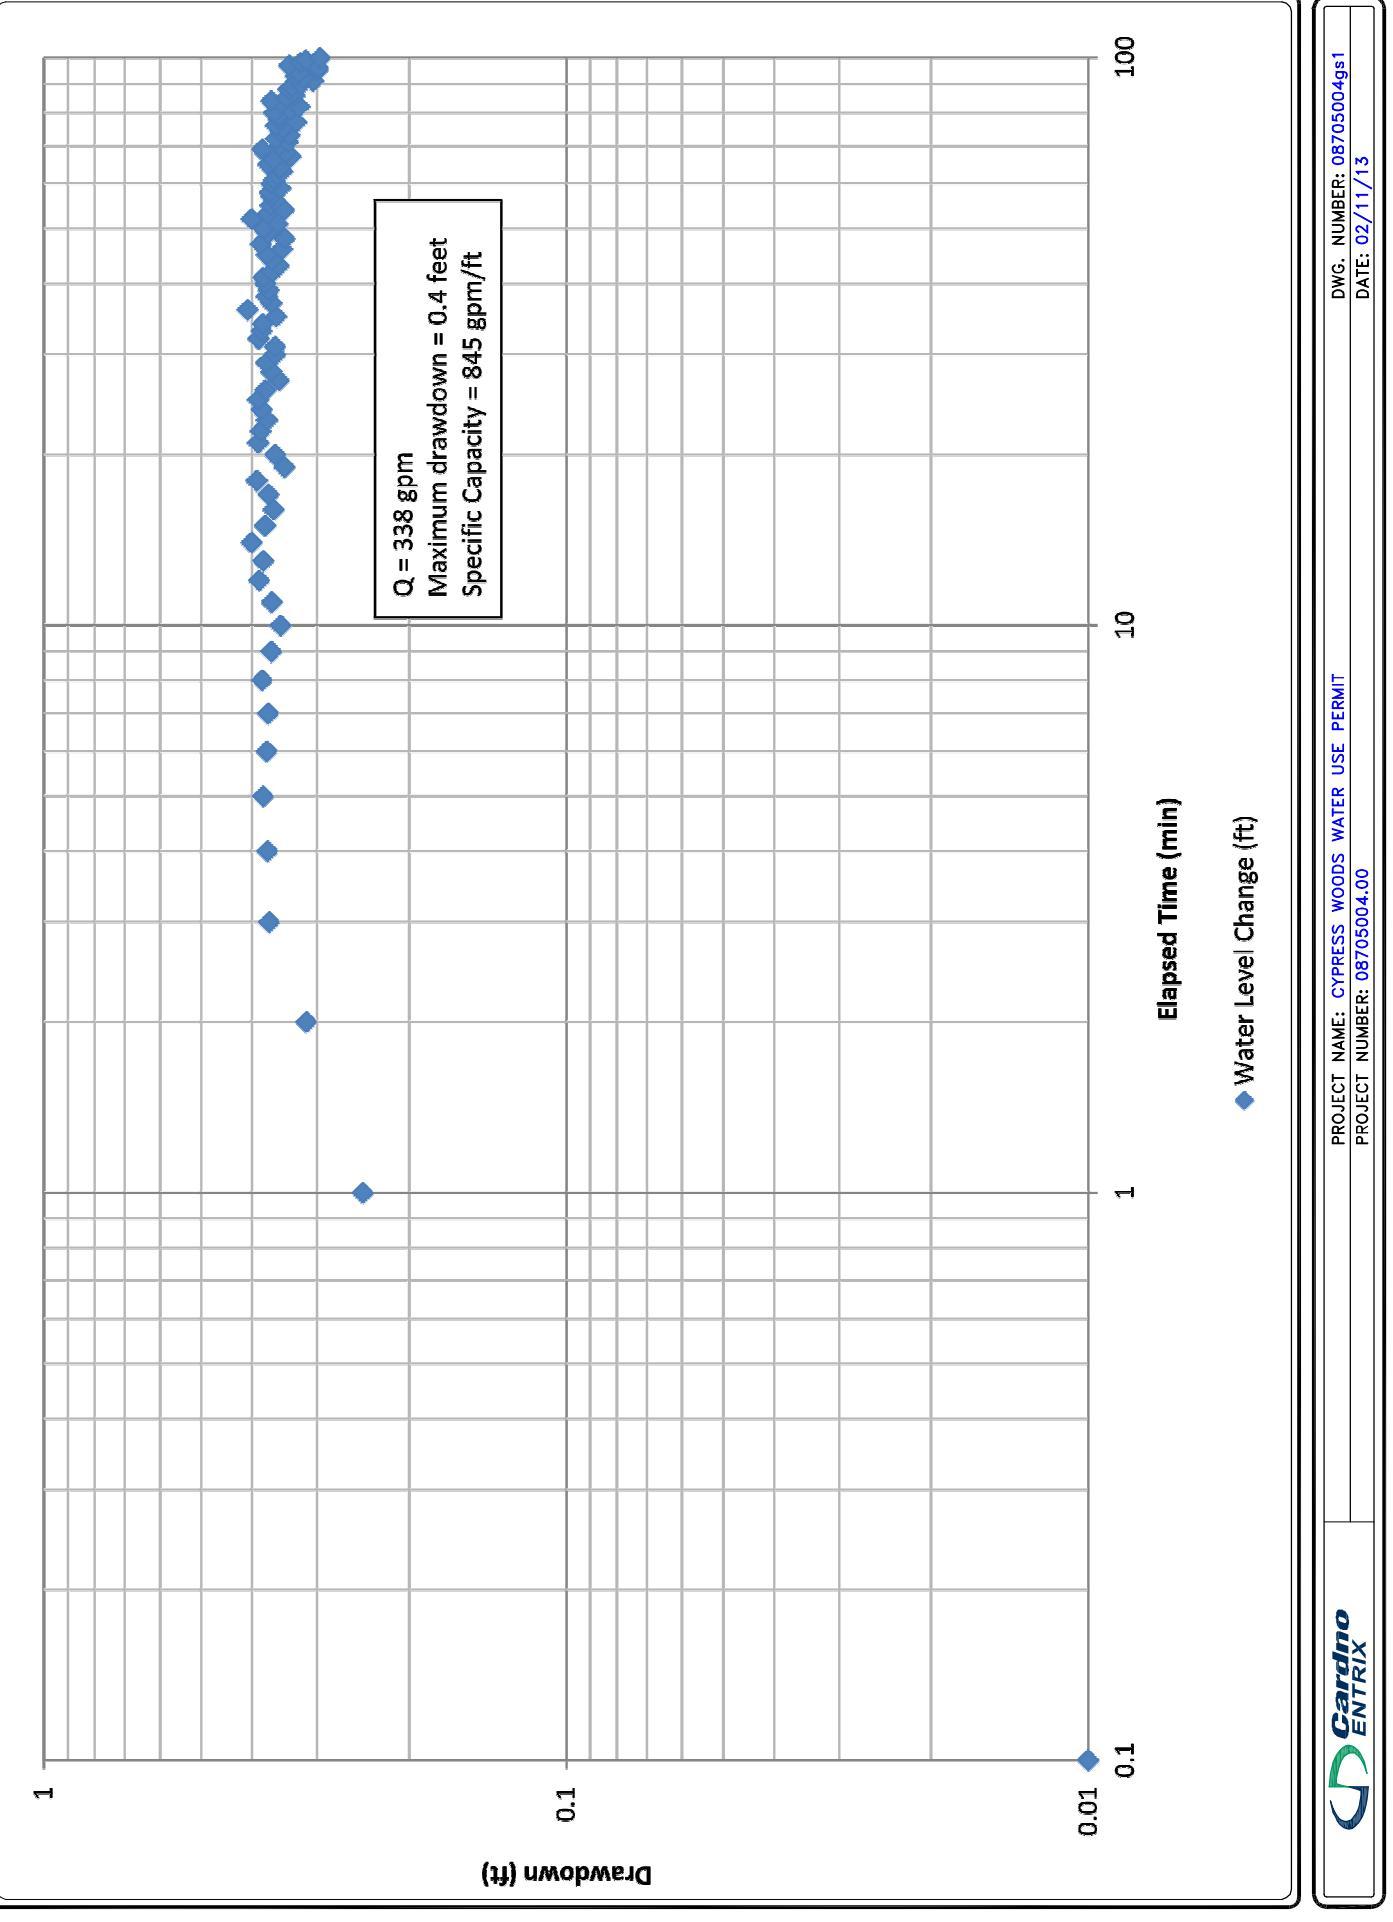
FIGURE 3. CYPRESS WOODS LOWER TAMIAMI AQUIFER APT WATER LEVEL DRAWDOWN.

The off-site influences in the Lower Tamiami Aquifer made the evaluation of the aquifer parameters difficult. However, the influence of off-site pumpage was gradual and the data from the first 100 minutes of the APT were plotted (Figure 3). The quick drawdown response and water level stabilization in the well, made curve matching analyses problematic; however, a specific capacity could be derived from the

drawdown. The maximum measured drawdown of 0.4 feet at a pumping rate of 338 gpm resulted in a calculated specific capacity of 845 gpm/ft.

The specific capacities measured during the initial well testing and during the APT were used to estimate the Lower Tamiami Aquifer transmissivity. Transmissivity (measured in gpm/ft) can be estimated by multiplying the specific capacity by a factor between 1,500 and 2,000. Based on this relationship, the estimated Lower Tamiami Aquifer transmissivity ranges from 1.1 million gpm/ft up to 1.69 million gpm/ft. Based on the testing, it is evident that the Lower Tamiami Aquifer has a high transmissivity. However, due to the off-site influences, data from other nearby APTs need to be utilized in determining the aquifer parameters to be used in computer impact modeling.
