Lake Okeechobee and the Herbert Hoover Dike

August 2006

Facts & Information

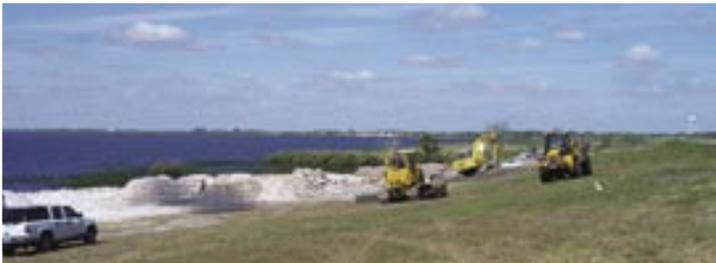
Assembled gabions and rock piles for repairs.

Stored in different areas around the lake are sandbags, stone, rock and other materials that can be used to make repairs or strengthen areas that may have become eroded by the force of hurricane-driven waves.

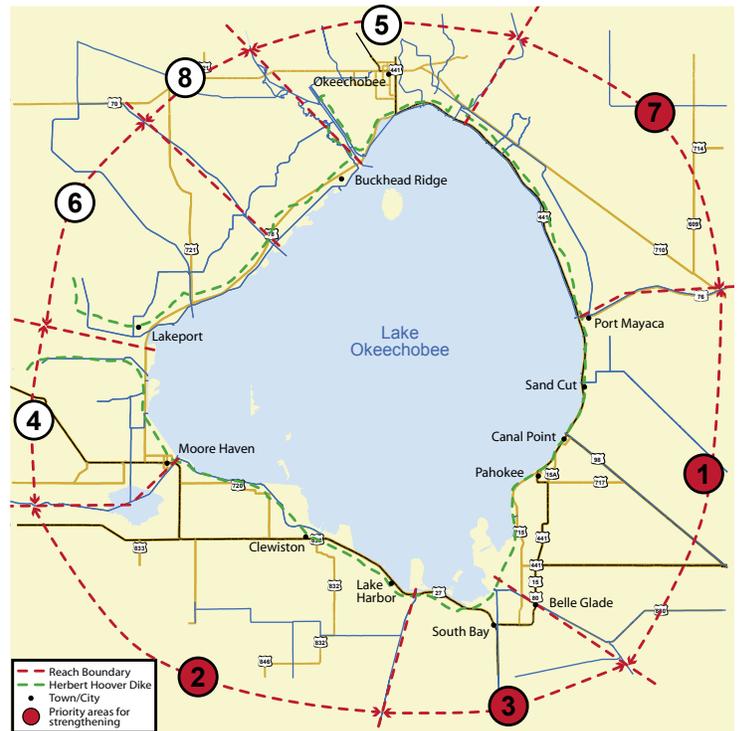
HHD rehabilitation reach boundaries identifying reaches 1, 2, 3 and 7 as the priority areas for strengthening.

Analysis has shown that we can make the Herbert Hoover Dike stronger in some areas that are experiencing higher levels of seepage. There are eight areas of the dike where improvements such as internal concrete walls will be constructed to hold back the water that seeps through and erodes the dike. The first part of this project consists of 4.6 miles from Port Mayaca south along to Sand Cut. Construction in this area began in December 2005.
