Appendix 4-2: Annual Permit Report for the Taylor Creek Stormwater Treatment Area

Permit Report (May 1, 2012–April 30, 2013)
Permit Number: 0194485

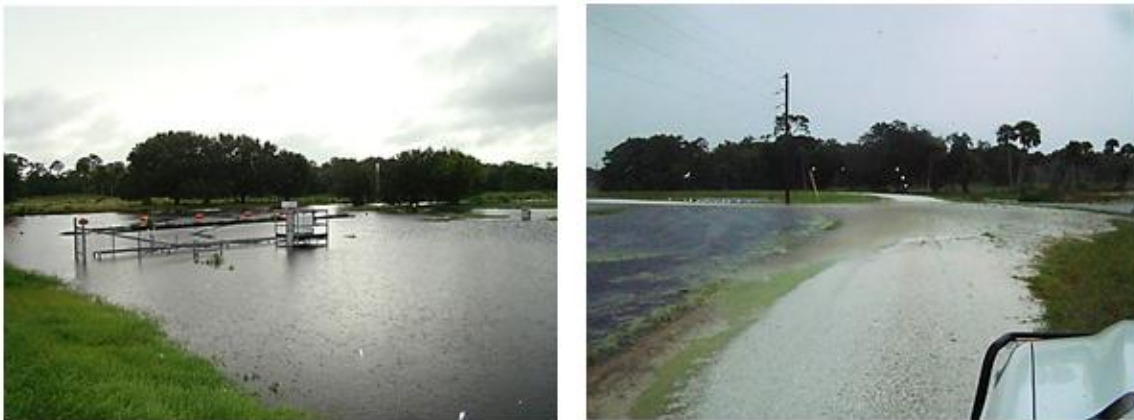
Figure 2. Inaccessible water quality monitoring station (left) and sheet flow into the stormwater treatment area (STA) from adjacent property (right) due to high water levels in Taylor Creek.

The TC-STA followed normal operations during the first six months of WY2013. Two of the four 6-cubic feet per second (cfs) pumps were operated continuously, except for a few days in June 2012. During this period, pumping operation was temporarily suspended for the repair and subsequent relocation of the damaged headwater stilling well, from the in-ground well on the other side of the levee to its current location adjacent to the water quality monitoring platform at S-390. Also during this time, the maintenance dredging of a small sandbar that had formed in the creek near the S-390 storage pool was completed. Pumps were turned off again on August 25, 2012, in anticipation of Tropical Storm Isaac. The storm caused flooding in and around the STA (**Figure 2**) but did not produce any impacts of structural or operational significance.

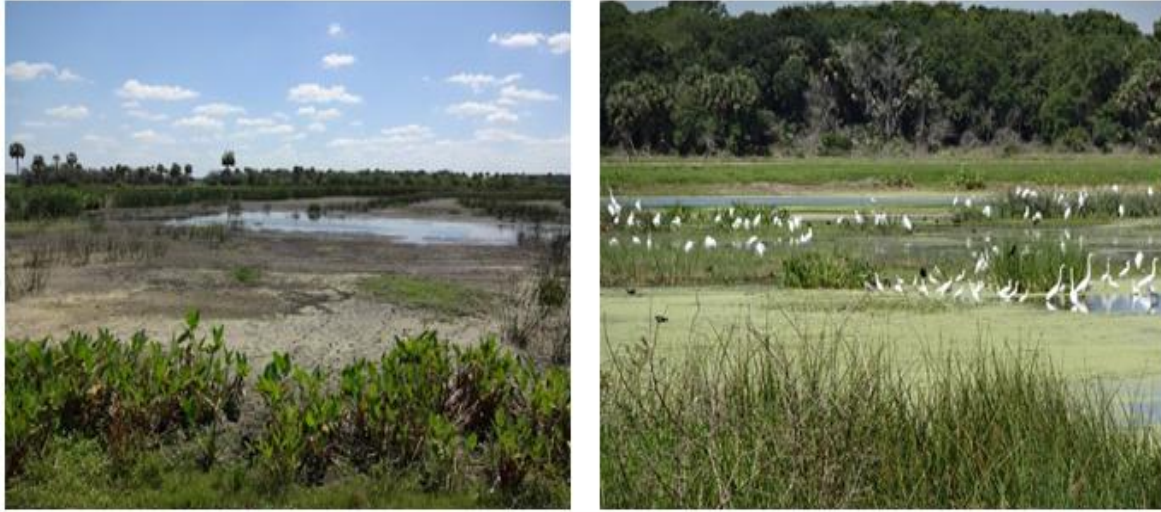
Figure 4. Exposed wetland soils in the northern section of the STA (left) and hundreds of birds actively foraging in Cell 1 of the STA (right) during drawdown.

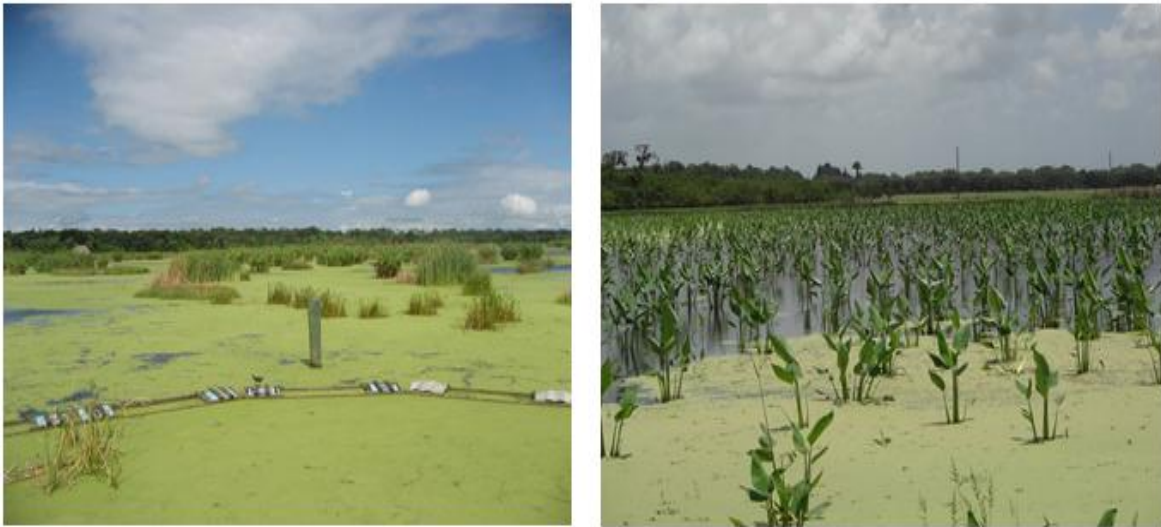
Figure 5. Hydrilla-dominated areas of Cell 1 looking north before (left) and after (right) plantings.

Prior to WY2013, emergent vegetation covered only about 20 percent of Cell 1, with the remainder of the cell being dominated by dense beds of submerged aquatic vegetation, including hydrilla (*H. verticillata*) and coontail (*Ceratophyllum demersum*). To increase emergent vegetation coverage in Cell 1, several strips of bulrush and alligator flag were initially planted in November 2012, using donor plants from the existing stands within the STA. Additional plantings were conducted in both cells of the STA in May 2013, as part of the drawdown activities. During drawdown, water levels in the STA were incrementally lowered over a 30-day period. This created conditions conducive to plantings and natural recruitment of emergents in portions of the STA where there was little or no wetland vegetation and associated permanent P removal mechanisms. The STA was home to hundreds of birds during this period, and provided excellent opportunities for wildlife viewing and photography (**Figure 4**). Currently, emergents cover about 75 percent of Cell 1 (**Figure 5**).

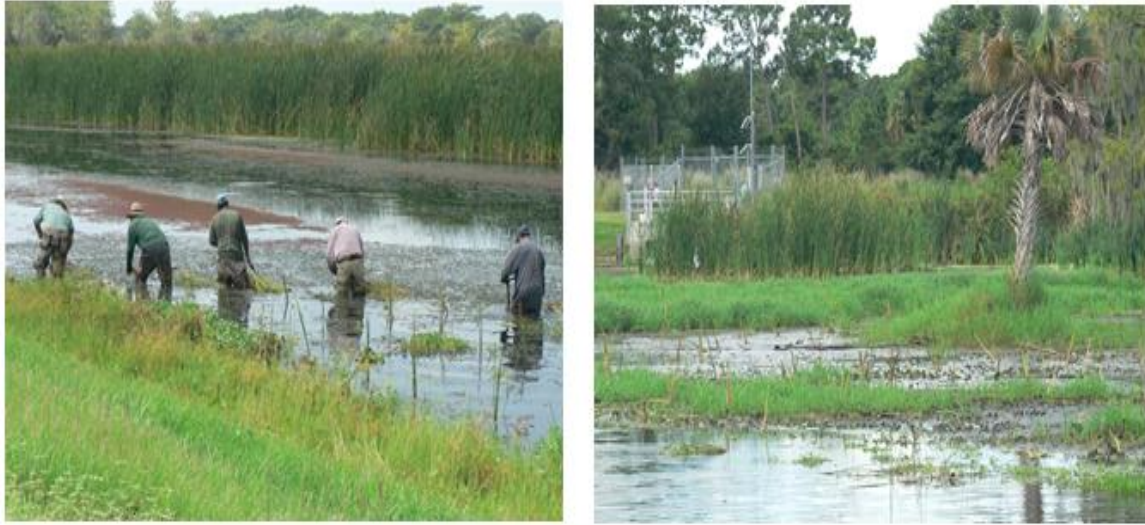
Figure 6. Bulrush planting in the northeastern portion Cell 2 (left) and transplants of alligator flag in the south end near outflow (right).

The plantings conducted in Cell 2 of the STA in November 2012 and May 2013, were part of an effort to eliminate the hydraulic circuits along channels that flank and meander through the emergent marsh and lead to the cypress stand at the outflow (**Figure 6**). Strategic plantings of bulrush and alligator flag in these channels should enhance P uptake and help contain growth of water lettuce that occurs within the cypress stand, which has made it inaccessible to airboats that are needed for herbicide control efforts.

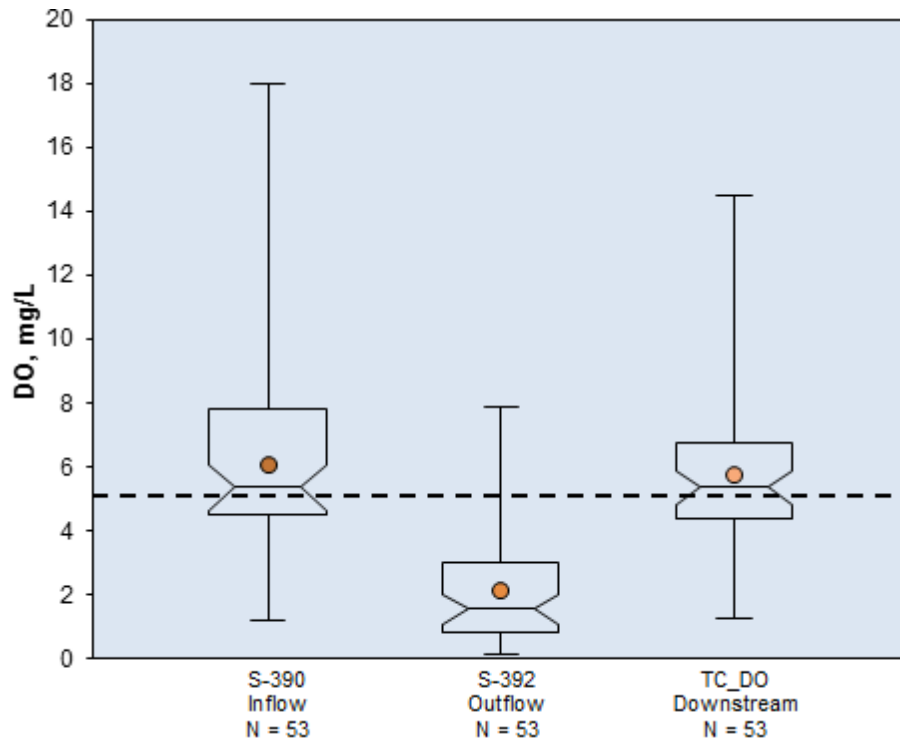
Figure 7. Notched box plot showing dissolved oxygen (DO) concentrations measured at the TC-STA in WY2013. Bottom and top of box are 25th and 75th percentiles, respectively, and line inside box is 50th percentile (median). Ends of whiskers represent minimum and maximum values; dashed line represents lower limit of the Florida Class III criteria for predominantly fresh, surface water (5.0 milligrams per liter or mg/L) and solid orange dots represent mean DO concentrations.

A notched box plot of the data was constructed to show differences in DO concentrations among locations for the following: smallest observation (sample minimum), lower quartile (Q1 or 25th percentile), median (Q2 or 50th percentile), upper quartile (Q3 or 75th percentile), and largest observation (sample maximum) (**Figure 7**). DO concentrations measured at the inflow showed higher variability than those collected at other locations. Range, defined simply as the difference between the minimum and maximum values, was 16.8, 7.8, and 13.2 mg/L at the inflow (S-390), outflow (S-392), and downstream (TC_DO) locations, respectively. Percentile values were highest at the inflow structure, with 50 percent of the observations (median or 50th percentile) having DO concentrations of greater than or equal to 5.37 mg/L. Compared to DO concentrations at the inflow station, DO concentrations at the outflow point were much lower, with 50 percent of the observations having DO concentrations of greater than or equal to 55 mg/L. DO levels below 5.0 mg/L are fairly common in macrophyte-dominated wetlands where photosynthesis and respiration result in wide diel swings in DO levels (Ivanoff et al., 2013). DO concentrations at the downstream location (TC_DO) were much higher than those measured at the outflow station, with a median value (50th percentile) of 5.36 mg/L. In the notched box plots (**Figure 7**), if the notches of two boxes do not overlap, there is a statistically significant difference between medians. As such, the median DO value at the inflow point of the STA was significantly higher than the median DO concentration at the outflow structure but not at the downstream location. The calculated mean DO values (solid orange dots in **Figure 7**) were slightly higher than the median DO values at all locations. Mean DO levels at the inflow (6.04 mg/L) and downstream (5.73 mg/L) locations are slightly higher than DO values recorded in WY2012 (Villapando, 2013), and are above the lower limit of the Florida Class III criteria for predominantly fresh, surface water (5.0 mg/L, as specified in Section 62-302.530, F.A.C.; see **Table 5**) (dashed line in **Figure 7**). While the mean DO concentration at the outflow was not greater than the mean DO concentration at the inflow, the mean DO value of 5.73 mg/L at the downstream location, and the associated decrease in outflow TP concentrations (see **Table 8**) keep the TC-STA in compliance with Specific Condition 8B.
